Historic Structures
Investigation Report

Hill-Woody House

Madison Heights, Virginia

Restoration Field School

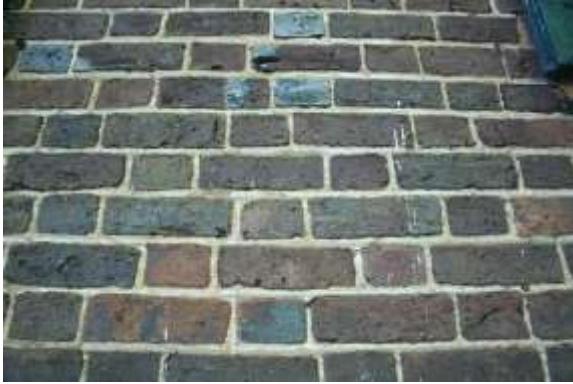
Typical water-struck brick

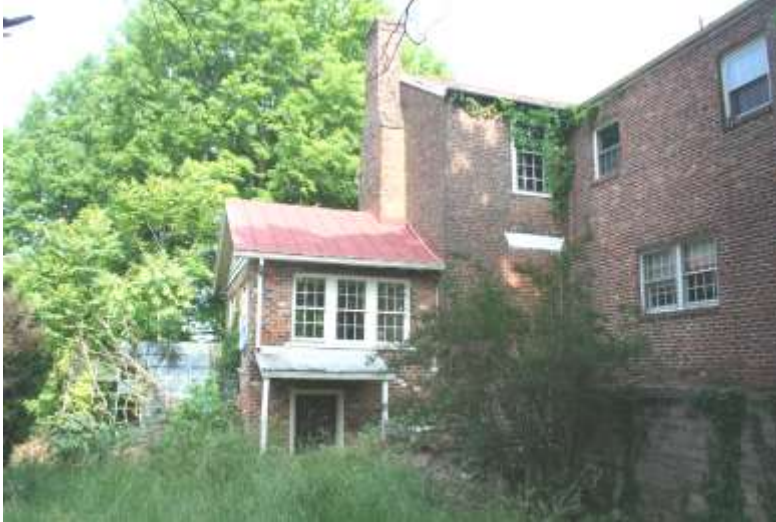
East Elevation, south side

The walls in this section are of a combination older and newer bricks varying in size (2.5" x 8" x 3.5" to 3" x 8" x 3") in a stretcher bond with closers mortared in Portland Cement. Spalling was observed on some bricks.

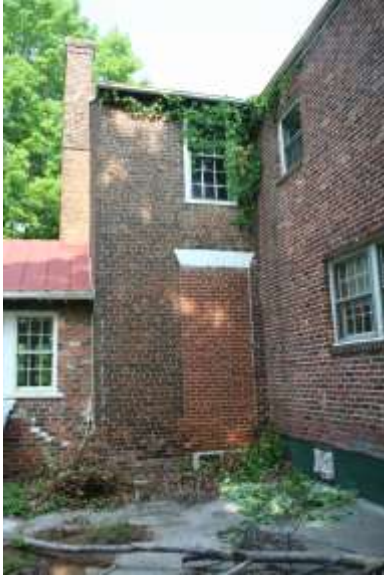
window also on the eastern elevation, found on *East Elevation of* the same original structure wall further, north (102, W 2) . The brick, sand -struck, used to fill in this ghost mark area, laid in 1:5 common bonding, is newer brick, sized on average at 2.5" x 8.25" x 4", and was applied with what appears to be an oyster shell mortar.

East Elevation of original house, south end, with bricked-up window.

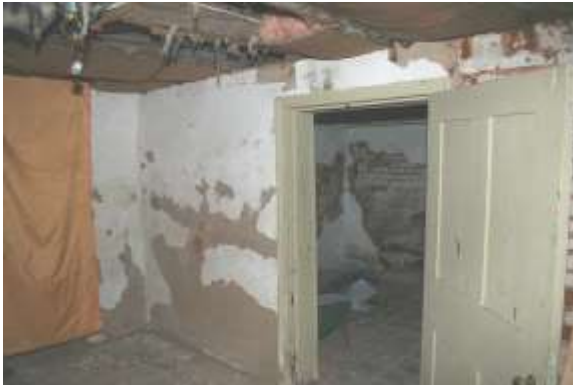
East: North side of wall has failing plaster with exposed wire mesh. South side of wall had exposed, light red brick with oyster shell mortar.

Room 001 View to Northeast

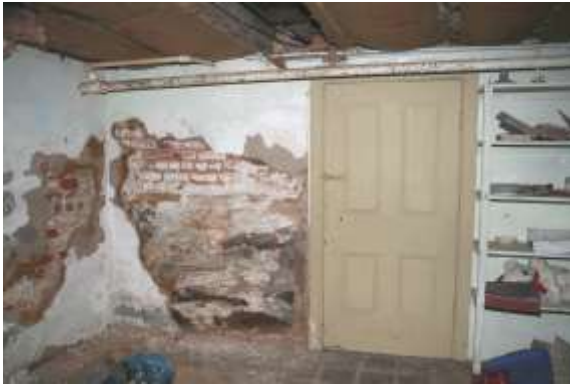
Room 003 East Wall

The east wall is constructed of first stone and then brick, like the north wall, and with the same layers of plaster in evidence. On the east wall, in the bottom northern corner, the plaster which has crumbled away to leave a cross-section of the wall reveals nails which were beneath all the plaster and therefore must have been put in prior to the plastering. Also a nail which is beneath the first two layers of plaster, possibly originally holding the metal lath to the wall, since it is surrounded by the rust ghost marks.

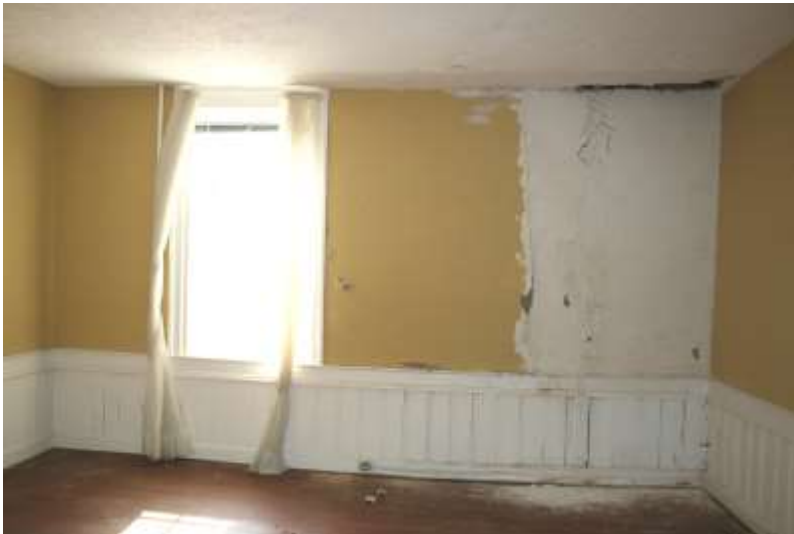
The wainscoting, painted white, was of 7" wide tongue and groove pine boards which were double beaded. Water and termite damage was visible on the East wall. The surbase appears to be original, however the wainscoting appears to be from a later date, perhaps covering the water damage on the lower portion of the wall.

Evidence of water damage was apparent on the East and West walls. Replastering on walls was also apparent, although not repairing the visible water damage. A cut nail was pulled from the wainscoting, which was collected for sampling. The architrave around the window is two part, 6".

Room 101, east wall

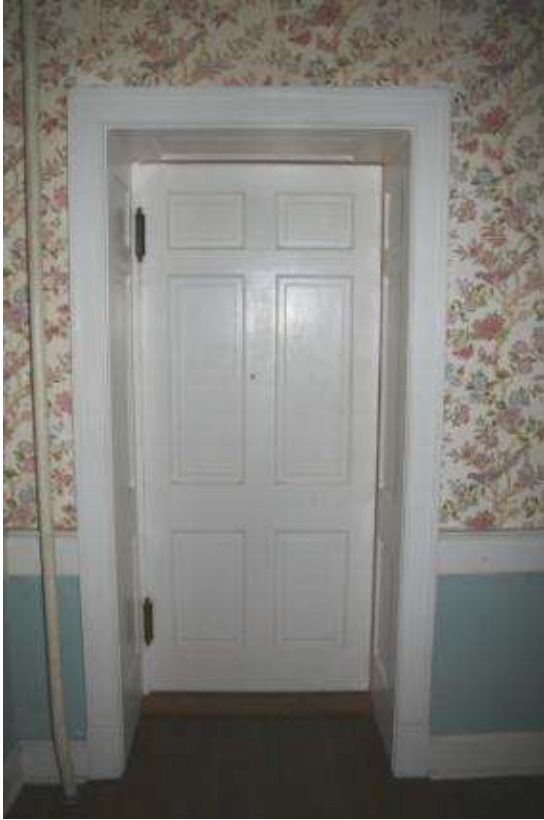
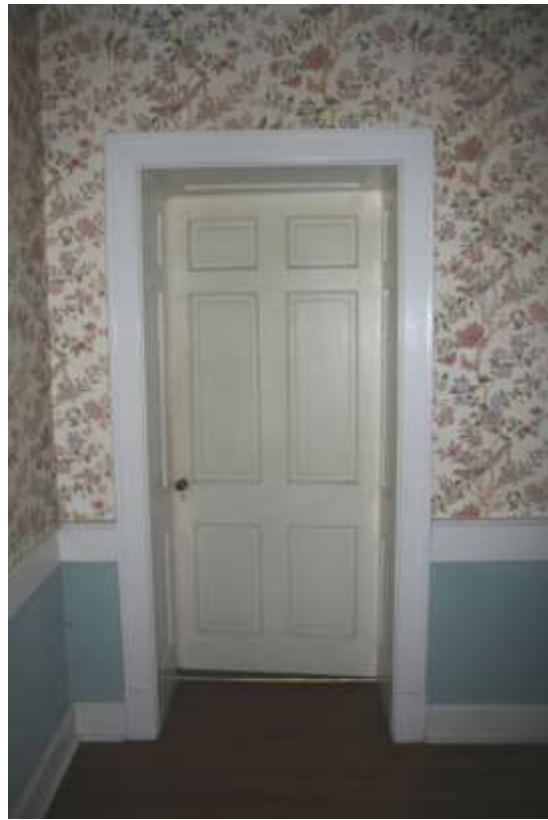
Door 2 on the east wall provides access to the kitchen in the addition, room 103. This door remains and swings both ways. The door is 7'0 ½" high. The doorway is 3'1" wide and 1'6" deep. (This also indicates an original exterior wall thickness of 1'6".) The doorway from room 102 to room 103 was previously a window, until the kitchen addition (see windows below.)

Door on east wall, used to be window Door to sunroom addition on south

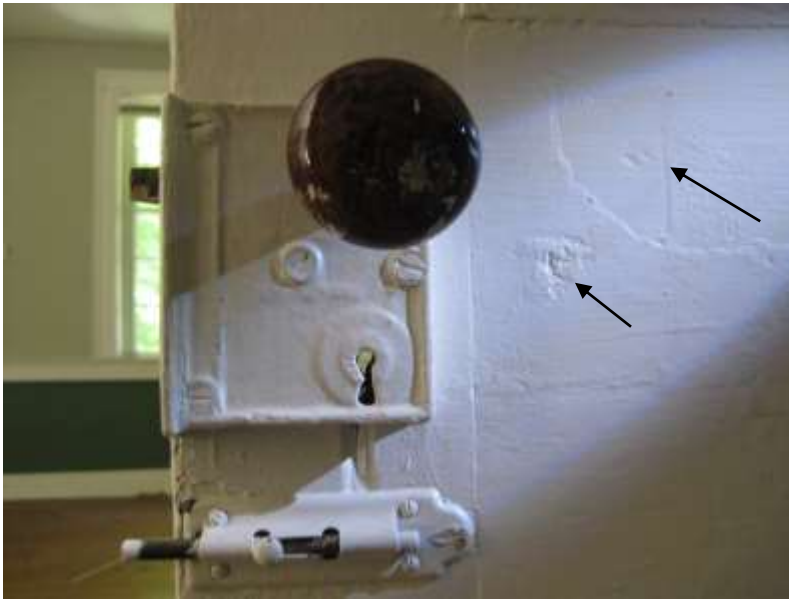
Room 205 Evidence of original lock system covered by paint (see right of doorknob)

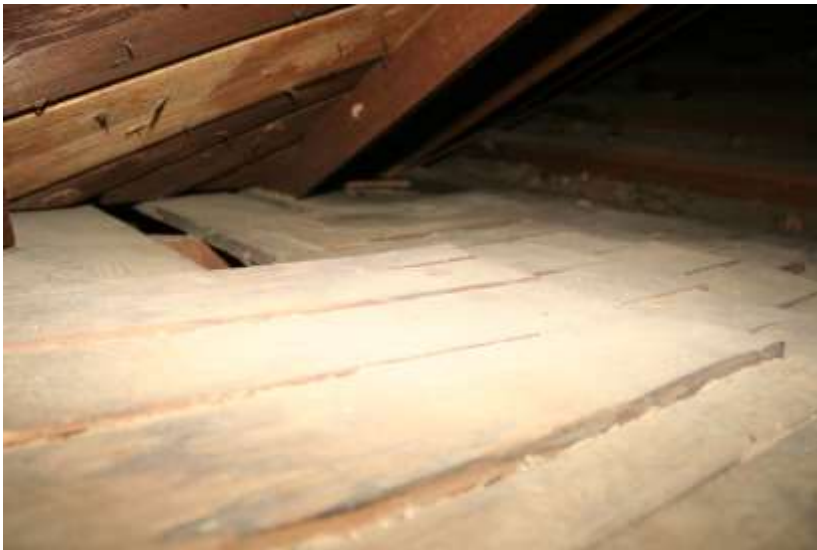
When the west portico was built it encapsulated some of the west roof. A hole in the sheathing from the main roof allows a view into the portico space. The 18" square-butt chestnut shingles have a 6" exposure and show evidence of red paint/stain (see Pictures). A nail pulled from one shingle appears to date to the mid-early 19th Century and does not match other hand wrought nails extant in the framing, indicating that the shingles were probably a second period covering, replacing a first period shingle roof (the encapsulated shingles were also in very good shape with little signs of weathering). The shingle roof was replaced prior to the addition of the portico. The lumber in the portico roof is circular-sawn material, indicating that it is no earlier than mid nineteenth-century. The Greek Revival style would suggest a late antebellum date.

Shingles of west roof slope preserved under west portico pediment roof
