(Attic 3rd floor)
Room 302

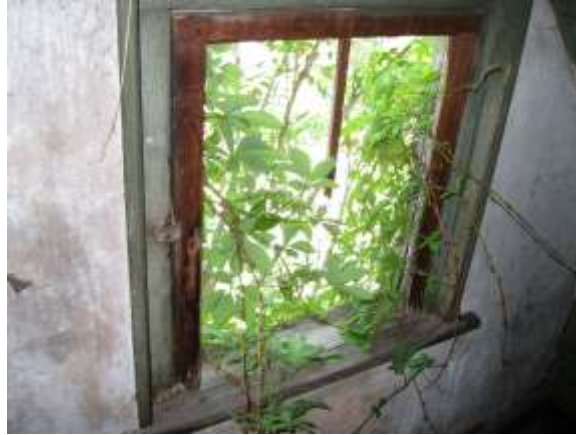
(Figure 1, W-W-2)

To the west of the room two small windows are installed. The window to the north (W-W-2) measures $24 \frac{2}{4} \times 30 \frac{1}{2}$, it has a shallow trim of $1 \frac{1}{8}$ (*see figure 1*). A wooden toggle was found on W-W-2 to hold cement in place attached a hand wrought nail. There is also a simple trim that outlines the window (W-W-2), it was metered upper cornices and butted to seal pieces that extend $2 \frac{1}{2}$ beyond the window frame on both sides (*see figure 2*). The window to the south (W-W-1) measures to $28 \frac{7}{8} \times 30 \frac{3}{4}$, this window's shallow trim measures to $1 \frac{1}{4}$. Both windows are inconsistent with window measurements from the first and second floors. The windowsills of both windows carried traces of green deteriorating paint.

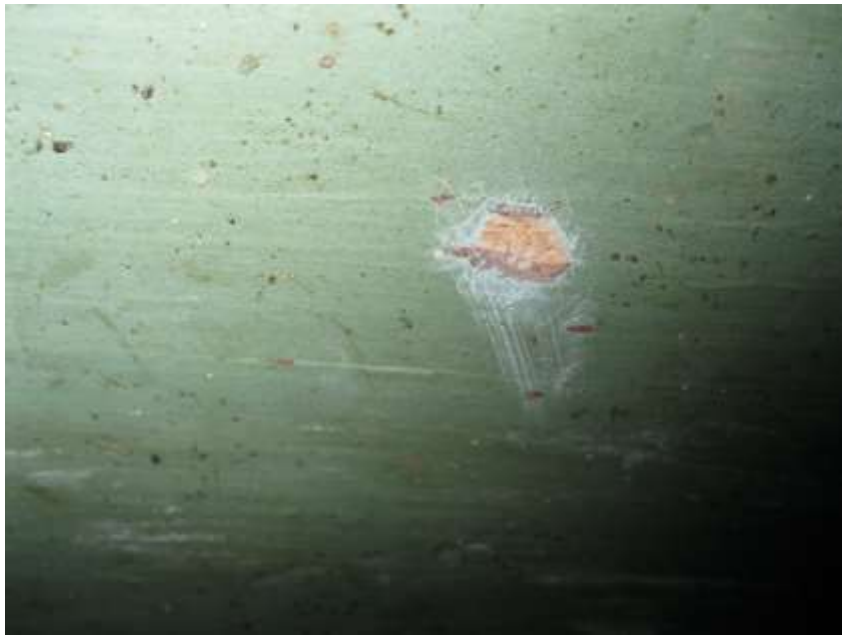
(Figure 3, attic wall)

The walls of the attic are wooden panels that were covered in green paint (*see figures 3 and 4*). The wooden panels used to create the wall were inconsistent in

size. The wall to the west seems to be covered with plaster. There is also a knee wall on the southern section of the room. The height of the knee measures to 35 3/8. The upper area between the door frame and knee wall is 45 inches. The wall boards near this knee are of various sizes. They range from 9 1/2 inches to 12 inches.

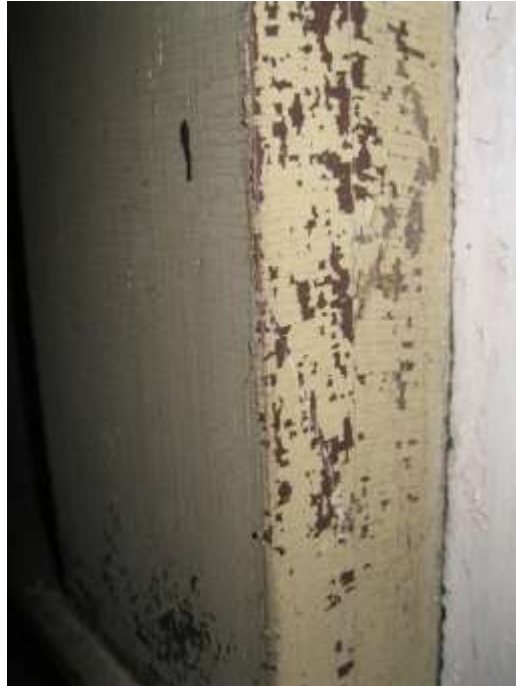
(Figure 5, door frame)

The door (D-E-1) was missing from the entrance (*see figure 5*). The door frame measures to 33 $\frac{7}{8}$ X 72 $\frac{7}{8}$. It has a simply butt trim that measure to a width of 3 $\frac{5}{8}$ and has a hanging lock hinge on the frame with leather washers. In addition, the

door jam measures to 4 inches. The door itself is missing from the attic. A door that was placed on the northern side of the attic did not fit the door frame's measurements. Therefore, it is impossible that this door once belonged to the attic.
