# 405 Cabell Street

This is a brief summary of the Poplar Forest Restoration Field School investigation of the Dabney-Scott-Adams dependency building at 405 Cabell Street. A more complete report will be forthcoming.

Reference: Building at 405 Cabell Street  
Lynchburg, Virginia  
MEAD Project No. 262-116

REPORT ON STRUCTURAL INSPECTION  
405 CABELL STREET  
LYNCHBURG, VIRGINIA  
MEAD PROJECT NO. 262-116

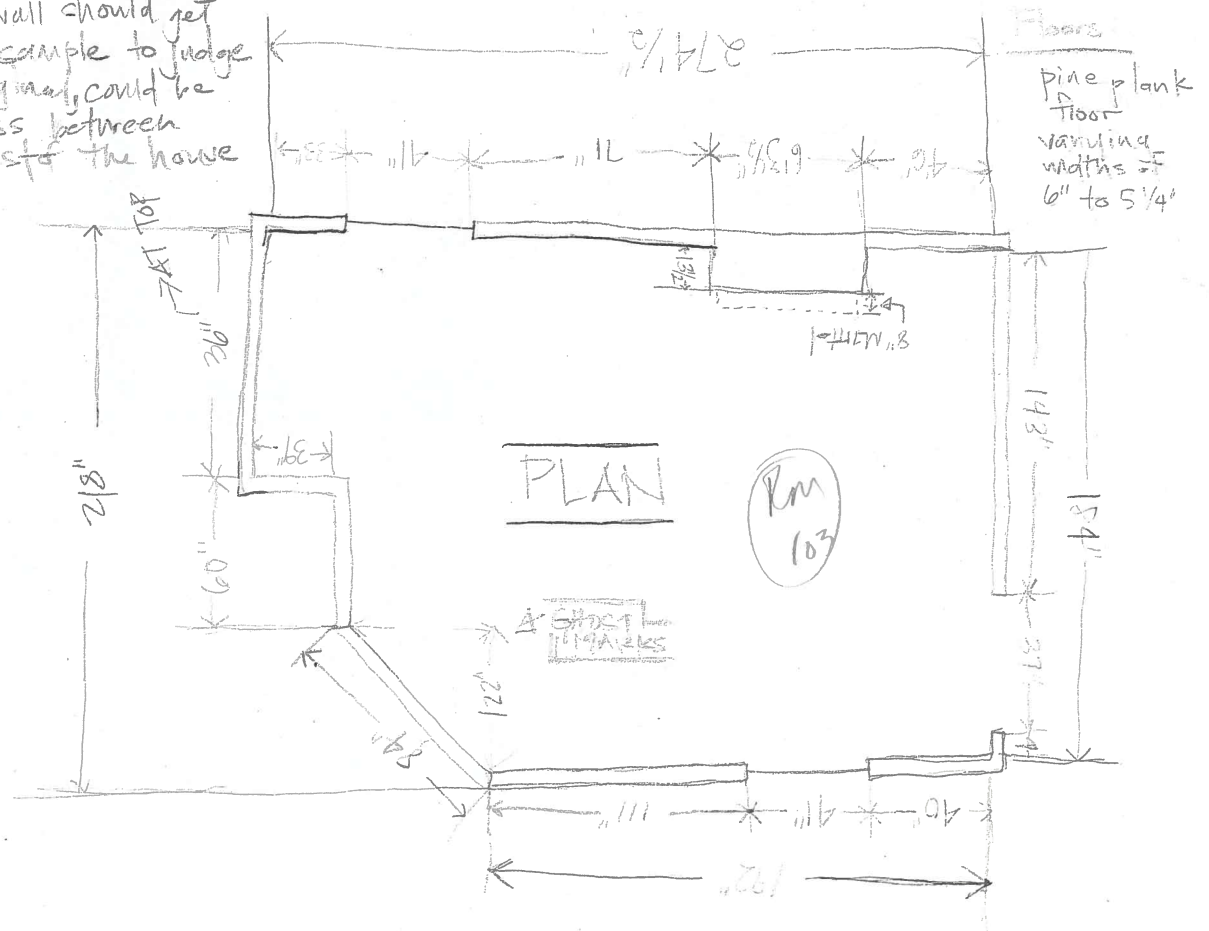
Walls:  
Lath on diagonal wall contains wire nails - no earlier than 1880.

Stairs  
underside of the stairs is plaster.

doors:  
pine door  
un-original hardware  
evidence of original hinges is on the inside of the jamb.  
Door knob is also a later addition as there is evidence of older hardware below

exterior facing walls  
Walls are plaster over lath. plaster is 3/4 inches thick. Walls are 13 3/4" thick

interior facing walls  
Walls are lath & plaster

↳ diagonal wall should get a plaster sample to judge if its original, could be older access between this part & rest of the house

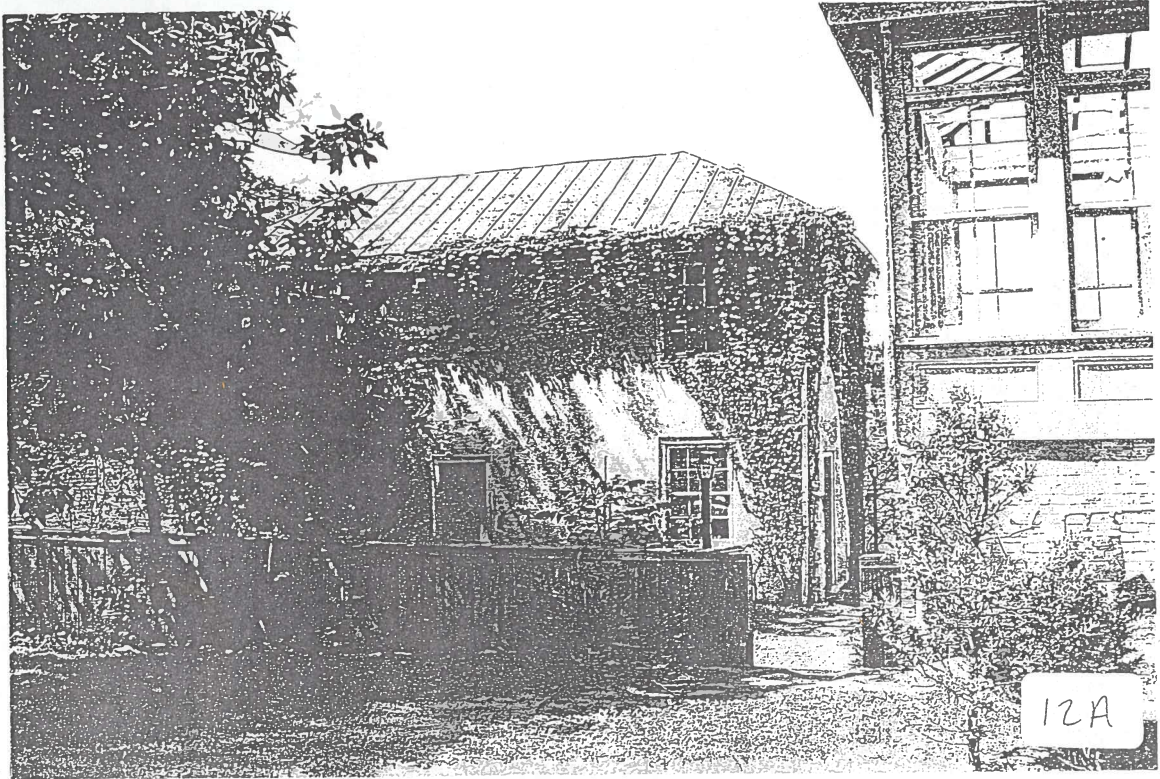
12A

The exterior of the building is partially covered with vines, which, in some cases, have attached themselves to the building and in cracks in the stucco and have grown between the stucco and the brick. Photograph 12-A shows the north face of the building and vines along the northwest corner and all along the eave at the roof level. The south wall of the building shows extensive damage where the stucco has come loose and fallen and shows the damage where the roof has been torn up by weather and allows rainwater to enter the building. Photograph 10-A shows the south and east walls of the building and, again, shows the extensive vine growth as well as the leaning of the chimney on the south wall of the building and a lesser leaning of the chimney on the east wall of the building. The east elevation of the exterior of the building is shown in Photograph 11-A, which, again, shows the growth of vines and a very perceptible leaning of the chimney in the east end wall of the building.

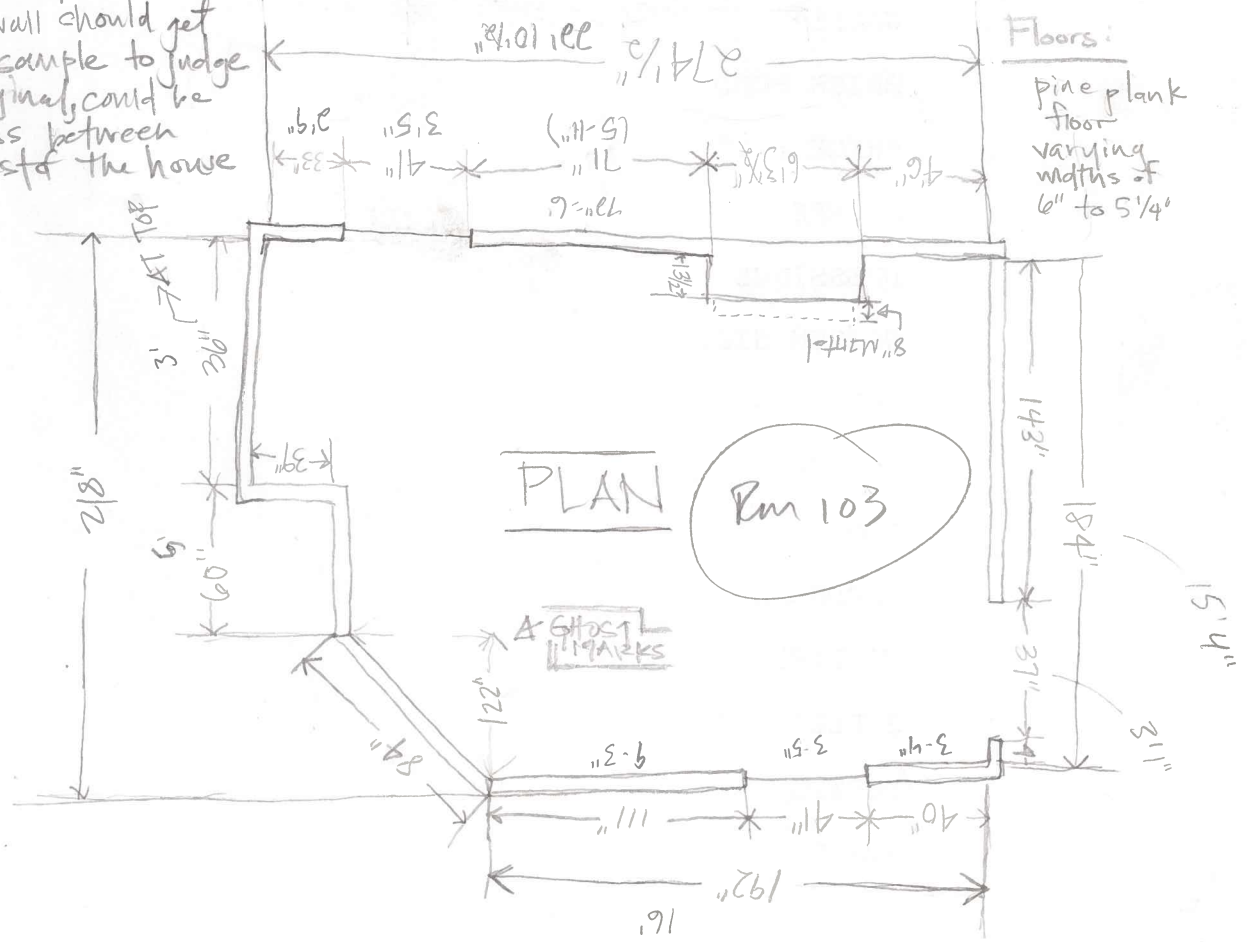
Walls:  
Lath on diagonal wall contains wire nails - no earlier than 1880.

stairs:  
underside of the stairs is plaster.

doors:  
pine door  
un-original hardware  
evidence of original hinges is on the inside of the jamb.  
Door knob is also a later addition as there is evidence of older hardware below.

Floors:  
pine plank floor  
varying widths of 6" to 5 1/4"

↳ diagonal wall should get a plaster sample to judge if its original, could be older access between this pm & rest of the house
