West Elevation

No foundation is evident under this portion of the house, and the brick extends directly to ground level without differentiation.

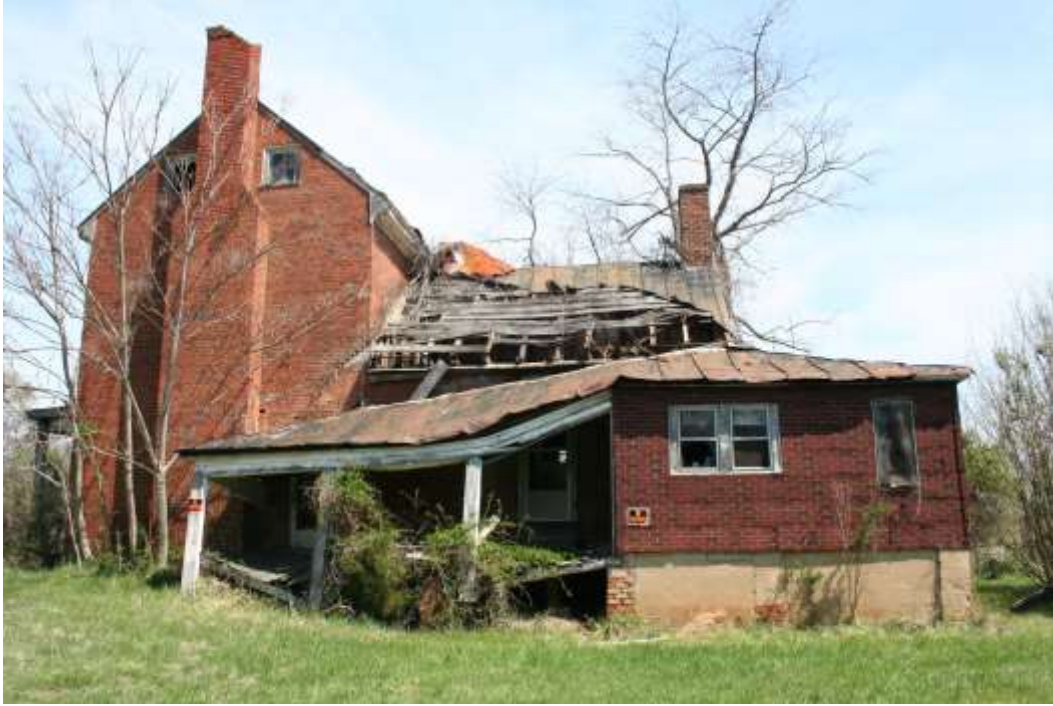
Figure 1 (TM Picture 216): West Elevation of Oakland, showing the three construction phases from north to south, and current condition of building.

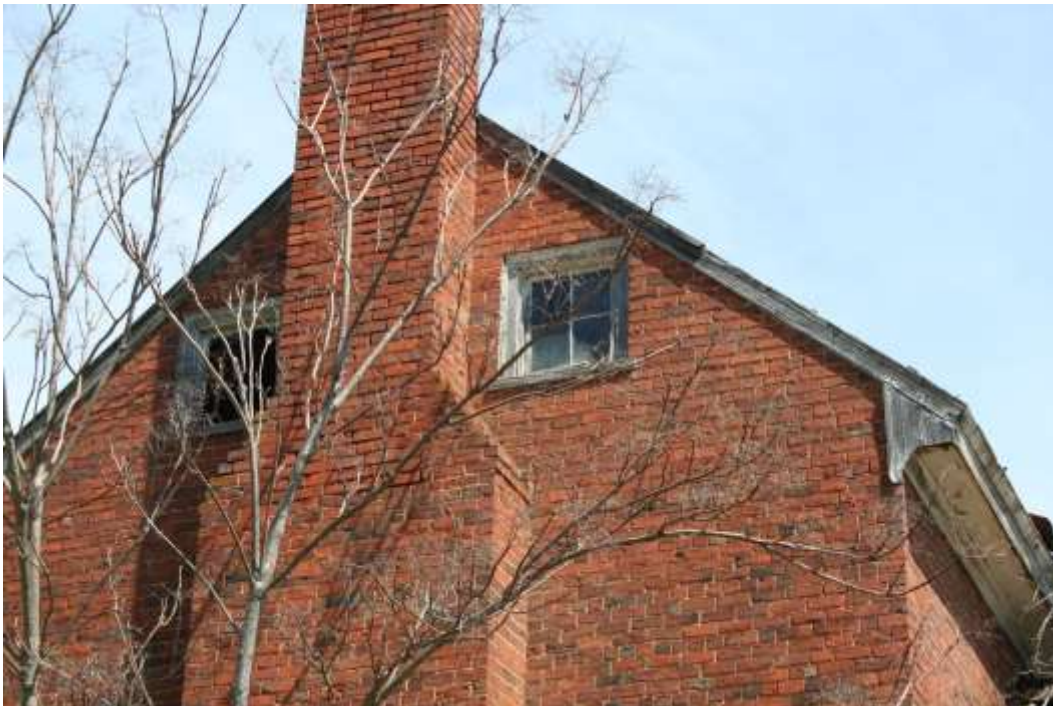
Figure 2: (TM Picture) Oakland, west elevation, showing chimney, attic windows, eave trim and cornice.

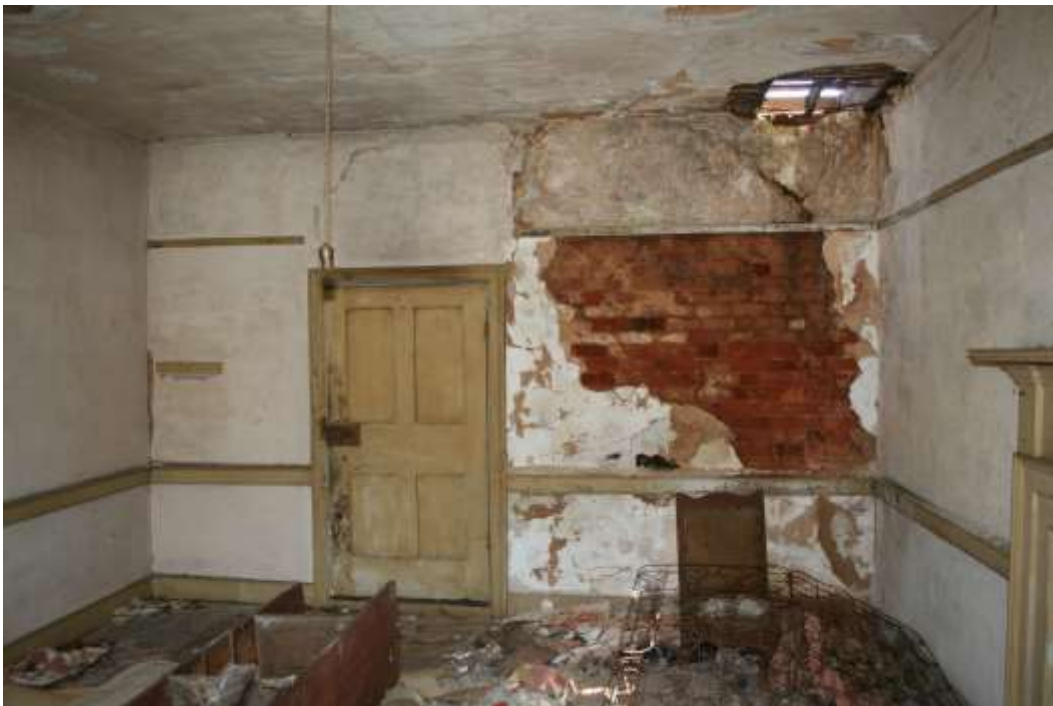
Figure X. (TM picture) Oakland, Room 202, showing door D-S-01 in south wall, exposed interior brick, and existing water damage to ceiling and wall.

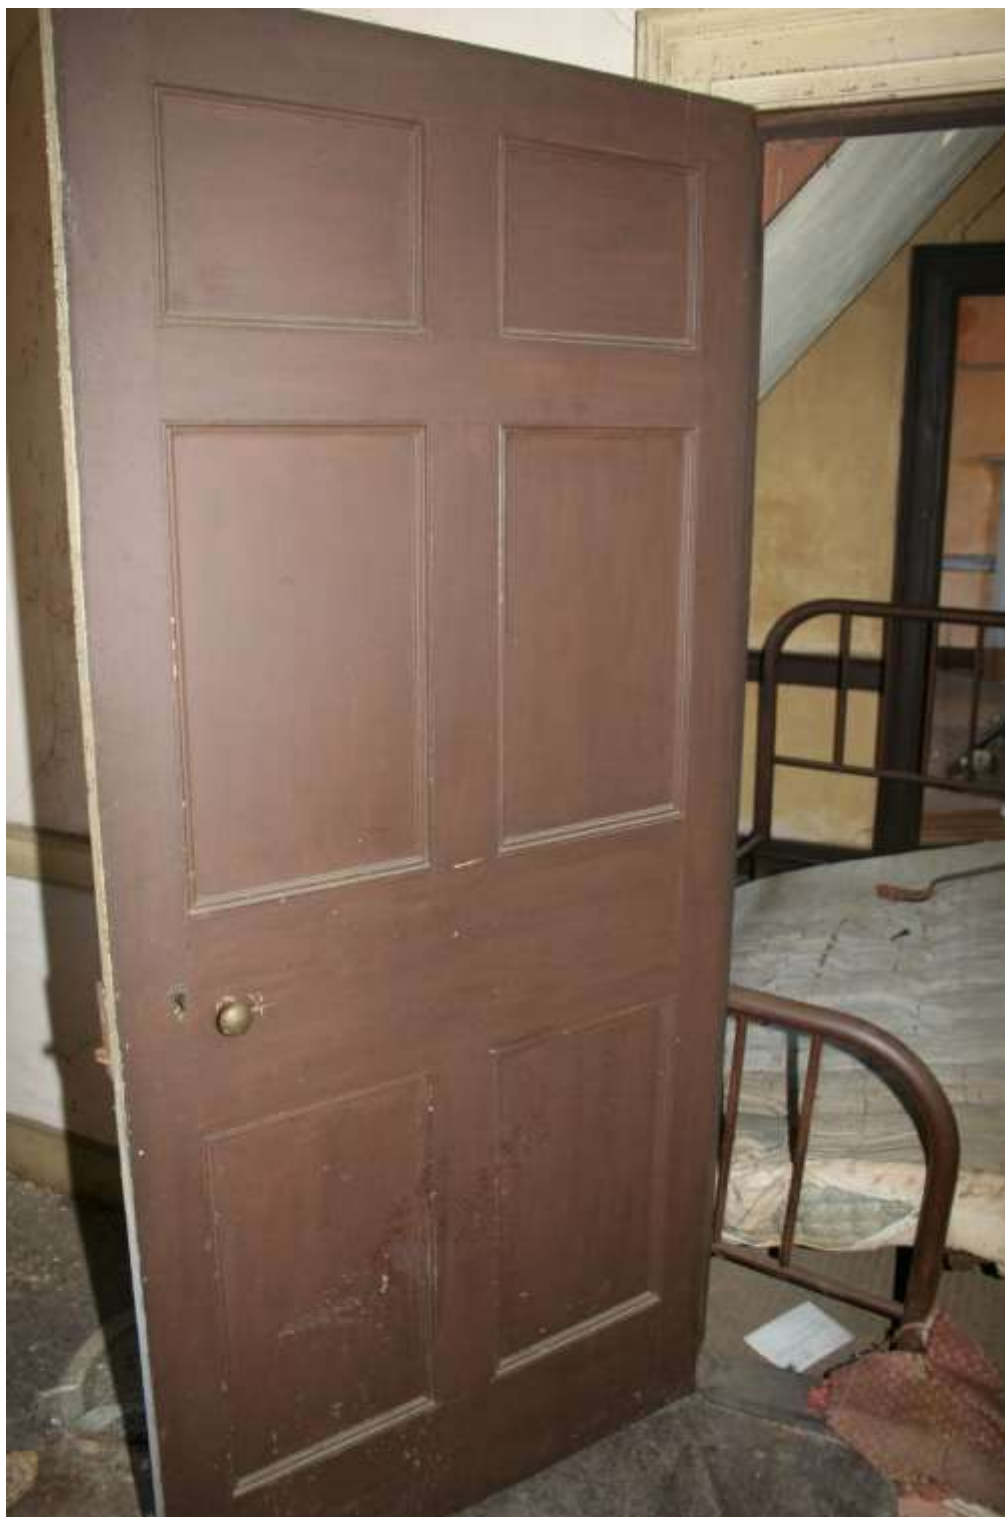
Figure X. (TM picture) Oakland, Room 202, hall face of door D-E-01 showing flat recessed panels, hardware, color and trim.
