Dabney-Scott-Adams House

Chris + Lara
6-6-01

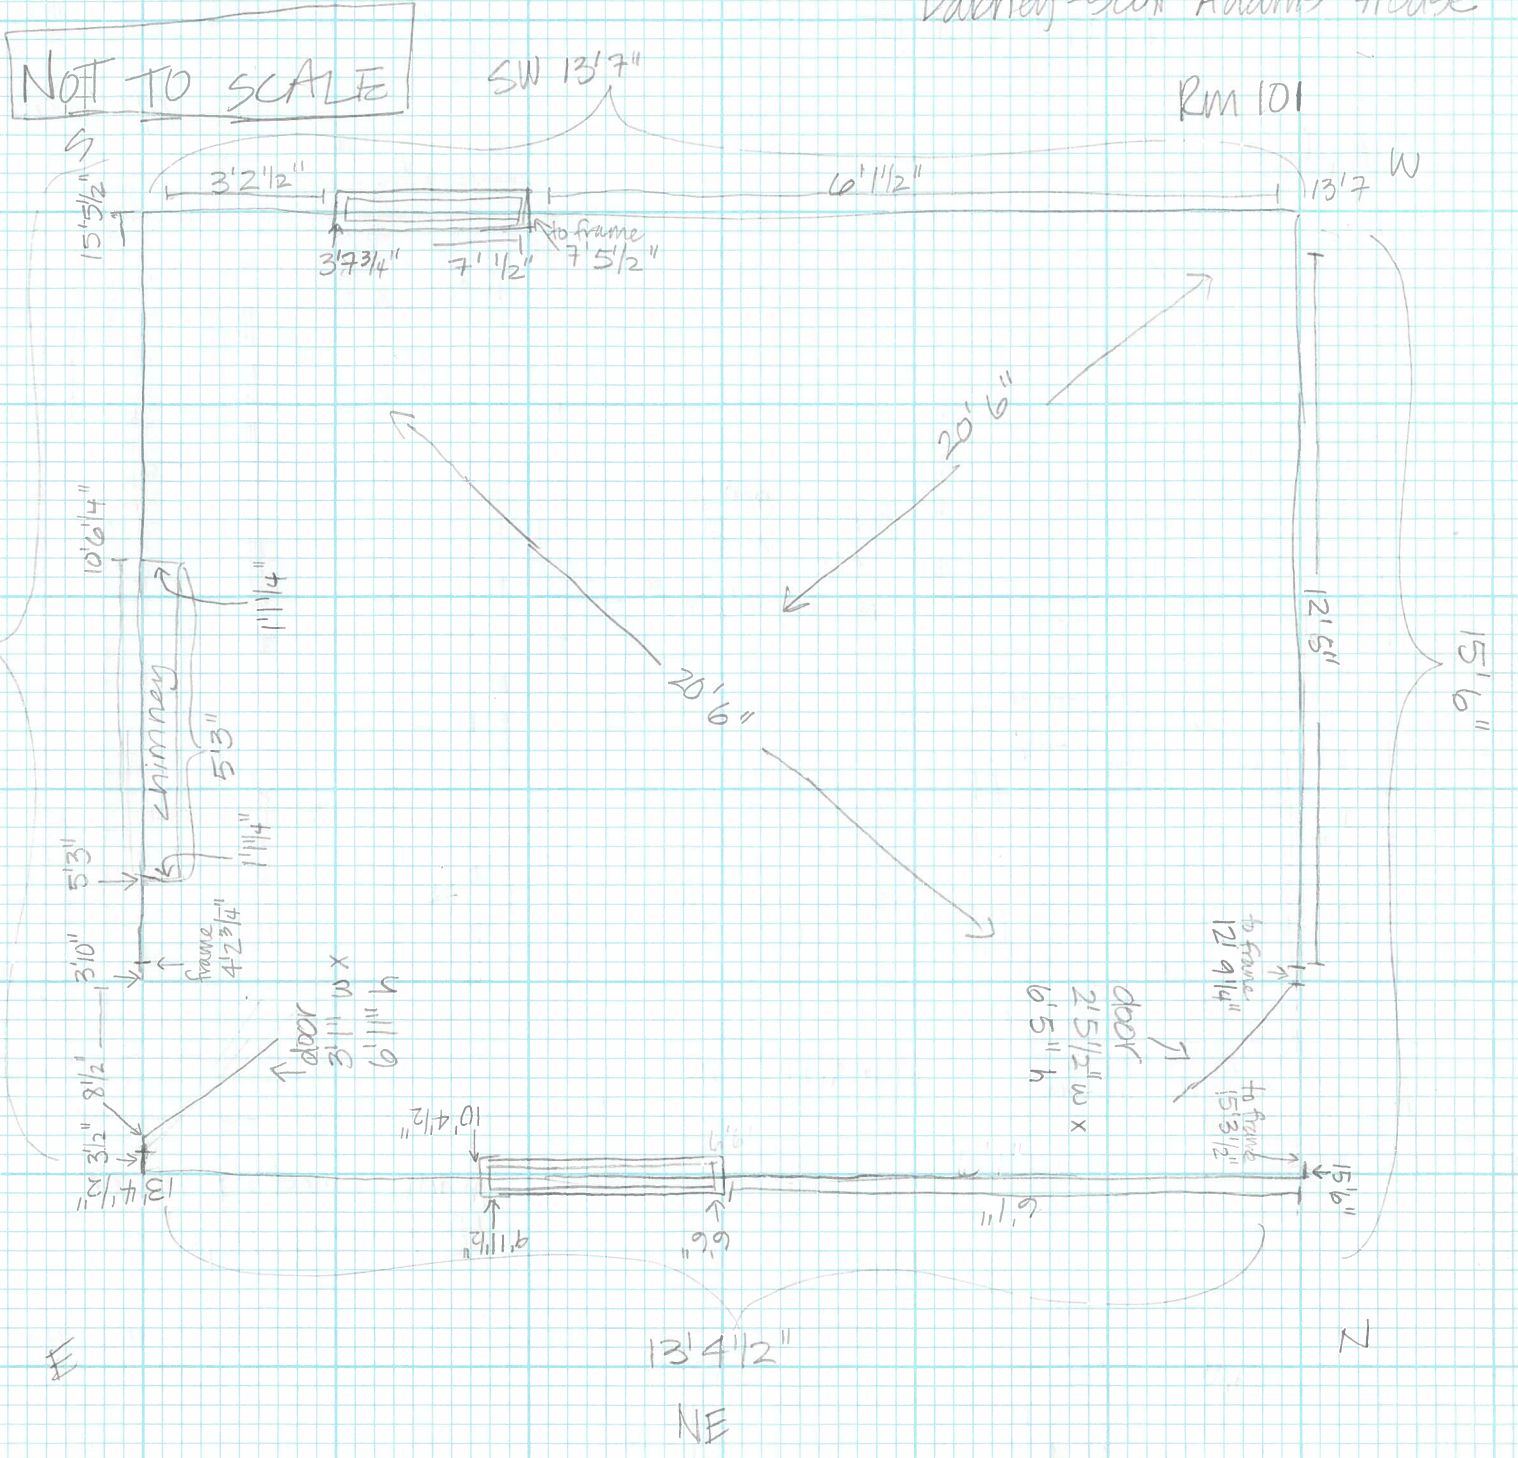
- W corner ceiling to floor 9'
- N corner ceiling to floor 9'1 1/2"
- E corner ceiling to floor 9'1 1/2"
- S corner ceiling to floor 9'

Bowed plaster & lath on walls & ceiling

A. Curious door
(from Rm. 101)

B. Damaging ivy

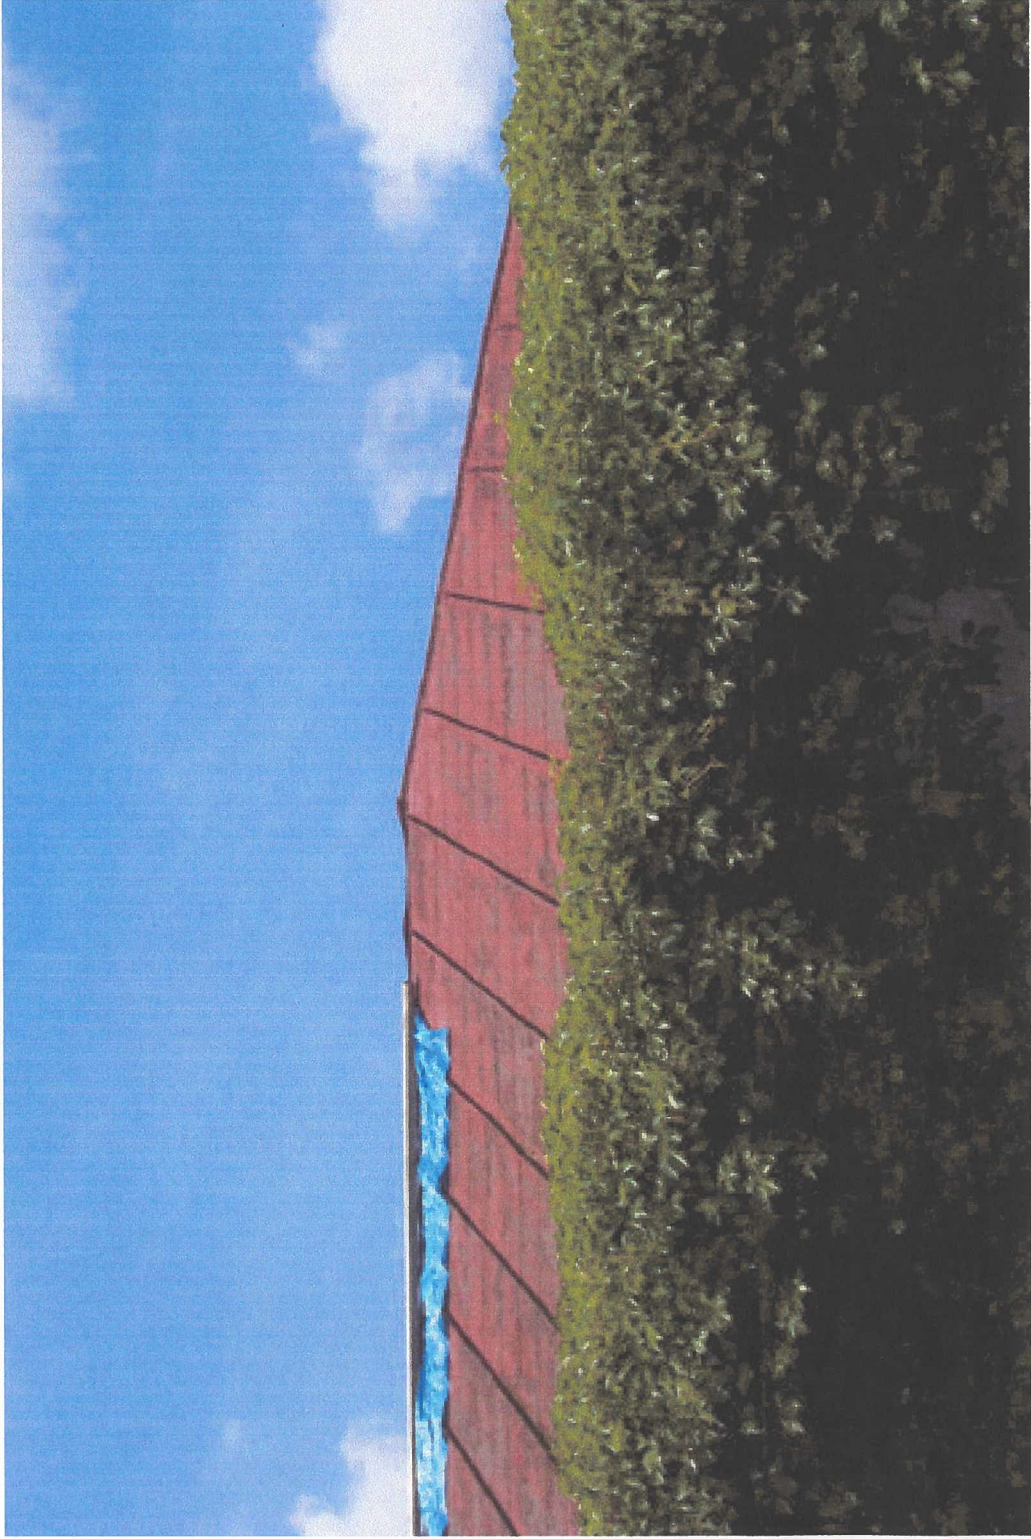
ORIGINAL STANDING SEAM ROOF

- A. Deteriorating paint and plaster
- B. stucco finish pattern visible
- C. sample taken

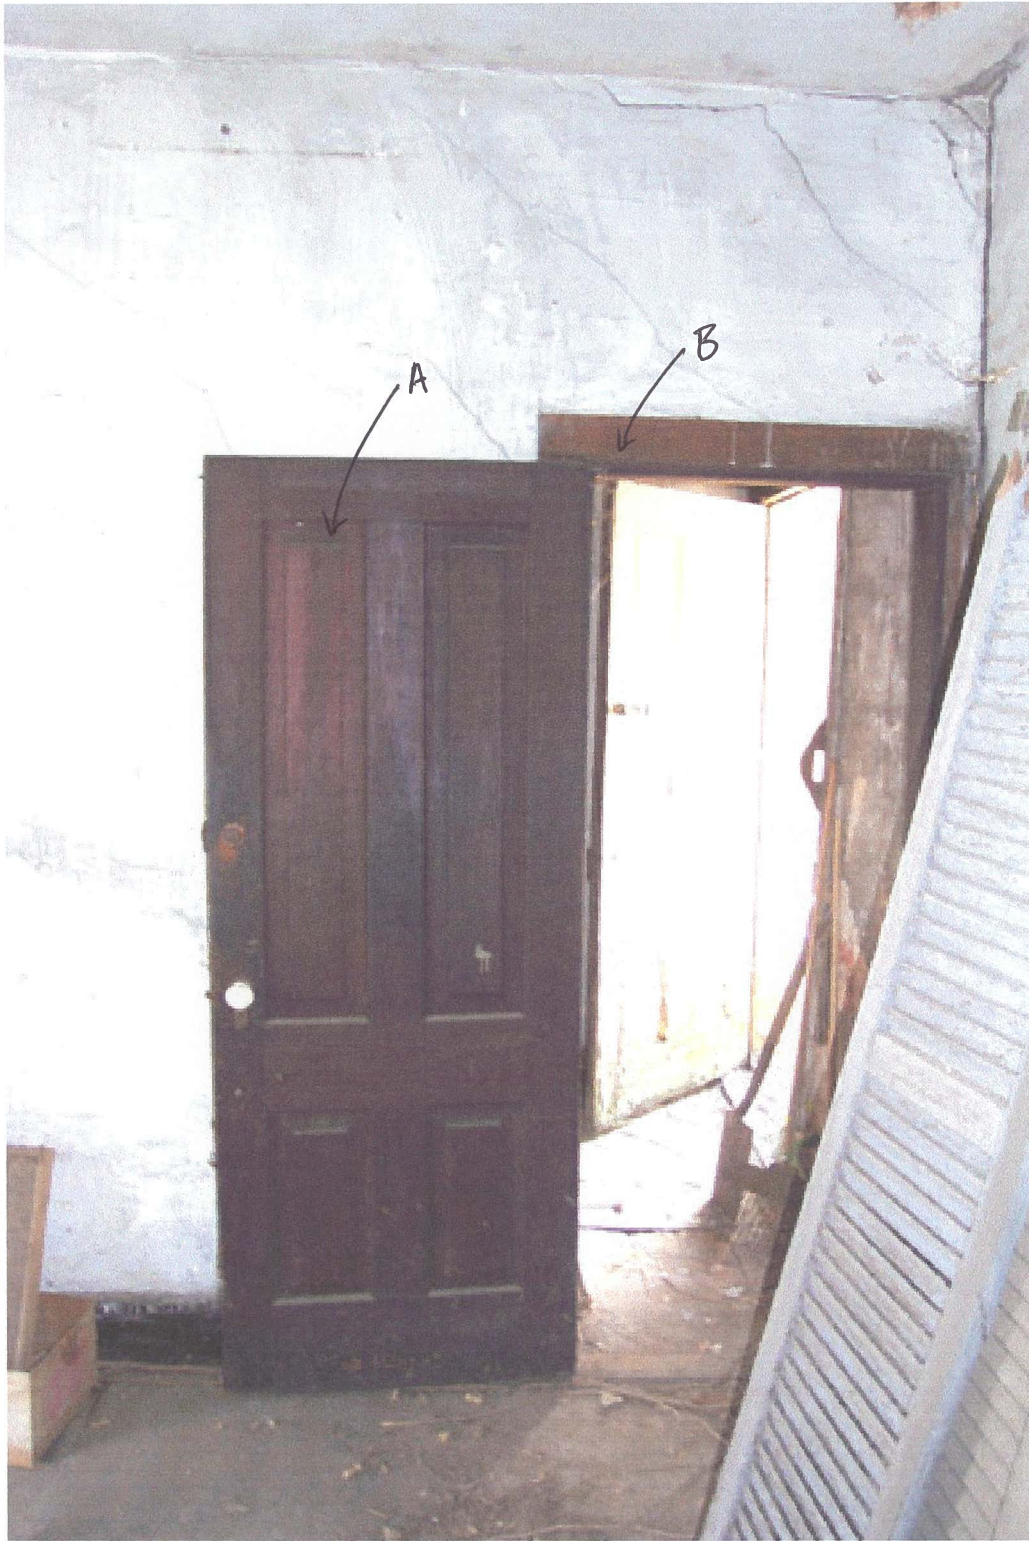
101
NORTH WALL

- A. only raised panel door in the house (probably not original)
- B. door frame does not match others
