### Dalony-Scott, Adams House

# Dabney-Scott-Adams House

ARCHITECTURAL FIELDWORK

STRUCTURE ~~BARBARA~~ DABNEY SCOTT ADAMS TENANT HSE.

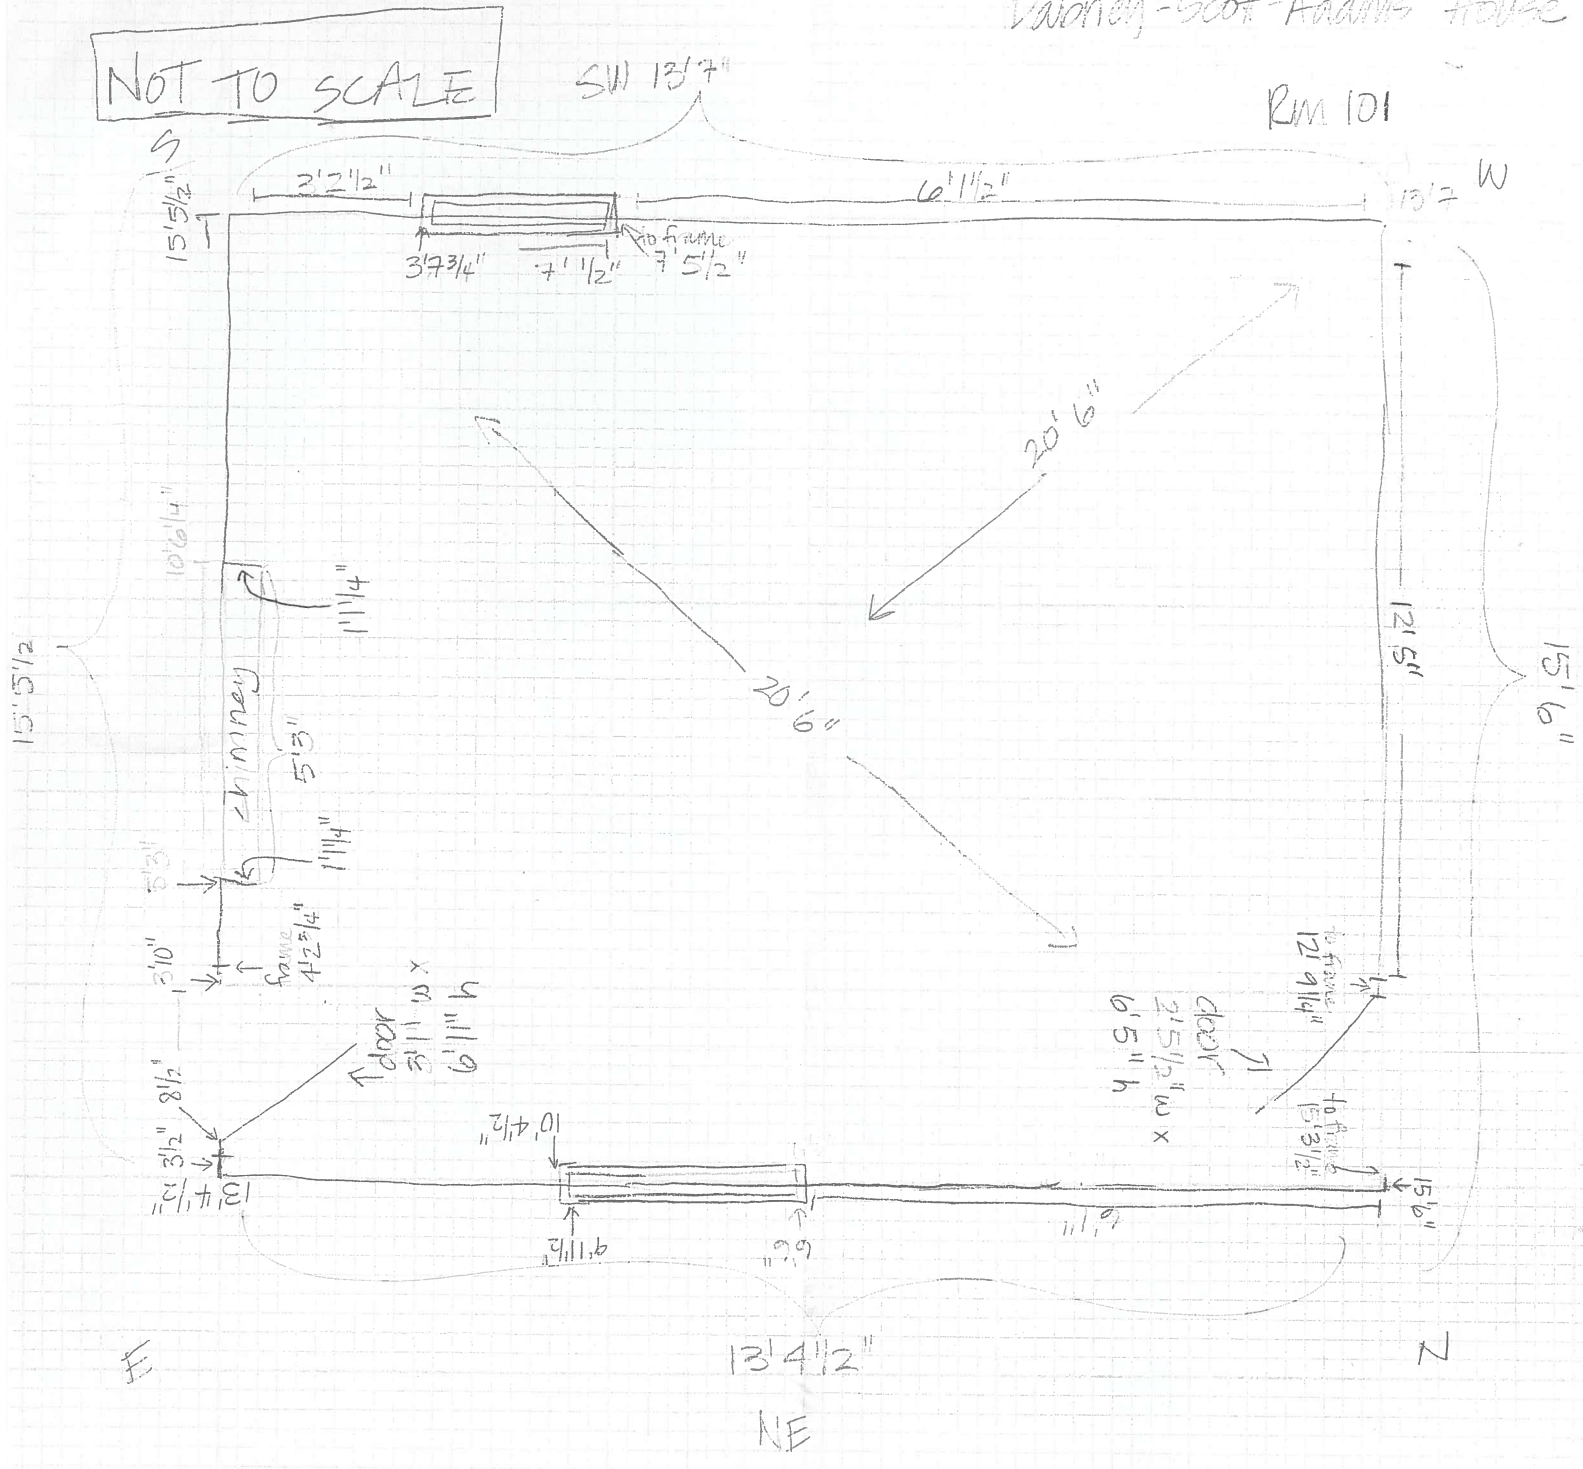
Rm 101

- W corner ceiling to floor 9'
- N corner ceiling to floor 9' 1"
- E corner ceiling to floor 9' 1"
- S corner ceiling to floor 9'

Bowed plaster & lath on walls & ceiling

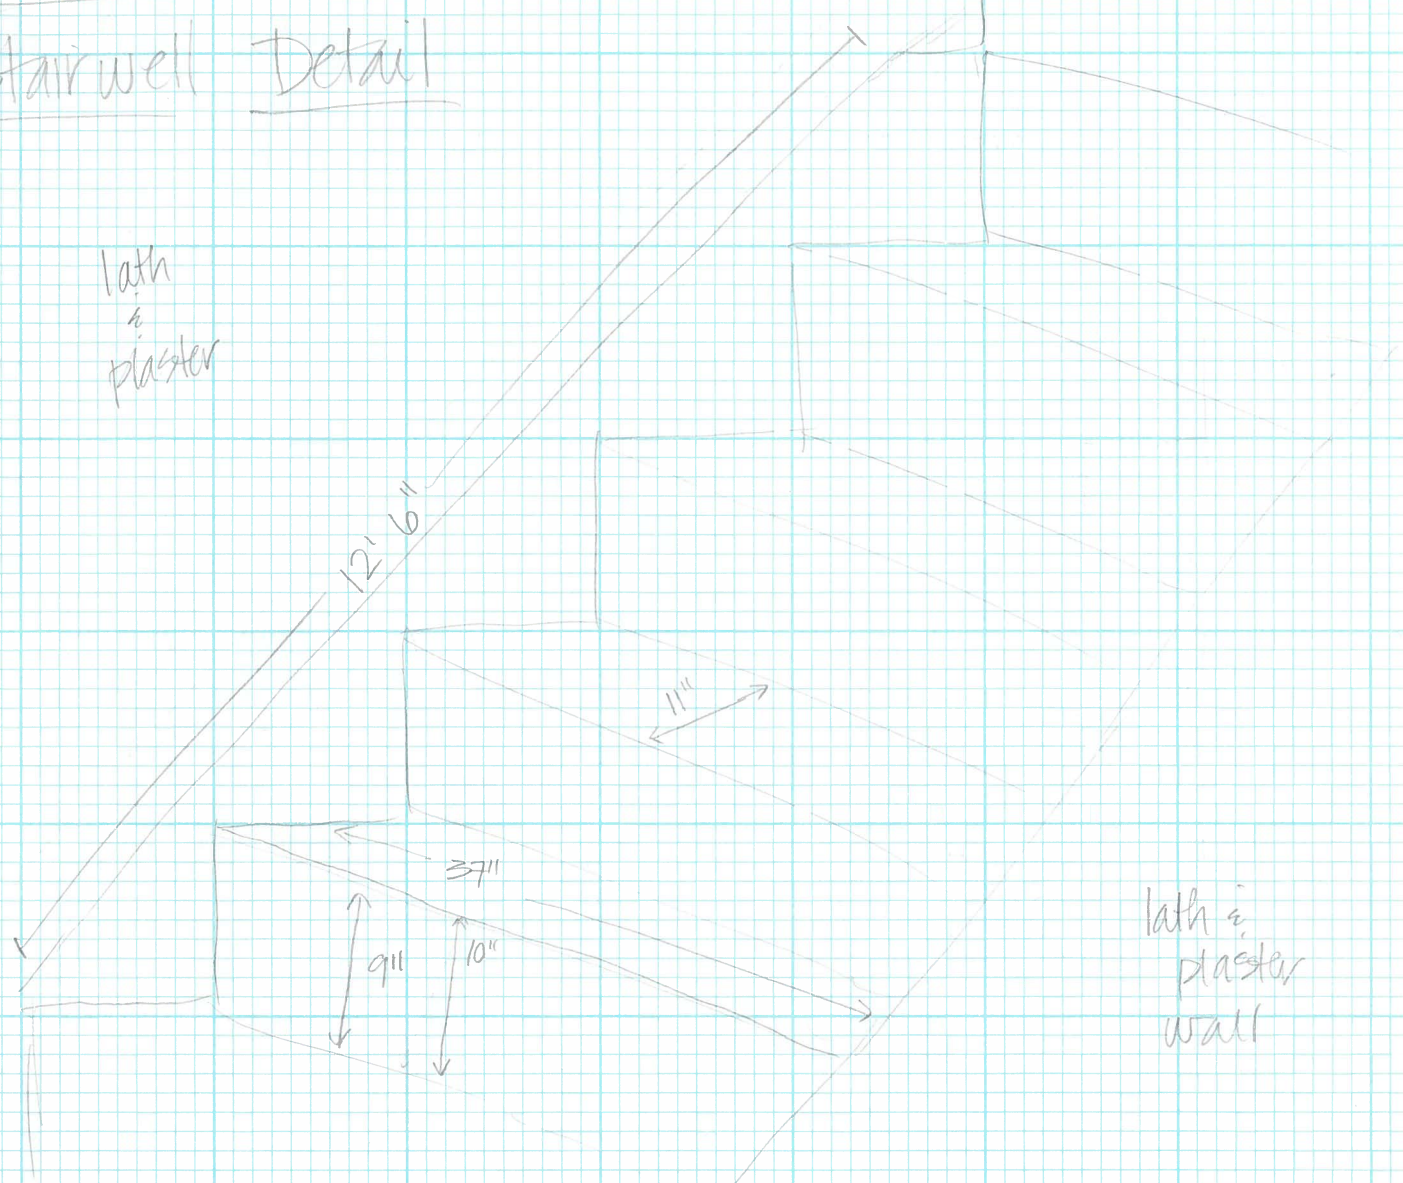
Stairwell Detail

lath & plaster

lath & plaster wall

Flattened newel  
 12 stairs  
 4x4 Newel post  
 1 1/2 x 3/4 balusters

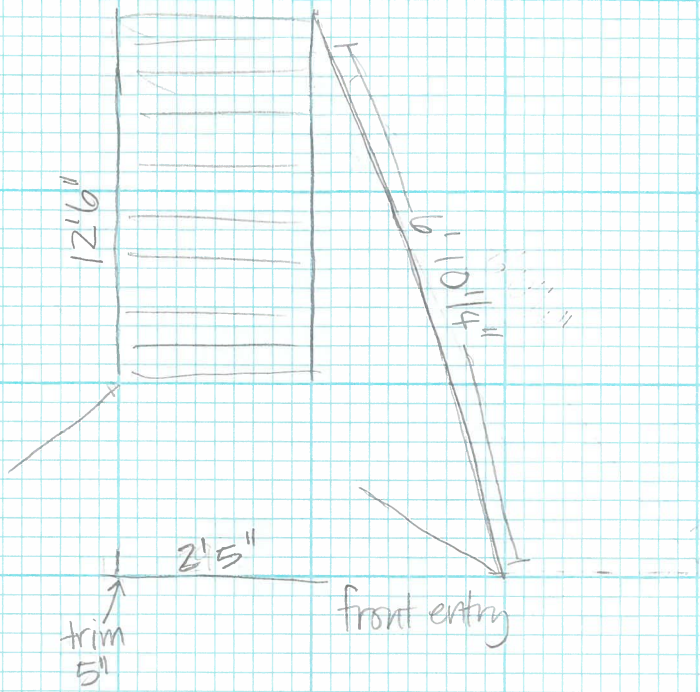
Rm 102

Stairwell

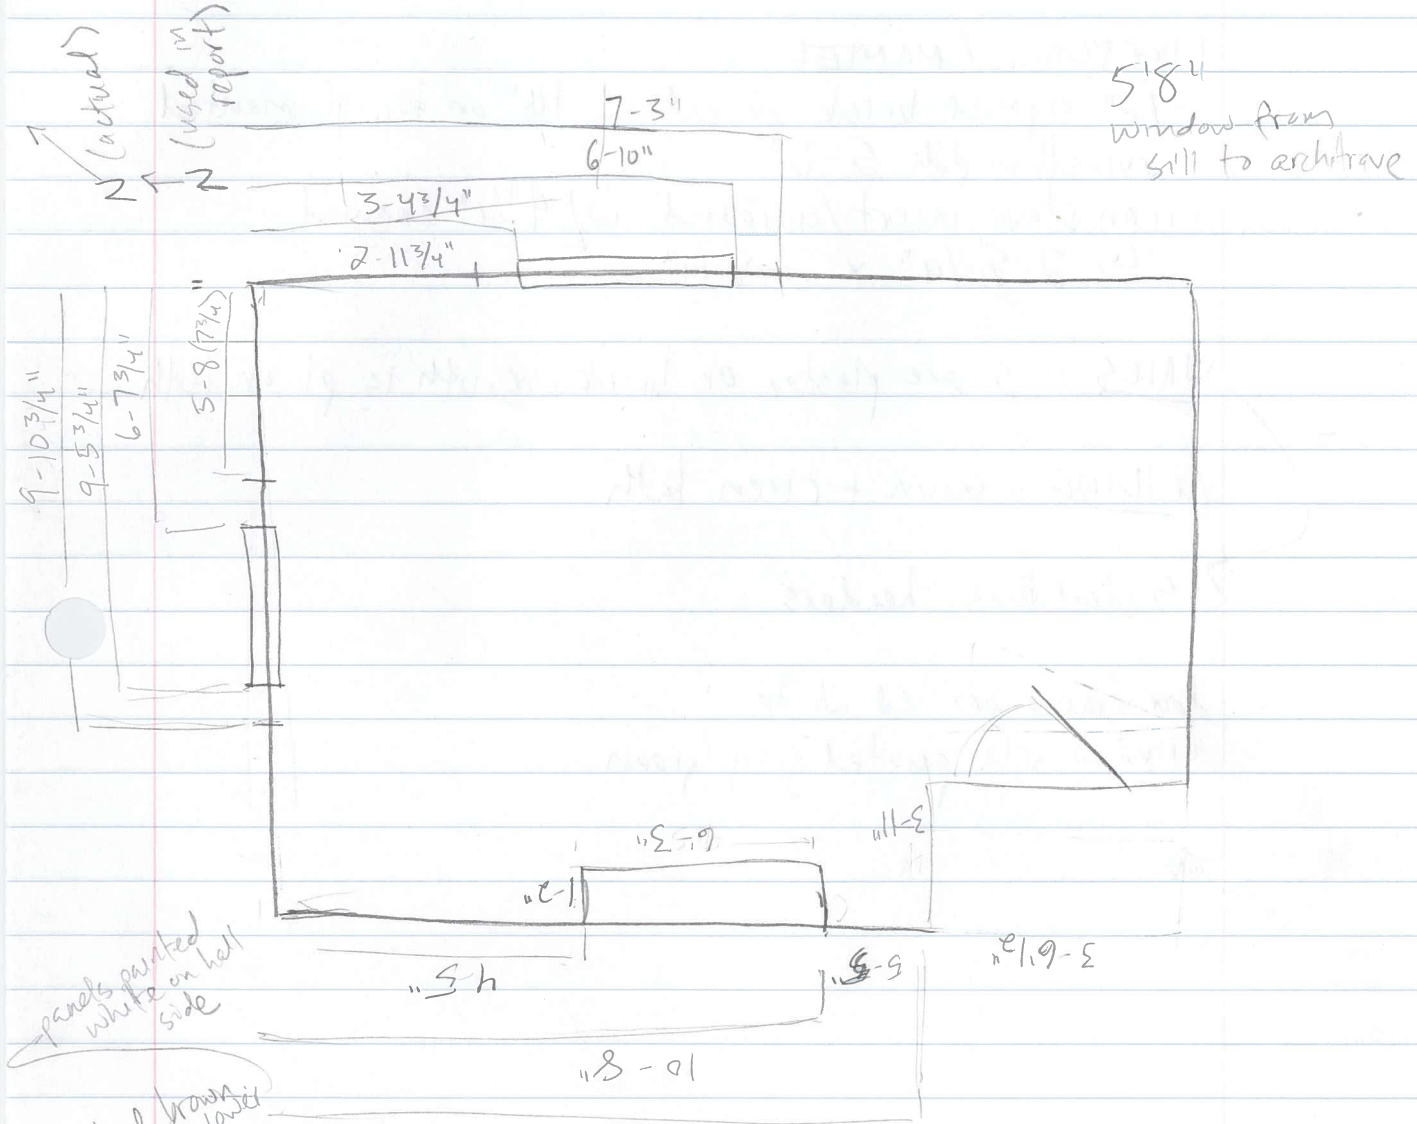
207

Ceiling 8-2 1/2 - north wall  
8-3  
8-4 1/4 - stair

has dropped 1"

- opens off hall - one 6/6 window centered on north wall, one at north end of east wall. Fireplace on west wall.

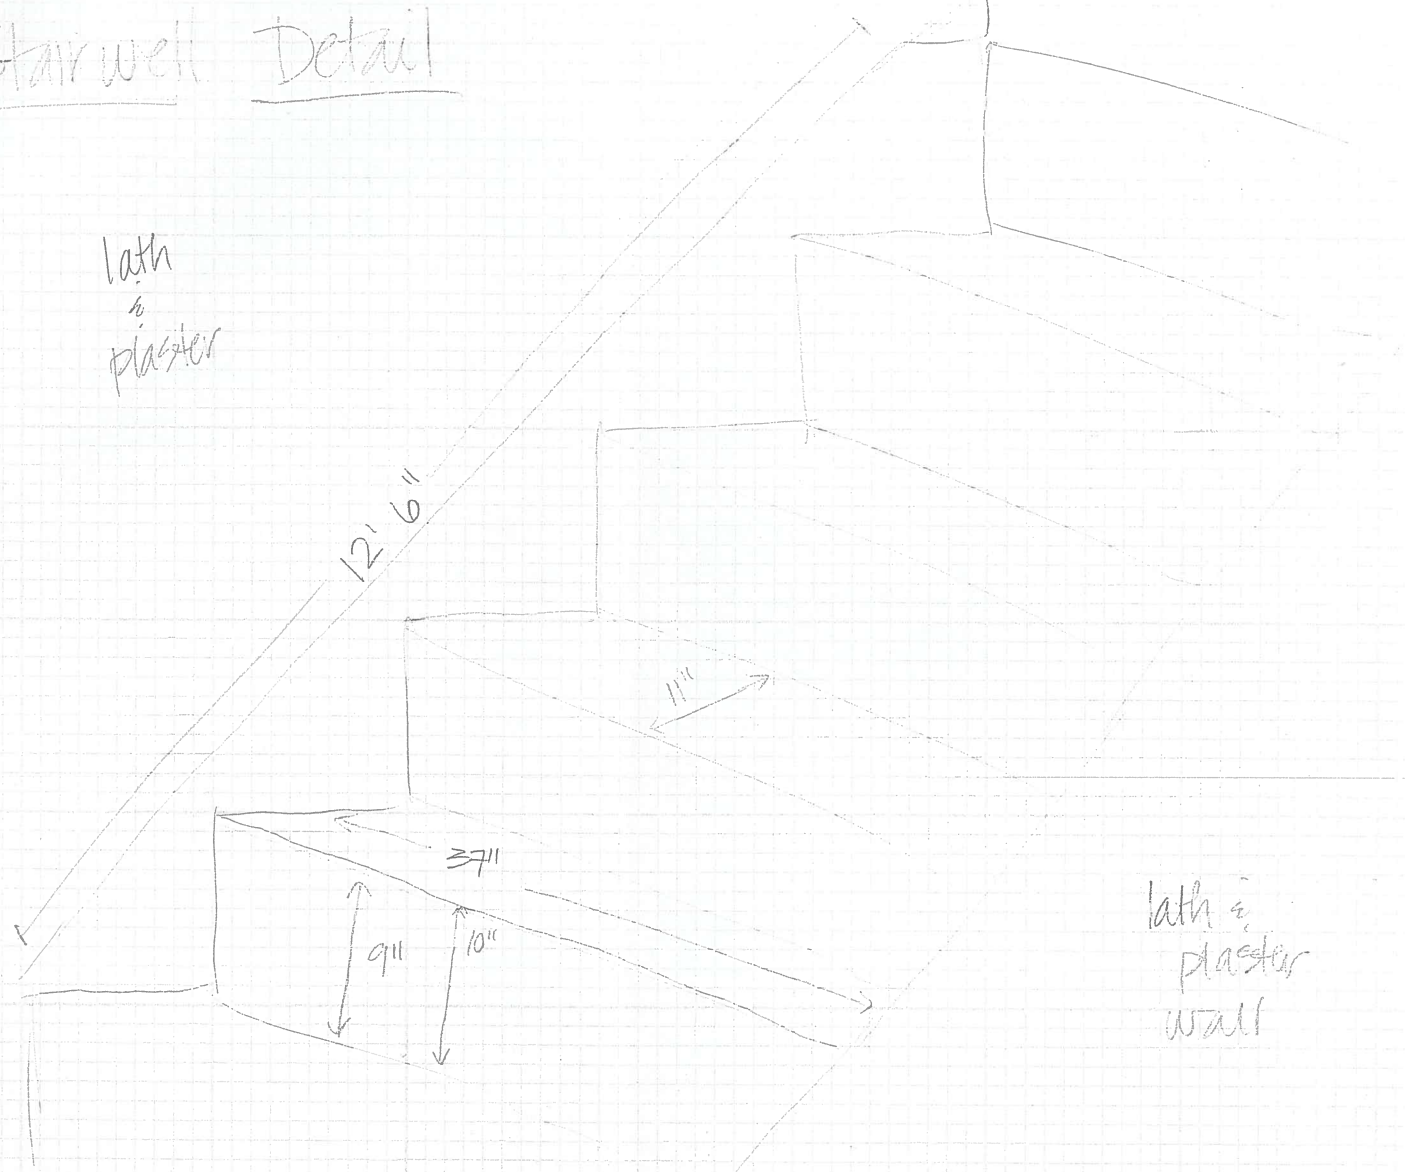
Stairwell Detail

lath  
&  
plaster

lath &  
plaster  
wall

Flattened newel  
2 stairs  
4x4 Newel post  
1 1/2 x 3/4 balusters

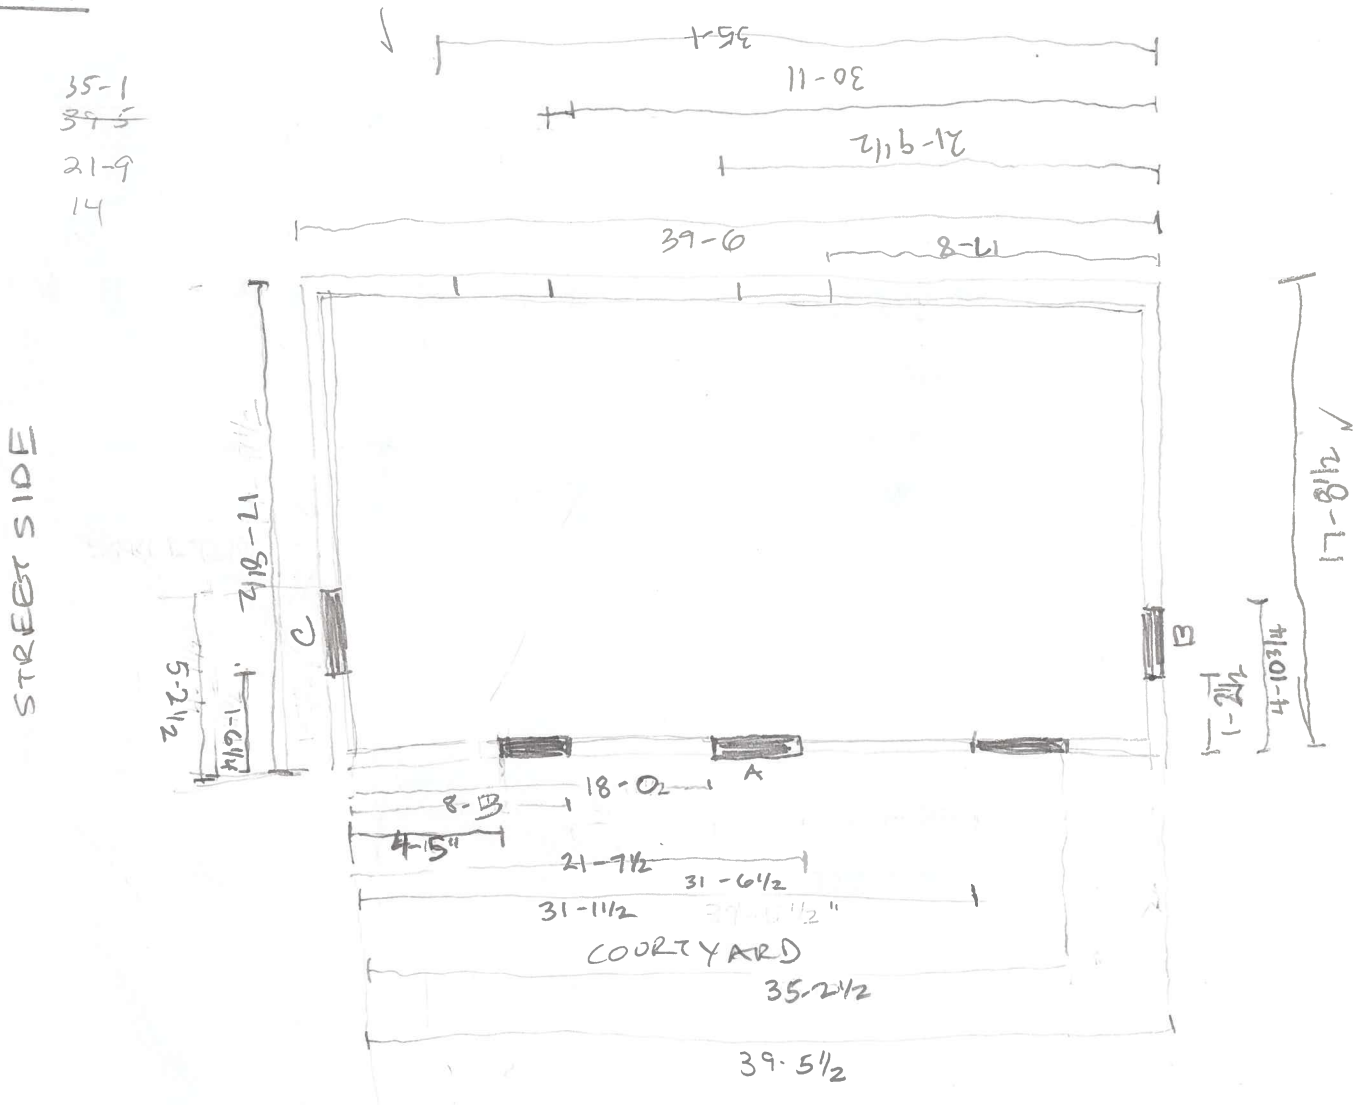
EXTERIOR

WINDOW MEAS<sup>d</sup> MASONRY TO MASONRY - NO FRAMES INCL.

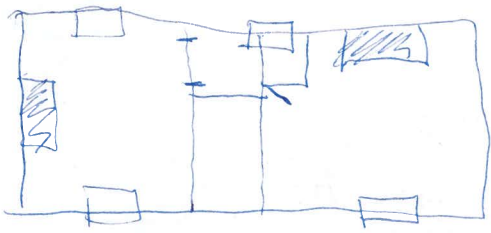
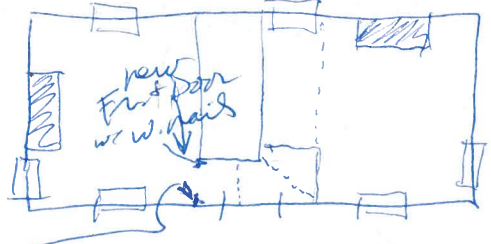
Bare  
brick  
behind  
Door  
Jamb
