## OAKLANDS

### NORTH FAÇADE

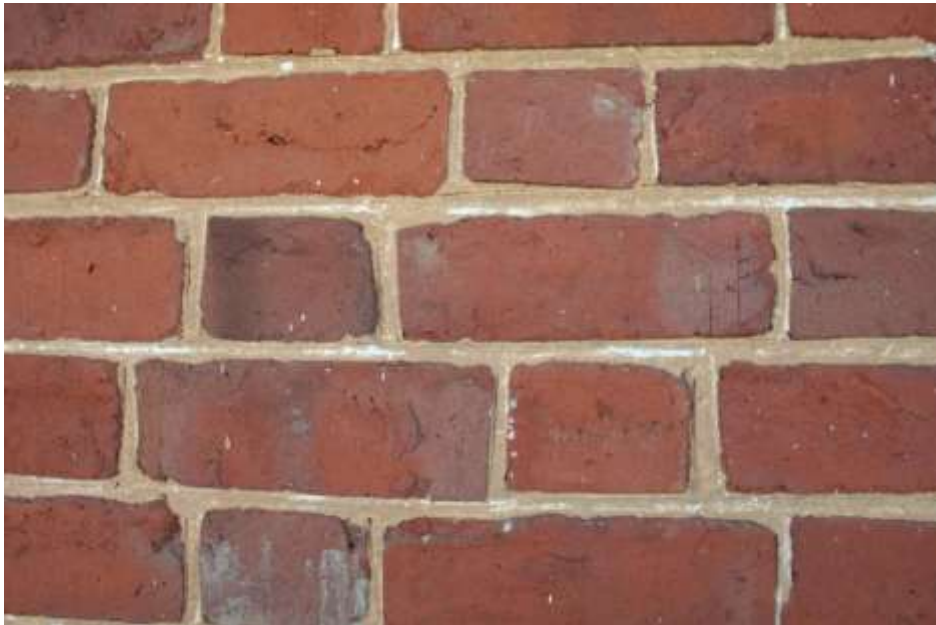
**Walls-** The façade walls are brick masonry laid in a consistent Flemish Bond with a white penciled joint [Fig 2.0]. The bricks are approximately 7.5x2.5x3.5 inches (LxWxH) with ½-inch bed joints and 3/8 inch head joints of lime mortar. Above the door opening and the central second story window there are 3 course tall jack arches [Fig 3.0]. Above the window, openings on the two side bays there are two course tall flat arches. The mortar appears to be consistent and original to the house, with the exception of under the two first floor windows. The masonry has been repointed with Portland cement from the porch floor to underneath the windowsill on the east bay [Fig 4.0], and from the floor up through the first 5 or 6 courses on the west bay under the window [Fig 5.0]. The second story central window appears to have been originally a doorway. Underneath the windowsill, the façade is covered with wooden boards rather than courses of brick. The coursework of the bricks stop along a vertical line extending from the jack arch down to the roofline, and there is no appearance of alteration or later cutting down of the course work. The use of a lower 3-course jack arch, rather than the higher flat arch used on the side bays, is also suggestive of an original doorway. [Fig 6.0]

Figure 2.0- Flemish Bond with Penciling. North Façade

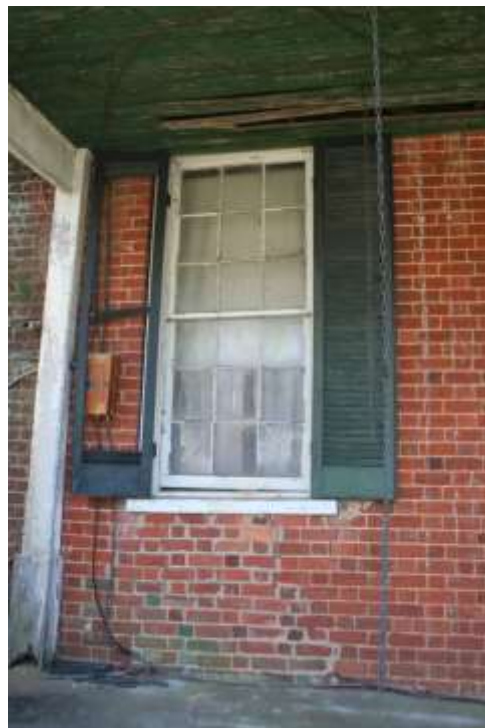
**Windows-** The façade is broken by five windows. On the first floor the two sides bays both have double sash, 9/9 windows with wood framing and trim [Fig 4.0 & 5.0]. The glass panes are 9.5x11.5 inches separated by 1-inch muntins. These two windows have green louvered wooden shutters. There was no evidence of shutters on the upper level windows. The each shutter is

Figure 4.0-East Bay Window with Altered Mortar Below. North Façade

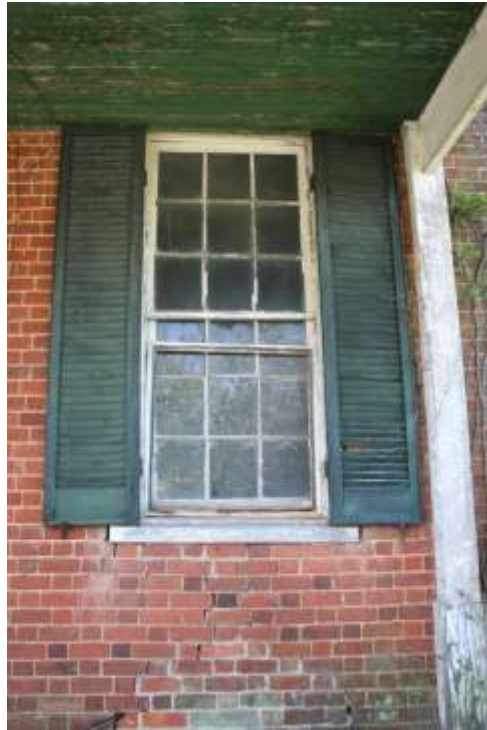
Figure 5.0-West Bay Window with Altered Mortar Below. North Façade

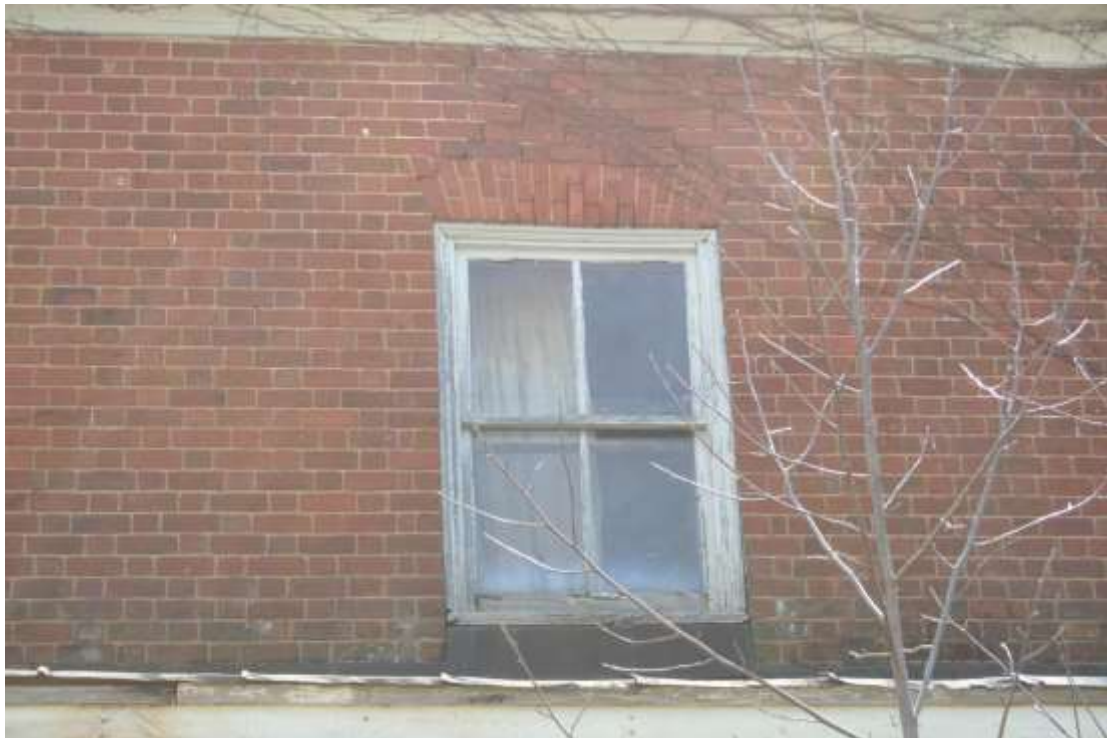
Figure 6.0- Central Bay Window in Earlier Doorway. North Façade

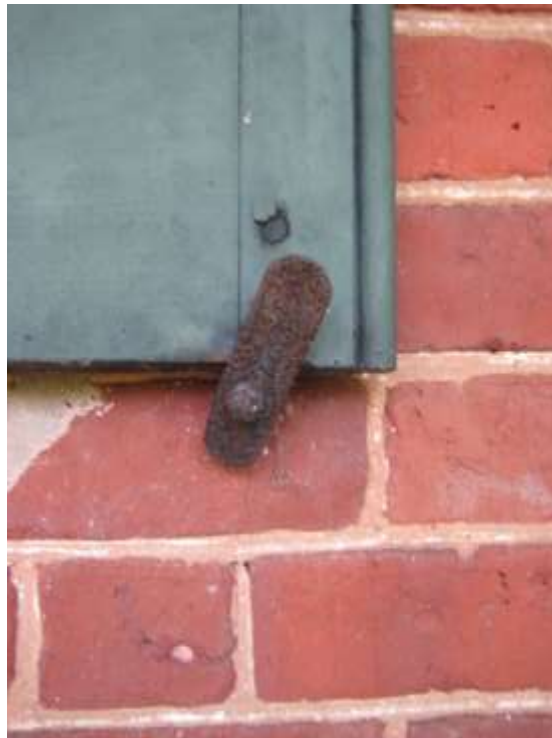
attached with two **(type)** hinges [Fig 7.0] and held to the façade with oblong shutter dogs attached to the brick [Fig 8.0]. The shutter dogs are painted the same green as the shutters. The fact that the shutter dogs are attached to the brick rather than the mortar suggests they were added later. On the left shutter of pair, there is a shutter clips [Fig 9.0]. The west windowsill has a rounded metal eye to which the clip could attach; there was no eye on the east window. Above these windows, the second floor outer bays have 6/9, double sash windows, also with wooden sills and frames [Fig 10.0]. Above the front door in the central second story bay, there is a 2/2 double sash wooden window [Fig 6.0]. This window has larger panes (14.75x24 inches) and wider muntins (1.25 inches) with a different profile than the other windows, supporting the other evidence of this window being added later within a previous doorway. All of the trim on the front façade is painted white.

Figure 8.0-Shutter Dog. North Façade

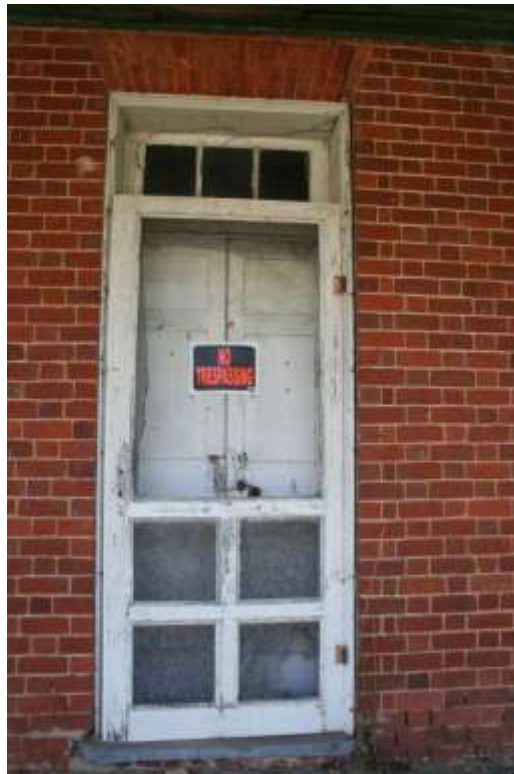
**Door-** The front bi-valve doors are located in the first floor central bay, with a screen door in front [Fig 11.0]. Above the doors, there is a 3-light transom window with wooden side panels equal in width to the door stiles. A 3-inch header as well as a horizontally laid board separates the transom from the doors. The doors are constructed of three variable height panels with separating stiles and rails. Thin 1.5-inch wooden trim surrounds the entire doorway, including both the doors and the transom. A wooden sill 3 feet 6.75 inches x 2.75 inches (approximately the same as a course of brick) and 12.5 inches deep forms the threshold, and is raised one course of brick above the porch floor. This sill is painted a bluish-grey color rather than white like the rest of the exterior trim. The keyhole and round metal doorknob are located on the right door. The key hole is upside down because it is a left-handed lock. The screen door is most likely a later addition. It is a right-handed door with a larger upper screen and four smaller lower screens.

Figure 11.0-Front Door. North Façade

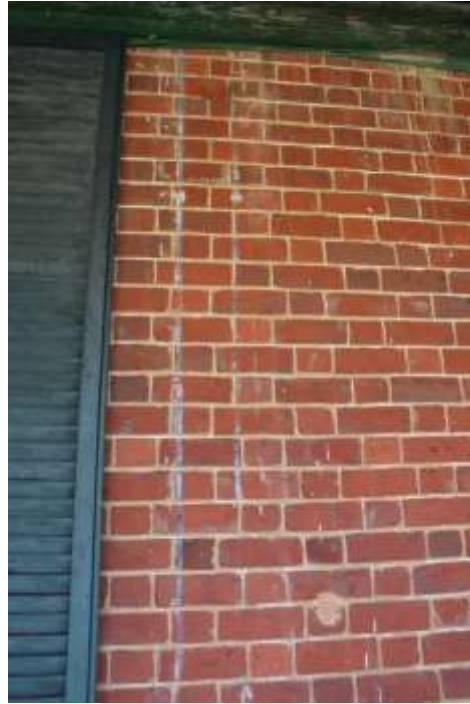
On the face of the brick, there are ghost marks of columns from an earlier portico [Fig 15.0]. These ghost marks are approximately 5 inches wide and run from the floor of the porch up past the ceiling. The marks are 4 feet 7.75 inches from the edge of the door opening, making the width of the previous portico approximately 15 feet 7 inches. Rising approximately 14 inches above the roofline there are nail marks in the brick aligning with the lower ghost marks, suggesting a balustrade or railing was at one time nailed to the façade. The doorway that has since been turned into a window would have allowed access onto the top of the portico.

Figure 15.0- Ghost Mark from Earlier Column. North Façade

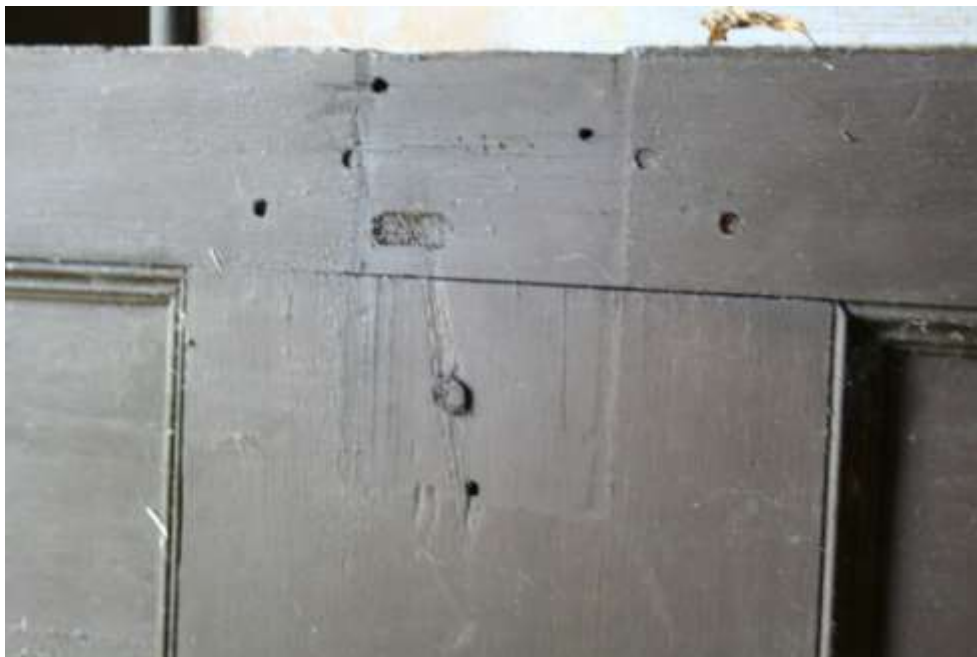
Figure 19.0- South Door Ghost Marks of Earlier Lock Placement. Room 100

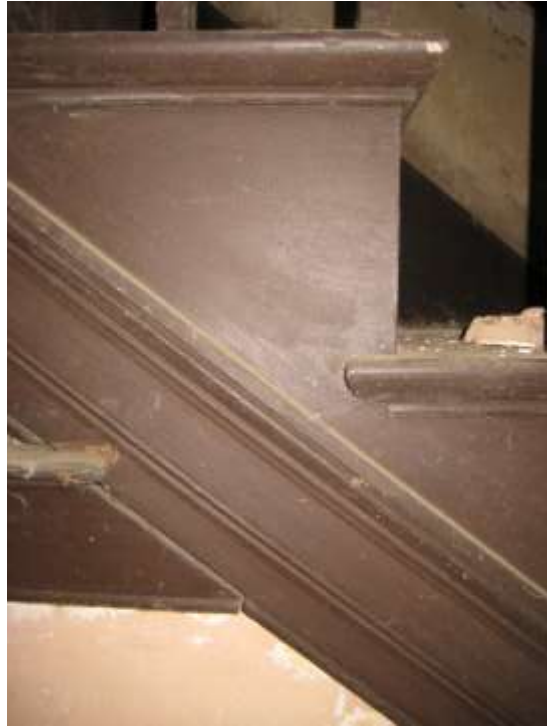
**Staircase-** The staircase ascends along the West wall of Room 100 for 13 steps plus a 5 tread return after the landing. It is made entirely of wood and connects Room 100 to Room 200. The wooden treads are approximately 10.75 to 11 inches deep and 38.25 inches wide plus another 2 3/8 inches for the outer nosing and balustrade, totaling 40 5/8 inches wide. The risers are approximately 7.5 inches high. The rounded nosing with bottom beading is 1.25 inches deep and 1.75 inches tall. The rounded piece is shaped from the edge of the tread board, while the bottom beading is an additional piece. The side nosing that projects out from the balustrade is a separate attached piece with a mitered corner. [Fig 21.0]

Figure 21.0- Tread and Riser Detail. Room 100

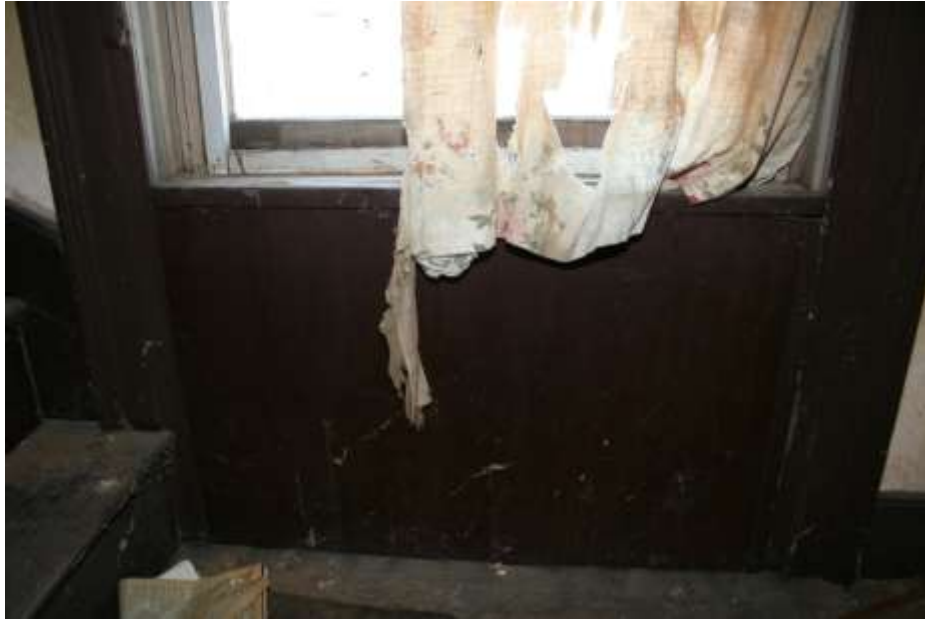
Figure 27.0- Wooden Paneling Under North Wall Window. Room 200

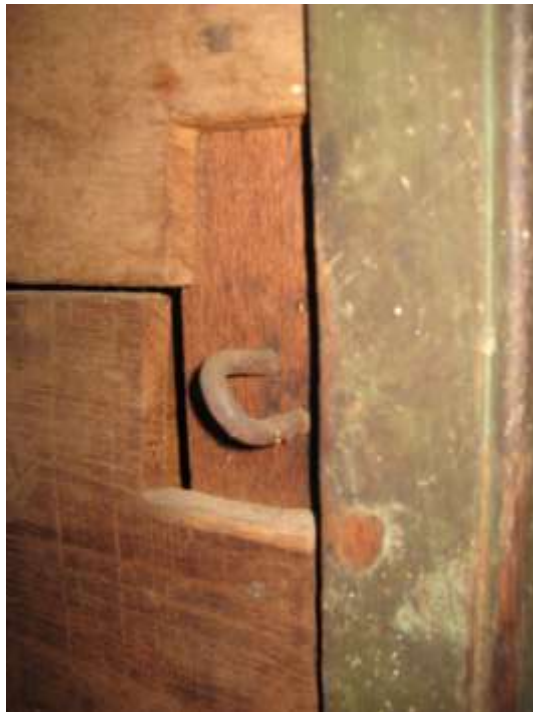
The doors were no longer hanging, but the West door to Room 302 had evidence of hinges and a metal loop on the left side of the door probably used as some sort of locking or securing piece.

Figure 32.0- Metal Loop. Room 300
