## **Restoration Field School**

Thomas Jefferson's Poplar Forest

## Architectural Investigation of Hog Town House

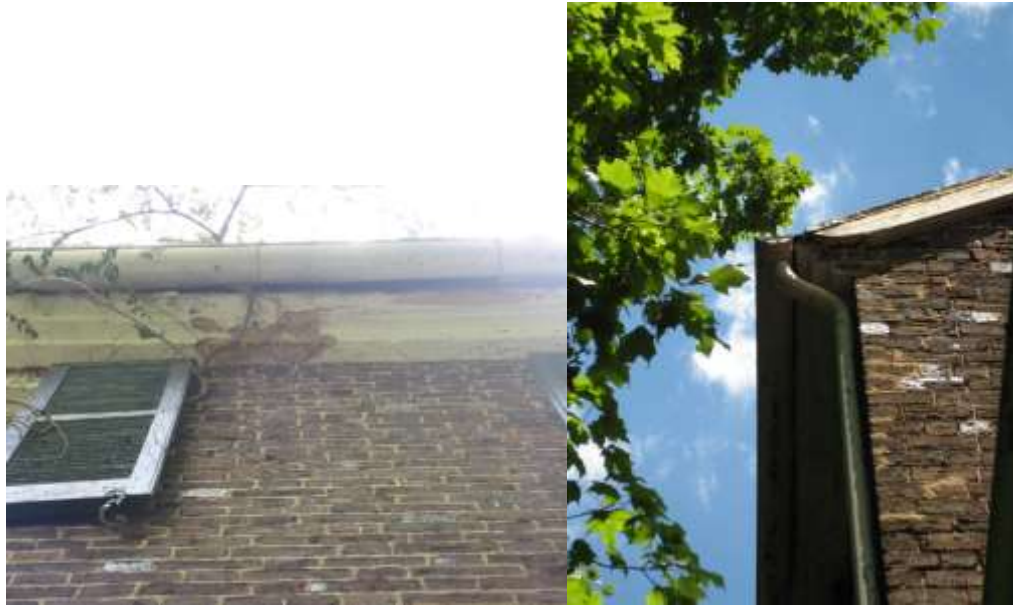
sand mortar are exposed on the west elevation and the actual three (3) level, stepped brick course is visible on the southwest corner section of the house.

June 2008, Three-Stepped Brick Course. Left: West Elevation view, Right: Section view

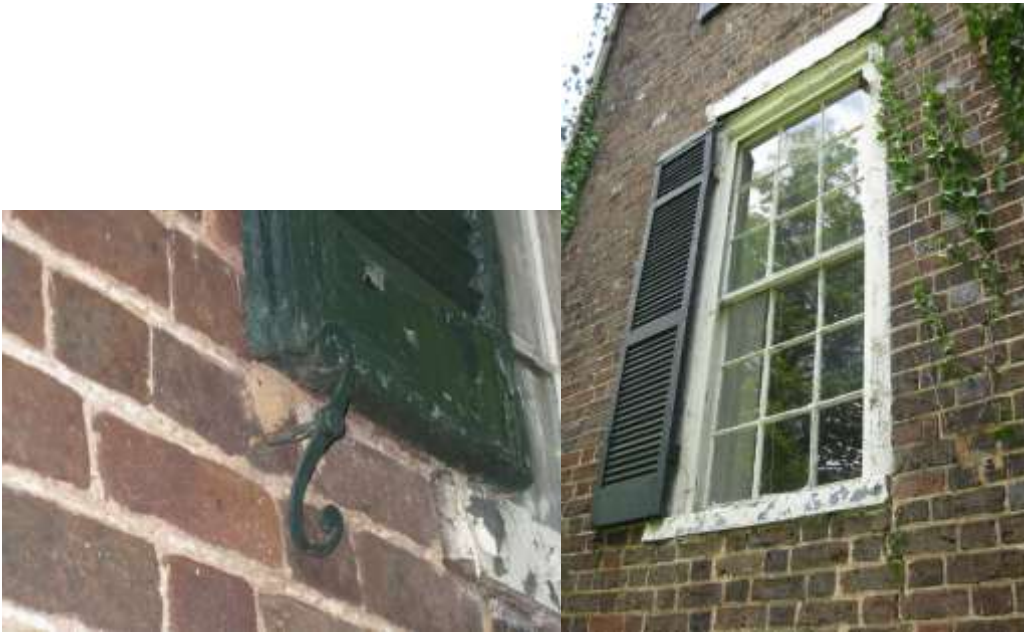
side of porch) are two (2) sash, 6/9, with wood framing and trim. All of the windows above the water table have louvered green shutters with “s” shaped shutter dogs that are drilled into the brick. Since they are drilled into the brick rather than the mortar suggests they are a later addition since original shutter dogs would most likely have been placed in the mortar. The hardware used for the shutter dogs also appears to be a later addition. The two basement windows on the north side of the portico consist of eight (8) lights each, with wooden framing. The framing and actual window panes are painted over white. The two basement windows on the south side of the portico have wooden framing with a sheet of Plexiglas nailed to the framing.

June 2008, West Elevation Shutter dog (left), and window (right), C. Lauth

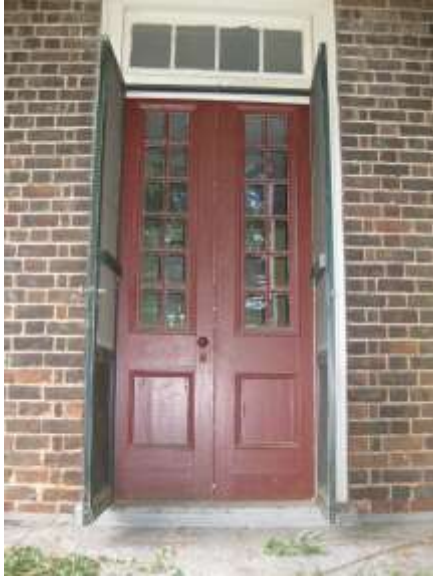
The entrance doors are paired with twelve (12) lights and recessed paneling on each door. They are wooden, and painted red. It is not clear if these are original, but most likely not. A keyhole is visible underneath a glazed ceramic doorknob, but no lock box is visible from the outside. There is a four (4) light transom, most likely original, above the door with white painted wood trim. There is a green trim around the red doors which matches the color of the outer screen doors. These metal-paired doors are a later addition, and have wire mesh screening and metal hardware.

June 2008, West Elevation entrance doors, C. Lauth

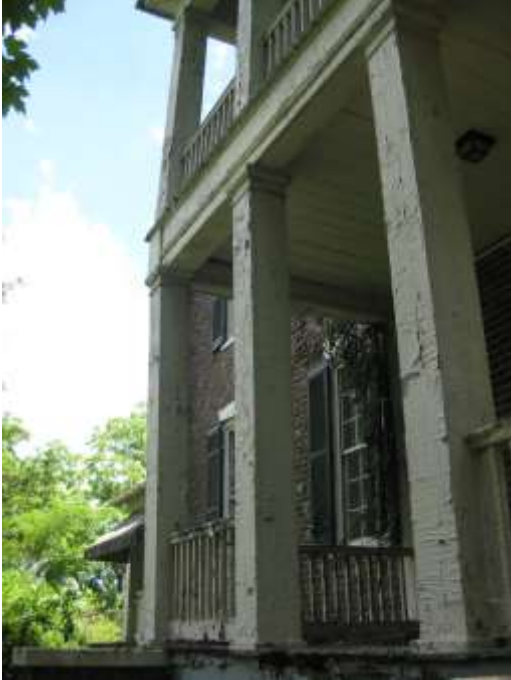
The west portico is a later addition with cement steps leading up to the portico. The wooden floor planks appear to be regular. There are planks near the front section of the portico that are visibly later than the rest of the portico planks. One of these planks is missing, which made visible one of the joists. The joists have circular saw marks. There are four wooden, square columns supporting the first and second floor porticos. Connecting these columns are wooden railings, which are comprised of rectangular posts. The handrail is made up of two parts of wood, which is connected to the posts with an additional wooden plank. The railings and columns are covered with at least two layers of paint, a bluish-green color that appears to match the color of the outer screen doors and possibly the shutters, as well as a white to coat. The pilasters on the north and south ends of the portico are not original. A ghost mark on the brick front next to each pilaster, as well as an exposed nailing block show where the pilasters were previously.

June 2008, West Elevation Pedimented Portico, C. Lauth

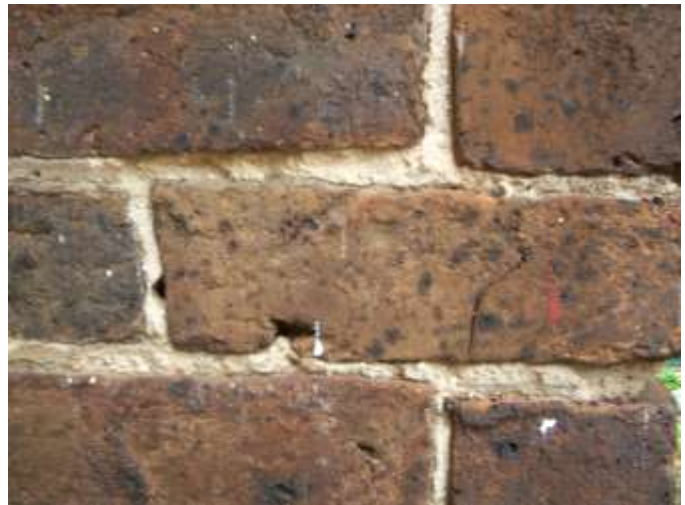
Figure 1. Old bricks,  
Photograph by Alden

The oldest section of the house is brick laid in a three-course common bond with a lime mortar (figure 1). The bricks are handmade, water-struck, with several glazed headers and sections of stretchers. The bricks measure approximately 9 ½" x 3 ¼" and some bricks feature fingerprints or leaf mark. The chimney is laid in a three-course common bond until it narrows at the second floor when it switches to a stretcher bond, perhaps an indication of a later rebuild. (A closer examination will be necessary.) The water table is 5' high, and slopes back eight inches to the first-floor wall. south elevation.  
Watts, May 2006.

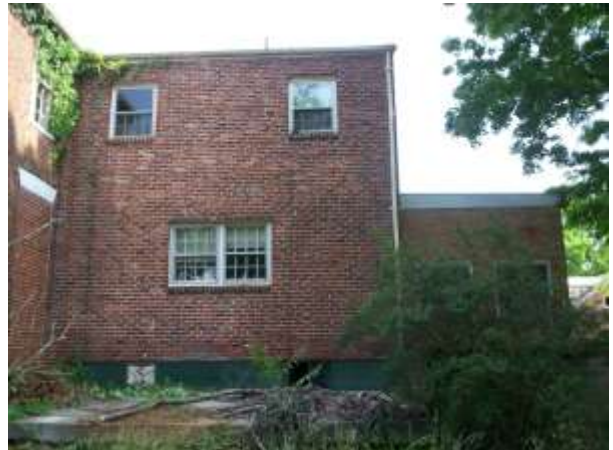
Figure 4. Rear additions, south elevation.  
Photograph by Alden Watts, May 2008.

Attached to the rear (east) elevation of the oldest section of the house is a two-story kitchen ell extending 22'8" with a cinderblock foundation (figure 4). The ell is built of brick laid in a stretcher bond and mortared with cement. The bricks measure approximately 9" x 3 1/2" and appear to be handmade. The west side of the wall shows a two-story dark streak from a leaky gutter that runs along the roof line.

The basement windows are set in the cinderblock foundation. The western window is stuffed with insulation. The eastern basement window was once a sliding window. The first-floor double window is 6'7" above grade. The two windows, each 8 over 8 double-hungs, total 6'6" wide, separated by a mullion, and are 4'4" high. There are two windows on the second story, both 8 over 8 and double-hung. The western window is missing its upper window sash.

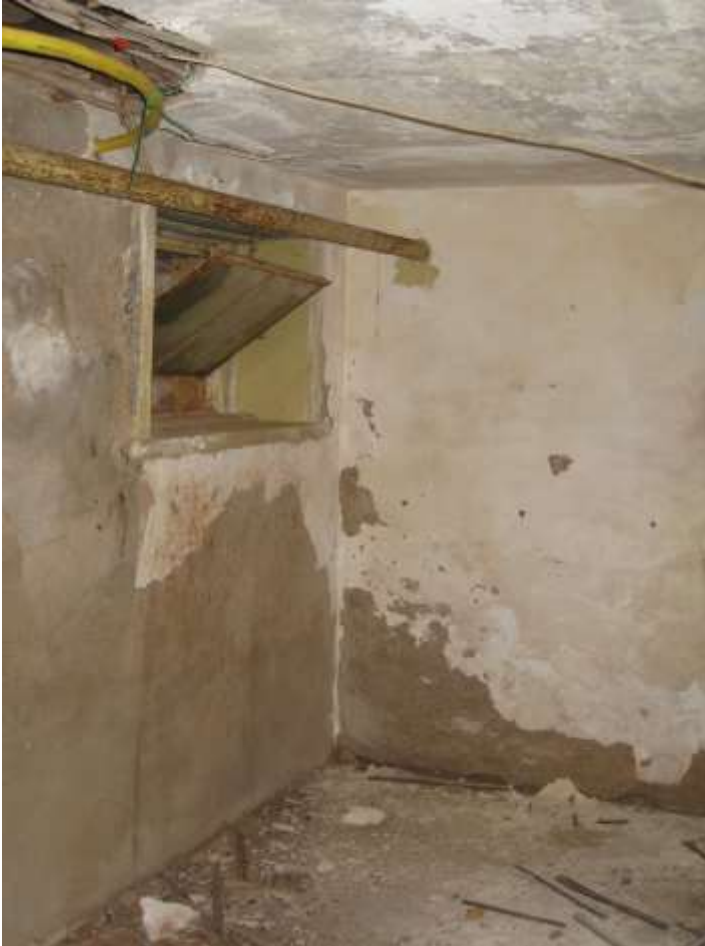
*Southeast corner of room 002. K. O'Shea*

Walls: Brick that was plastered and painted. East wall is concrete over brick.

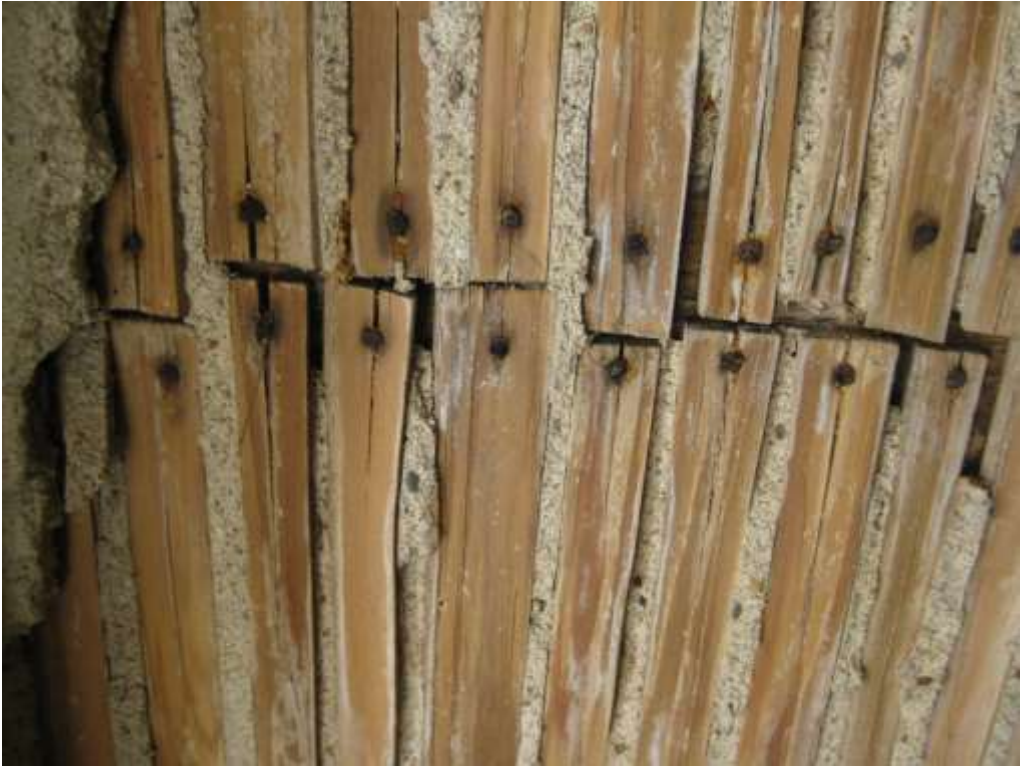
*Room 002, Ceiling, K. O'Shea*

Ceiling: Split lath and plaster with mesh screen and plaster in between joints. Fiber glass insulation above mesh in between joists.

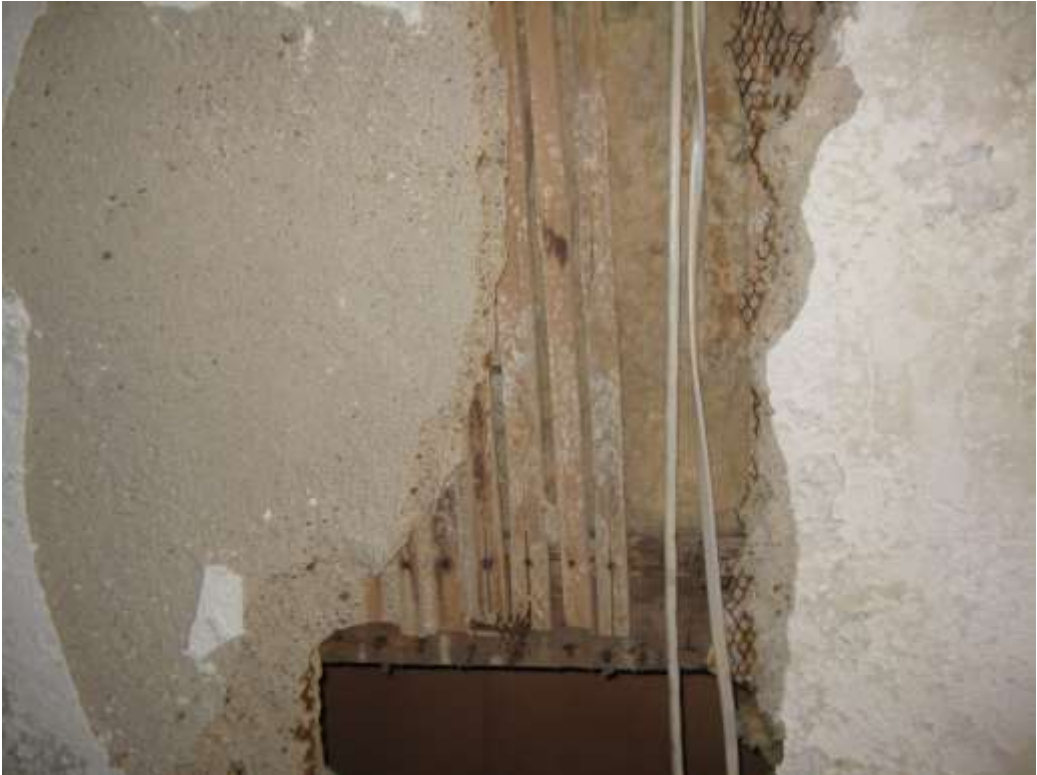
Room 002, ceiling – a more modern plaster. K. O'Shea

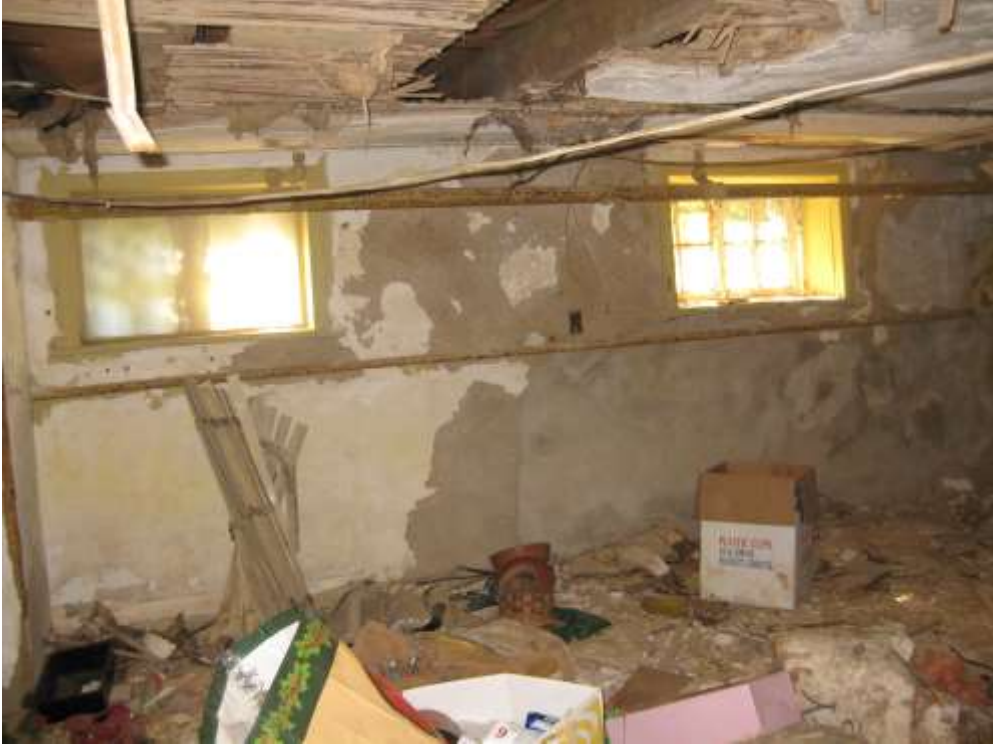
Room 002, windows on west elevation

South window is mortis and tendon with pegs. North window was fastened with wire nails.  
Evidence of tan paint on window. Both windows are located 4' 2 1/2" from cement floor.

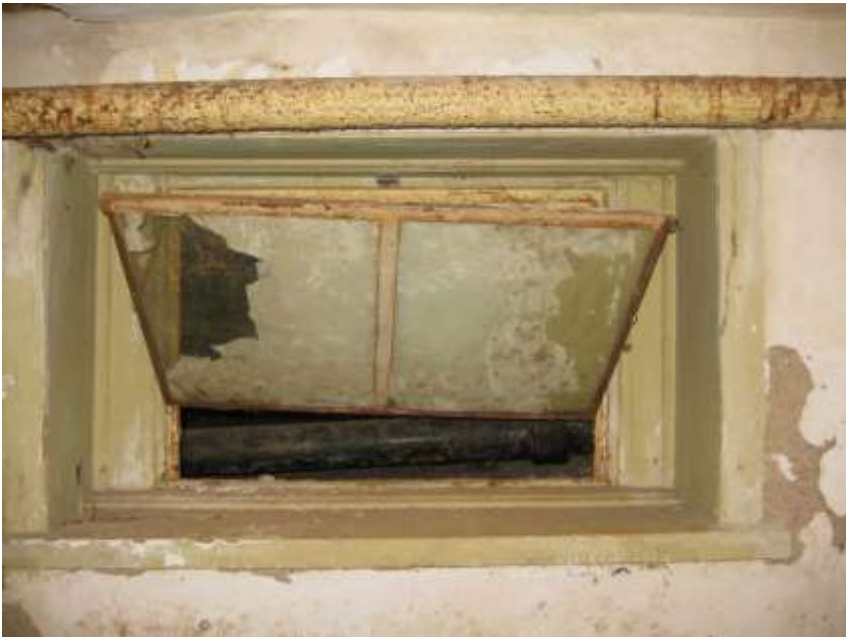
Room 002, window on east wall, K. O'Shea

Window on east wall in southeast corner goes into crawl space, under addition, two pane, made of metal, with a wood casing. Depth is 1' ½", height is 1' 10".

Window lifts up and out and is located 4' ½" up from the cement floor.

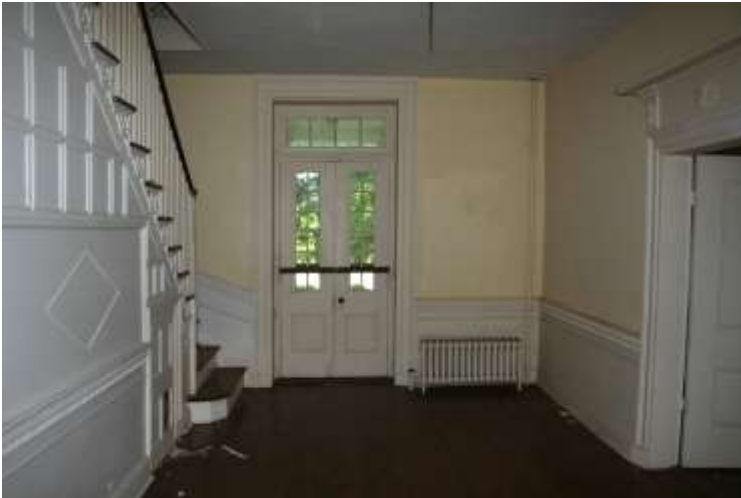
Figure 1. Room 100. Photo by Travis McDonald, June 2008.

Three of the walls of the room are all plastered and painted a light yellow color (figure 1). The south wall under the stairs is entirely covered in highly decorated wainscoting and paneling. The other walls feature an elaborate baseboard and sur-base. The baseboard measures 7" high. The sur-base is 8 ¼" high, and has decorative elements such as reeding and faux-dentil carvings (figure 2—[insert drawing](#)). The west wall of the hall is the front entrance of the old house. The front door is centrally located within the wall. South of the front door, the stairway begins before turning east as it ascends. North of the front door is a radiator and a steam pipe that runs from the floor to the ceiling. Under the stairway to the second floor, another door leads to the basement stairs.

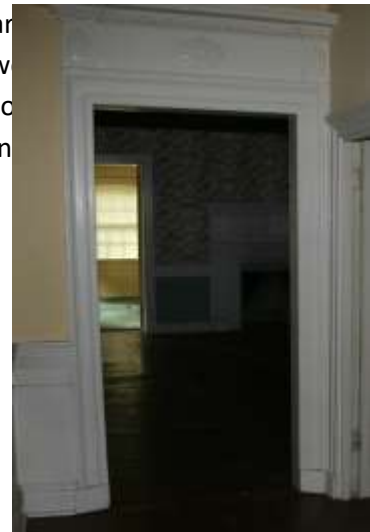
Figure 4. D100-2. Photograph by Travis McDonald, June 2008.

The north door architrave and doorcap (D100-2) matches those of the south door (D100-5) (figures 4 and 5). Both have an architrave and doorcap. The doorcap is highly ornamental in a derivative Federal folk manner. The cornice of the molding contains beaded, rope, and dentil courses. In the center and at the ends of the frieze section are what might be

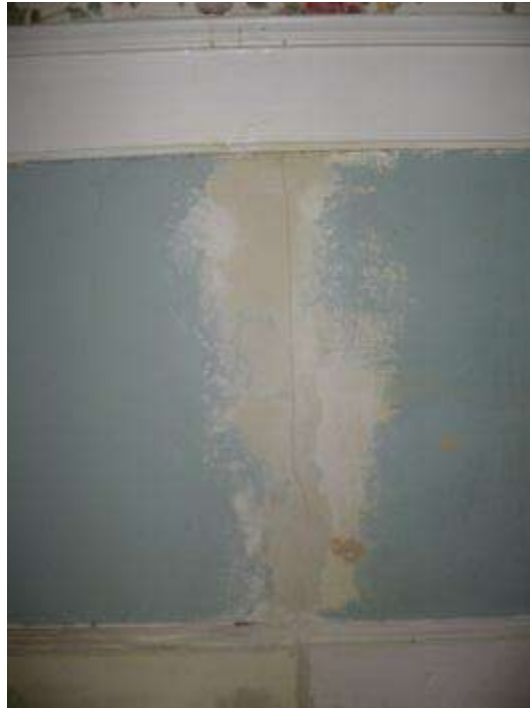
The walls in room 102 are constructed of plaster, but are currently covered in wallpaper above the surbase. Between the base and surbase the plaster, which is of a rougher texture than the plaster covered by the wallpaper, the plaster is painted light blue. The rougher plaster is possibly from a later period. From floorboard to ceiling, the walls are 10' in height. There is no apparent structural damage. However, on the west wall there is a patch in the plaster below the surbase. This patch is located in the center of the wall, but its purpose is not evident. The base

to the south of the patch is not painted white and a seam is visible. Above the surbase, if the patch does continue, it is obscured by the wallpaper. However, with the simple technique of knocking on the wall for sound, this area sounds less solid than the surrounding solid plaster walls.

*Room 102, west wall, detail of repair to plaster wall between base and surbase, K. O'Shea*

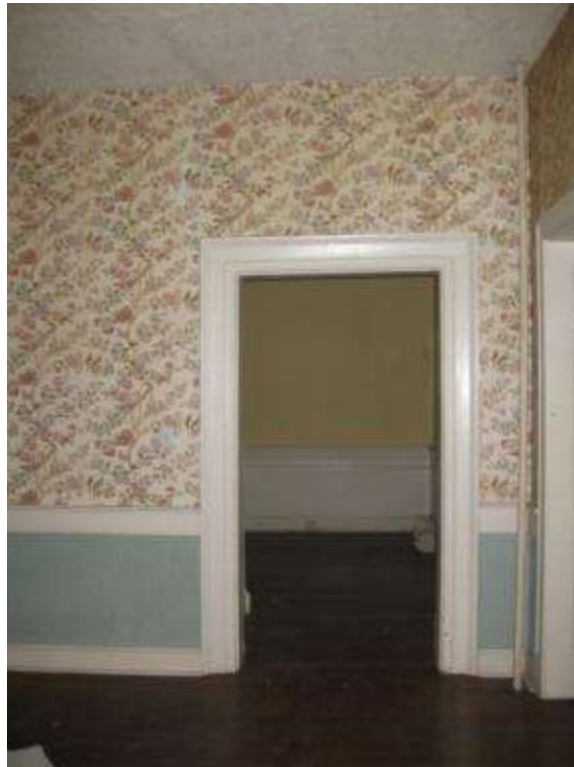
*Room 102, Door 1, K. O'Shea*

Door 1 on the north wall connects to the passage, room 100. There is no longer a door, although there are ghost marks of door hinges, which indicate that the door would have swung in and to the left in room 102. The doorway is 6'10 <sup>3</sup>/<sub>4</sub>" in height and is 3'5" in width. The depth of the doorway is 1'6". The doorway from room 100 to room 102 is original.

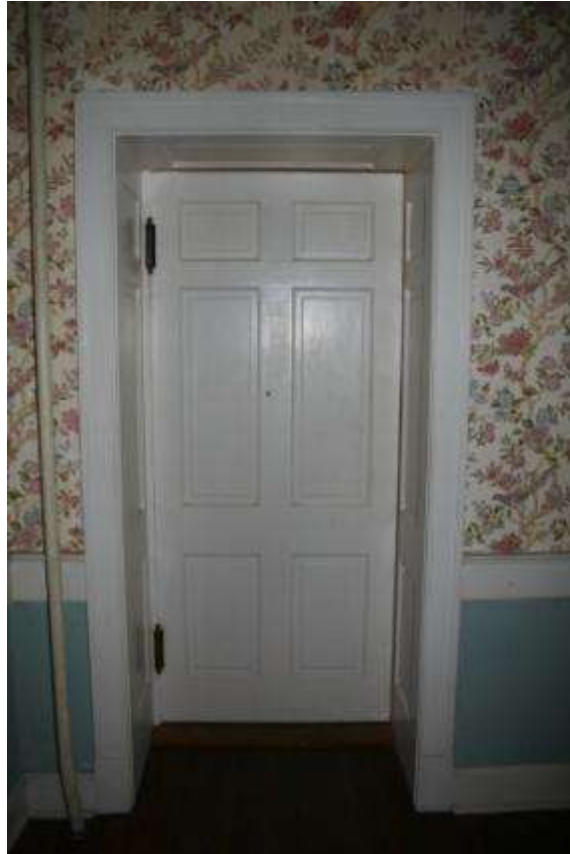
*Room 102, Door 2, T. McDonald*

Door 2 on the east wall provides access to the kitchen in the addition, room 103. This door remains and swings both ways. The door is 7'0 ½" high. The doorway is 3'1" wide and 1'6" deep. (This also indicates an original exterior wall thickness of 1'6".) The doorway from room 102 to room 103 was previously a window, until the kitchen addition (see windows below.)

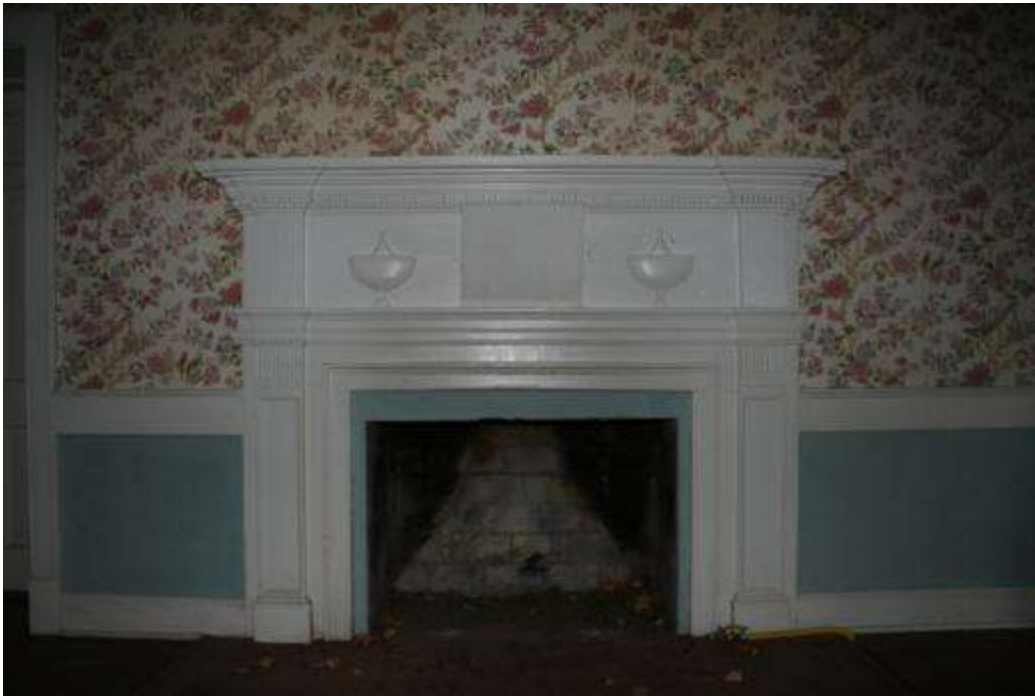
*Room 102, Fireplace and mantel, T. McDonald*

The mantle is constructed of wood. It is currently painted white, but investigation reveals a black coat, which would indicate it may have been painted to look like basalt. It measures 7'2" wide with the shelf. It is 5'4 ½" in height. The shelf is 1 ½" thick. The fireplace was later converted to a gas fireplace, as indicated by the yellow pipe in the photograph. The mantel is believed to be original.

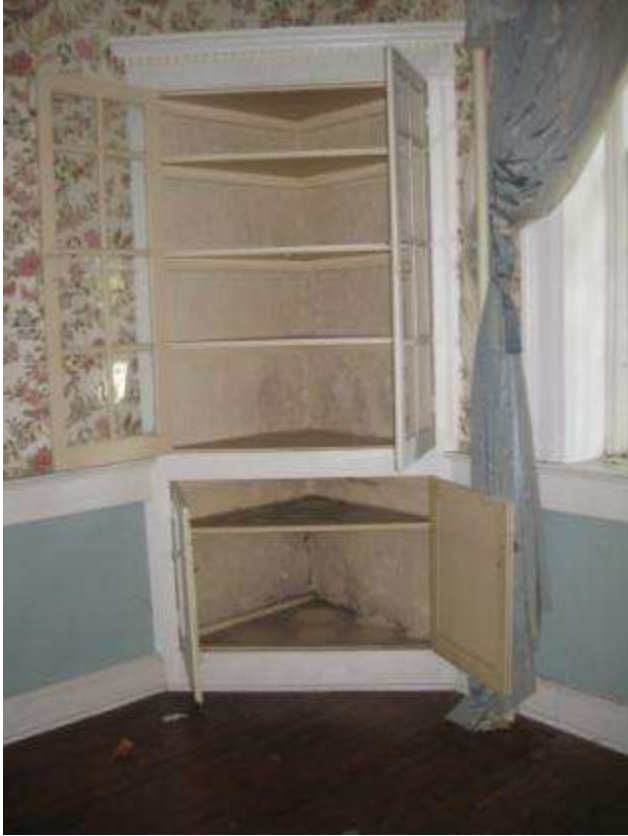
*Room 102, southwest corner, K. O'Shea*

A corner cabinet has been added in the southwest corner of the room. There is not a back to the cabinet; the shelves are supported by wood pieces?? About 1 ½ " thick. The cabinet is determined to not be original, as the surbase is seen in the bottom portion of the cabinet. However, the cabinet was likely added before the wallpaper and blue paint was applied since the shelves reveal the top coat of plaster, though without a white lime wash. The cabinet measures 7'7 ½" in height and 3'6" across the front. The shelves are isosceles triangles, measuring 2'5 ½" on each side (the west and south walls of the room.)

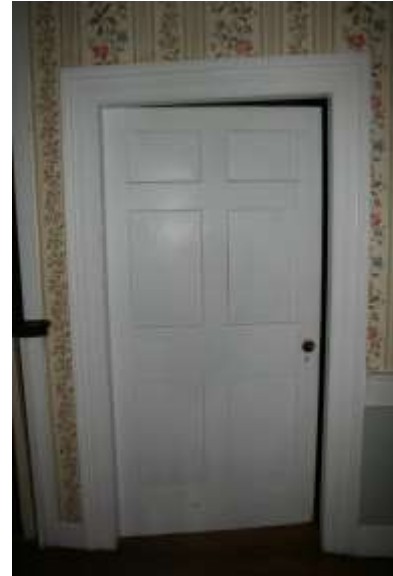
Figure 2. D201-1. Photograph by Travis McDonald, June 2008.

There are four doorways in the hall. The west door (D201-1) is of mortise and tenon construction, and is paneled (figure 2). The door frame has an elaborate architrave, suggesting that both might be second period. The door opening is 3' 2 1/2" by 6' 10 1/2". The architrave is 6 1/4" thick, making the dimensions of the door 4' 2 1/2" by 7' 4". The knob of the door is porcelain, finished with faux wood burling. The keyhole measures 1 1/2" by 2".

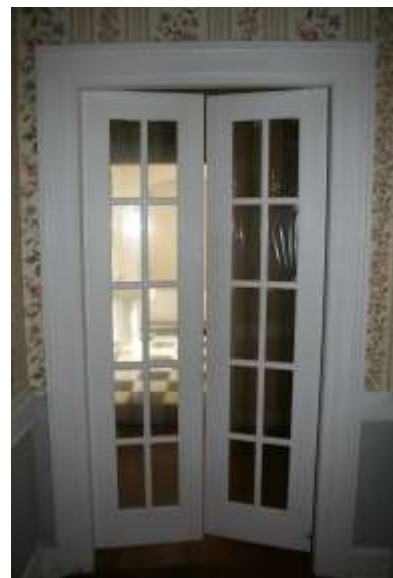
Figure 3. D204-1. Photograph by Travis McDonald, June 2008.

The north doors (D204-1) are twentieth century, although the architrave might be earlier as it matches that of the south door (figure 3). The door opening is 3' 3" by 6' 11" with double French doors, each measuring 1' 7 3/4" by 6' 7". Each door contains ten lights arranged 2 by 5. The panes of glass measure 5" by 12 1/2" each. The doors are hung 3 1/2" above the floor. The architrave is less elaborate than that of the west door, measuring 6". The entire door measures 5" 1' by 7' 4 1/2".

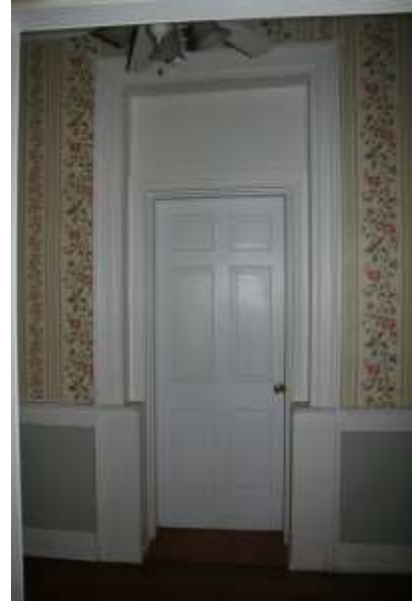
Figure 4. D206-1. Photograph by Travis McDonald, June 2008.

The east door (D206-1) opens into a later ell addition, and might have been converted from a window, which would have been the sole window in the hall (figure 4). The door opening is cut into the sur-base, and its two-part architrave reflects its later addition. The outer architrave is 6" deep, and the inner is 2 1/2" deep. Above the door is what appears to be a filled-in transom light which matches the corresponding door on the first floor. The door opening is 2' 6" by 6' 7". The entire door opening with the architrave and transom is 4' 2" by 9". The door is paneled with a modern brass-plated knob.

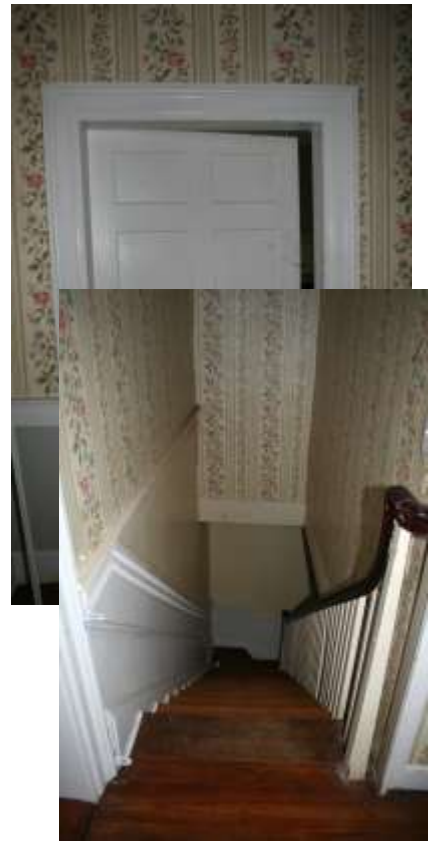
Figure 5. D205-1. Photograph by Travis McDonald, June 2008.

The south door (D205-1) is likely an original (figure 5). The architrave matches that of the north door. The door opening is 3' 3 1/2" by 5' 10". The door is of mortise-and-tenon construction, and its panels (simpler than those of the east and west door) show evidence of channeling under its many coats of paint. The doorknob is brass. The door's hinges measure 1' by 3" on each side that attaches to either the door or jamb.

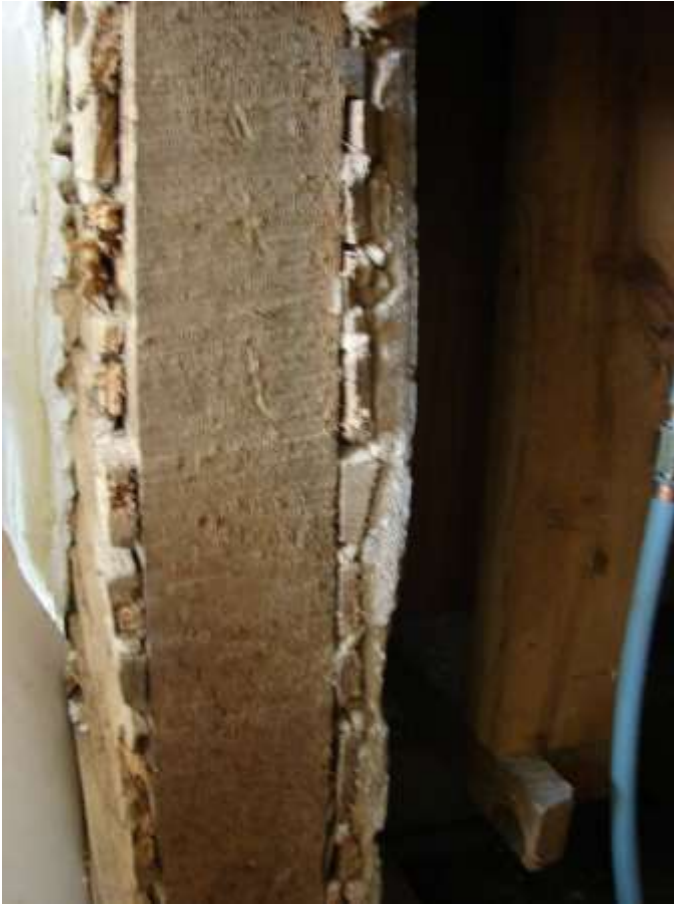
The east wall is a later partition constructed of a wooden frame of pit-sawn wood with split lath of poplar wood nailed to it and a lime-based plaster, infilled and plastered and painted over. There is one panel near to the northern corner where the original lath has been removed, to allow access to the plumbing of the bathroom next door.

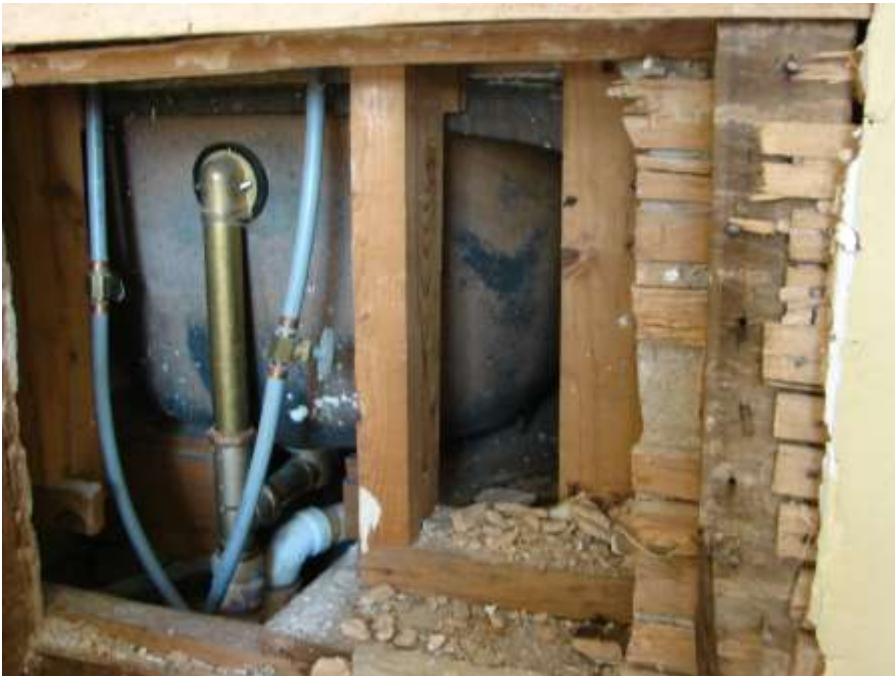
Foam insulation has been added here and a cardboard partition stapled to the original beams, which show the ghost-marks of the old laths, to cover the gap.

Inside the previous surbase and baseboard can still be seen, which are in the same style as the surbase and baseboard on the west wall of room 202. In the far corner of the cavity there is a very early form of linoleum, from before the bathroom floor was raised.

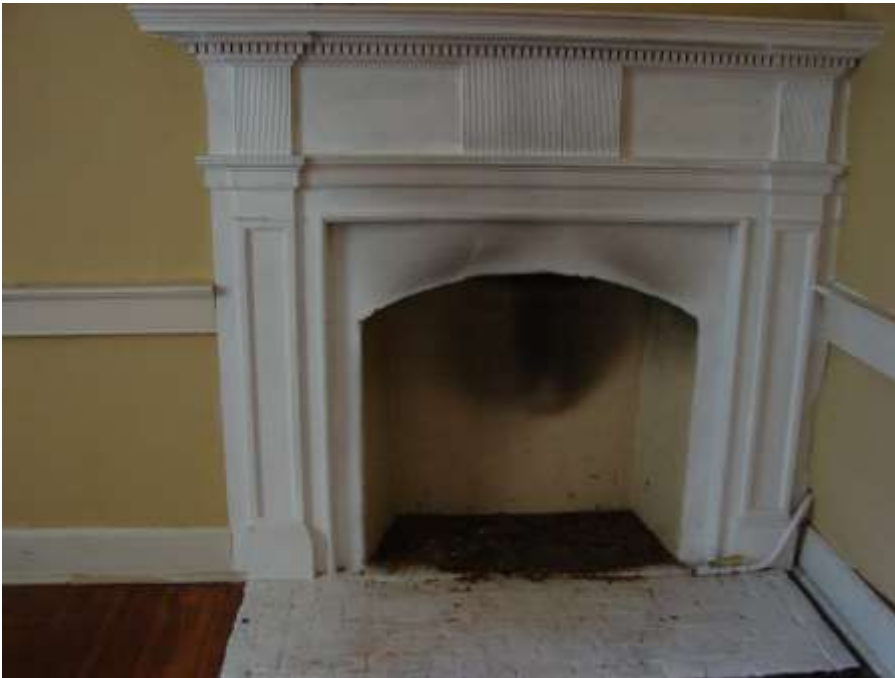
This is probably the original fireplace. The hearth is painted white, of bricks where it extends into the room, but this brick surface stops short at the edge of the grate. Inside the floor of the grate is a smooth surface.

The surbase of the wall is not molded round or notched into the trim of the mantel, but cut off abruptly when it reaches it.

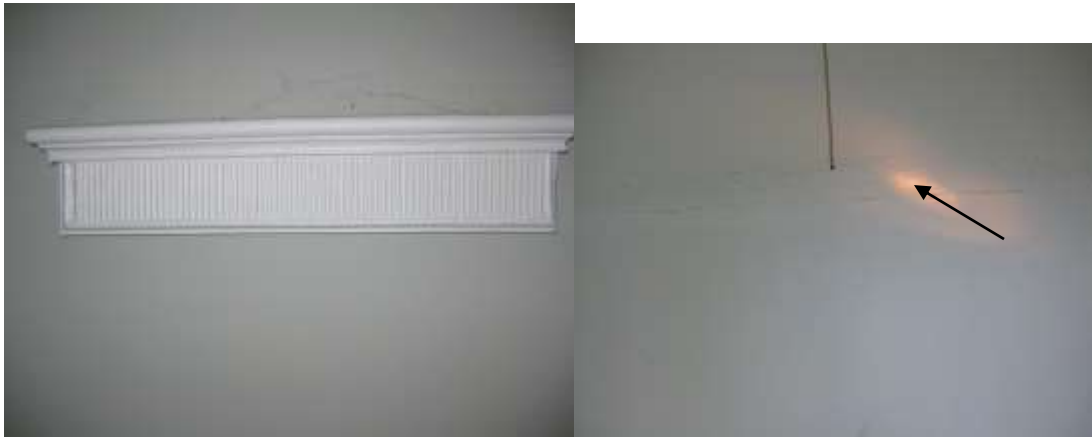
The walls are made of plaster, which covers the brick. The added exterior wall of the closet consists of plywood. These closets, which are wallpapered on the east and west walls, are not original as the surbase from the original south wall has been removed and reused on the exterior of the added closet wall. Federal wall decorations adorned the west and east walls. They most likely were transferred from another molding in the house and reused in this room as it matched other trim on the first floor. There is evidence of a 2" strip that covers the entire room except for the original south wall (it is visible on the closet wall additions). The height at which this strip is seen is 6' 1 1/2" high. This is most likely used for hanging pictures. The baseboard is 6" high and 1 1/2" deep, the surbase measures 5 1/2" high, and the ceiling height is 9' 5 1/2".

June 2008, Room 205 Federal Wall Decoration, Room 205, Ghost mark of wall trim

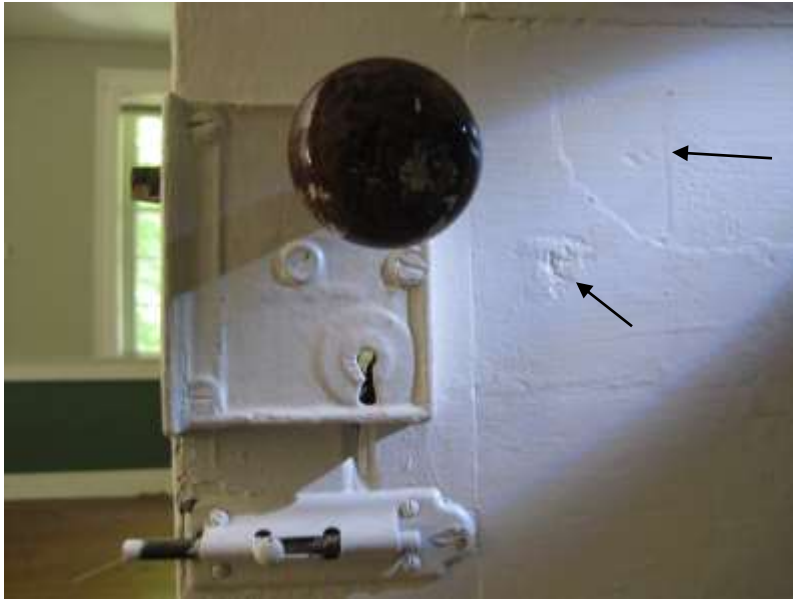
There is one entrance door to the room located on the north wall which is original. There are six recessed panels on both sides of the door that are mortise and tenoned. An original keyhole is still visible, but the current lock system includes a lock box that sits on the exterior of the door. Evidence of the original lock system, such as the pegs used, are visible underneath the paint.

June 2008, Room 205 Evidence of original lock system covered by paint (see right of doorknob), K. O'Shea

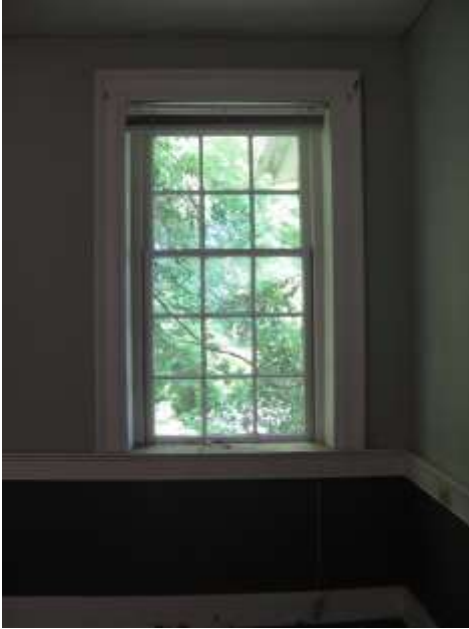
There are three (3) windows in room 205, two on the west wall and one on the east wall. The windows have double sashes with a movable lower sash and six over nine lights. The windows are of mortise and tenon and pegged construction. The windows sit 6" into the wall. From the sill to the bottom of the top architrave measures 5' 7 1/2". The width of the window sash is 2' 9 1/2". The muntins are 3/4", and the window lights measure 9 1/2" wide and 11 1/2" in height. The recessed shelving in the northeast corner of the room is believed to be a window originally, but was later bricked in.

June 2008, Room 205, West wall window, K. O'Shea

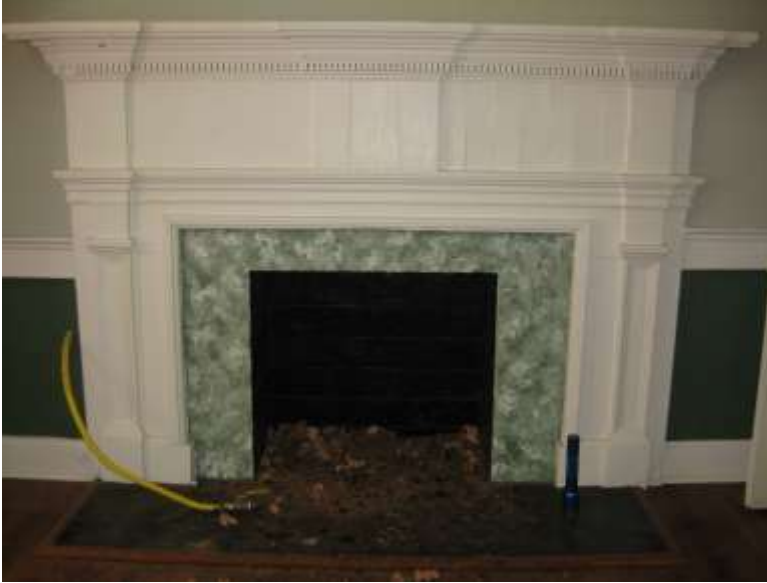
Room 205 Fireplace

The fireplace is located on the south wall. The firebox is made up of brick painted black. The firebox height is 2' 5  $\frac{3}{4}$ " from the hearth, the opening width is 2' 8  $\frac{3}{4}$ ", and the depth is 1' 2  $\frac{1}{4}$ ". There is no damper and the lintel consists of metal. The fireplace surround is a green faux marble design, which is not original. The hearth is stone, painted black, and has wood trim that is face-nailed to the floorboards. The width of the hearth is 6' 1  $\frac{1}{4}$ ", and from the back of the firebox to the edge of the hearth is 2' 11  $\frac{1}{4}$ " with an additional 1  $\frac{1}{4}$ " trim. The trim is most likely not original. This fireplace was later converted to a gas fireplace, as indicated by the yellow tube next to the mantel.
