Historic Structures
Investigation Report

Hill-Woody House

Madison Heights, Virginia

Restoration Field School

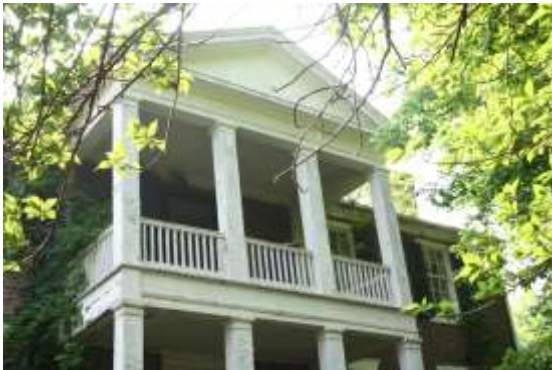
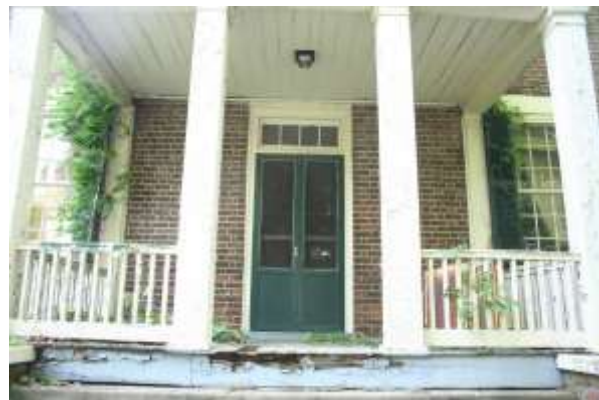
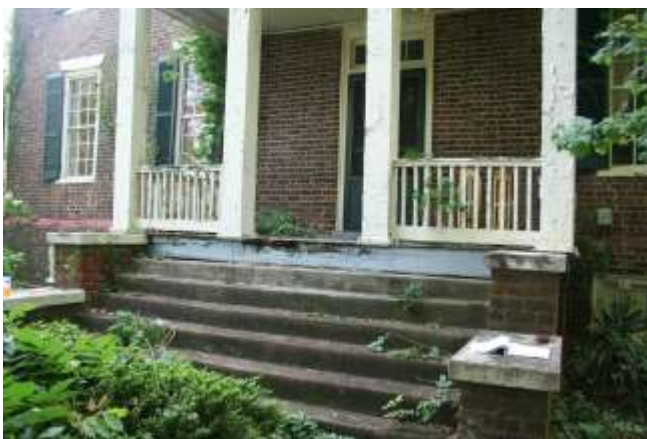
The west portico is a later addition with cement steps leading up to the portico. The wooden floor planks appear to be regular. There are planks near the front section of the portico that are visibly later than the rest of the portico planks. One of these planks is missing, which made visible one of the joists. The joists have circular saw marks. There are four wooden, square columns supporting the first and second floor porticos. Connecting these columns are wooden railings, which are comprised of rectangular balusters. The handrail is made up of two parts of wood, which is connected to the posts with an additional wooden plank. The railings and columns are covered with at least two layers of paint, a bluish-green color that appears to match the color of the outer screen doors and possibly the shutters, as well as a white to coat. The pilasters on the north and south ends of the portico are not original. A ghost mark on the brick front next to each pilaster, as well as an exposed nailing block, show where the pilasters were previously.

Entrance portico on West

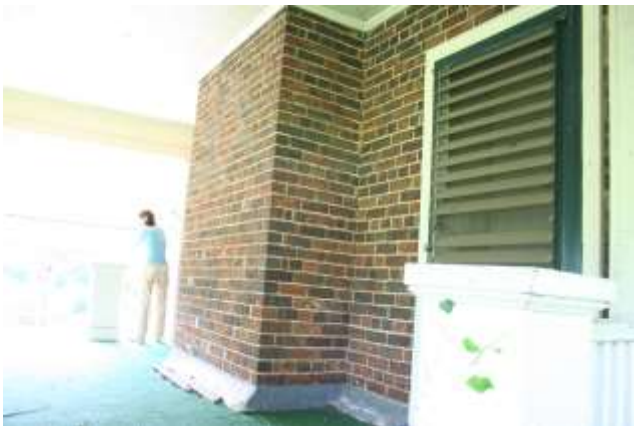
The brick walls of the original house consist of a three-course common bond design with penciled lime mortar joints. The bricks are multi-colored water-struck bricks measuring $8\frac{1}{4}'' \times 4\frac{1}{4}'' \times 3''$. There have been some repairs made to the mortar joints with Portland cement. The top portion of the water table exposed on the side porch has been painted with a gray colored paint. The first addition walls consist of an all stretcher bond design, with Portland cement mortar joints. The bricks are reddish brown, sand struck bricks. The brick size of this addition is $8'' \times 4'' \times 2\frac{1}{2}''$. The second addition walls consist of an all stretcher bond design with Portland cement mortar joints. The bricks are tan, sand struck bricks measuring $8'' \times 4'' \times 2\frac{1}{4}''$.

Original north wall and chimney

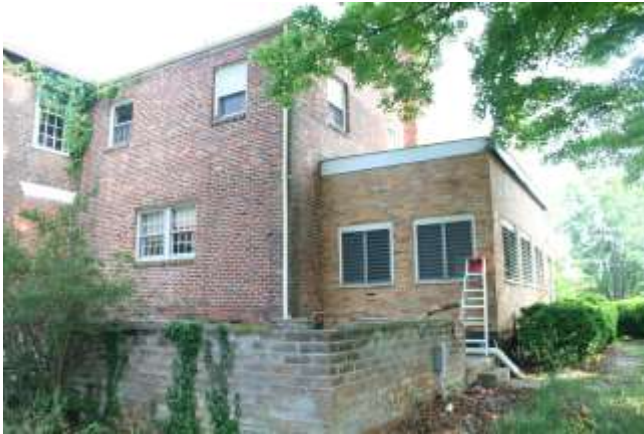
Second and third additions

Attached to the rear (east) elevation of the oldest section of the house is a two-story kitchen ell extending 22'8" with a cinderblock foundation. The ell is built of brick laid in a stretcher bond using Portland cement mortar. The bricks measure approximately 9" x 3 1/2" and appear to be handmade. The west side of the wall shows a two-story dark streak from a leaky gutter that runs along the roof line.

The basement windows are set in the cinderblock foundation. The western window is stuffed with insulation. The eastern basement window was once a sliding window. The first-floor double window is 6'7" above grade. The two windows, each 8/8 double-hung, total 6'6" wide, separated by a mullion, and are 4'4" high. There are two windows on the second story, both 8/8 and double-hung. The western window is missing its upper window sash.

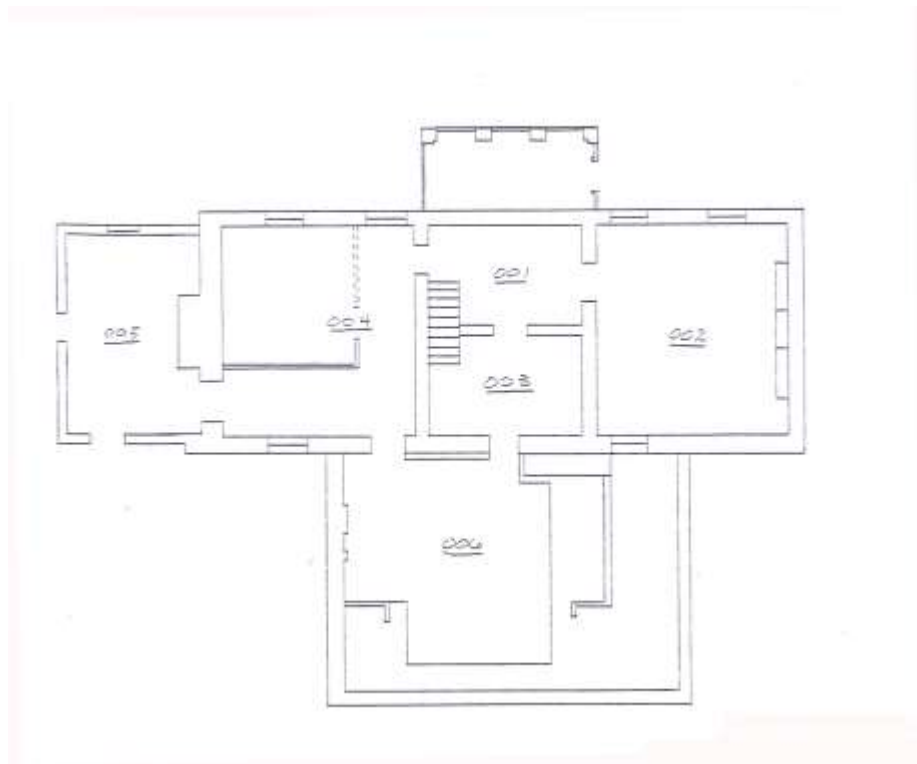
Room 001

East: North side of wall has failing plaster with exposed wire mesh. South side of wall had exposed, light red brick with oyster shell mortar.

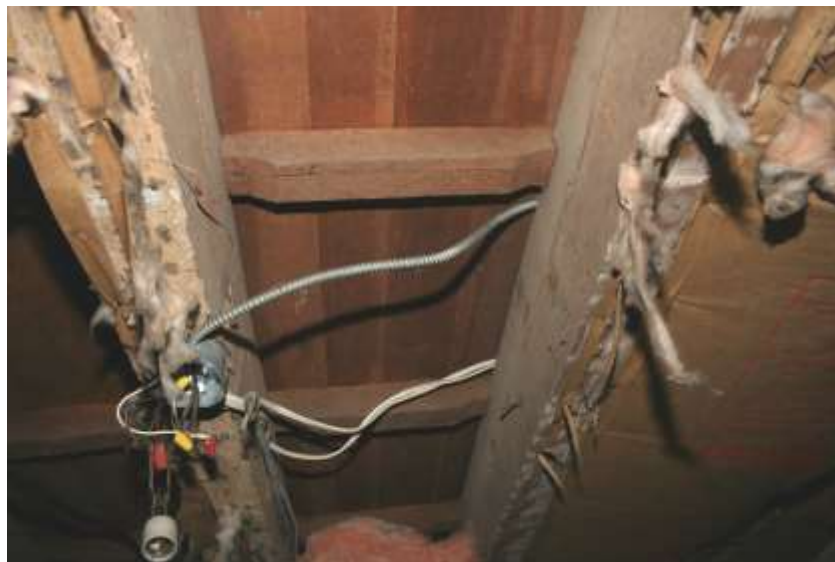
Exposed pit-sawn oak joists, 4" wide by 9" high. Vertical brick headers between joists at the west wall. Floor boards rest on purlins, which are pit or hand sawn. Floor boards running parallel to joists. Floor boards are roughly cut out in center so as to lay flat on the purlins. Purlins are 2 1/2" – 3" wide. 6' 9" from floor to joists. There is a pegged newel post poking through the ceiling. On the east wall, a joist hole is located 1'4" from the top of the door. Evidence of non-extant riven lath and plaster on the bottom of the joists.

Room 001 Ceiling showing purlins notched over joists for floor boards to run east/west

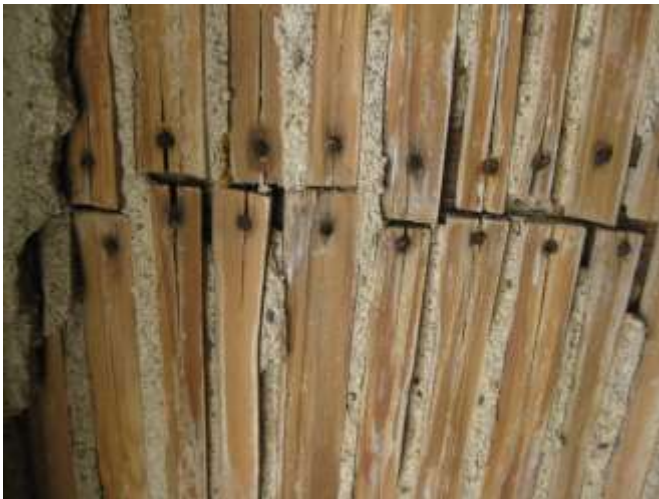
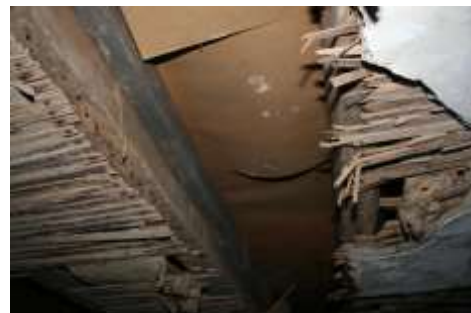
Room 002, Ceiling

Split lath and plaster with mesh screen and plaster in-between joists. Fiberglass insulation above mesh in-between joists.

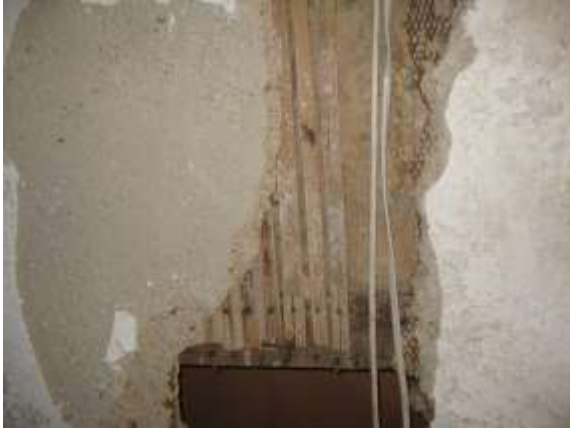
Room 002, ceiling – a more modern plaster on wire lath

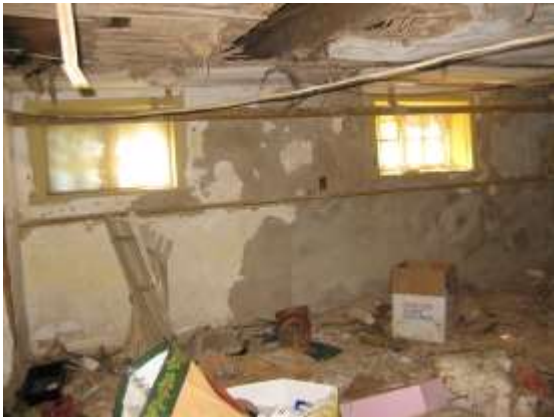
Room 002, windows on west elevation

Two windows on west wall, each a sliding sash. South window is mortise-and-tenon with pegs. North window was fastened with wire nails. Evidence of tan paint on window. Both windows are located 4' 2 1/2" from cement floor.

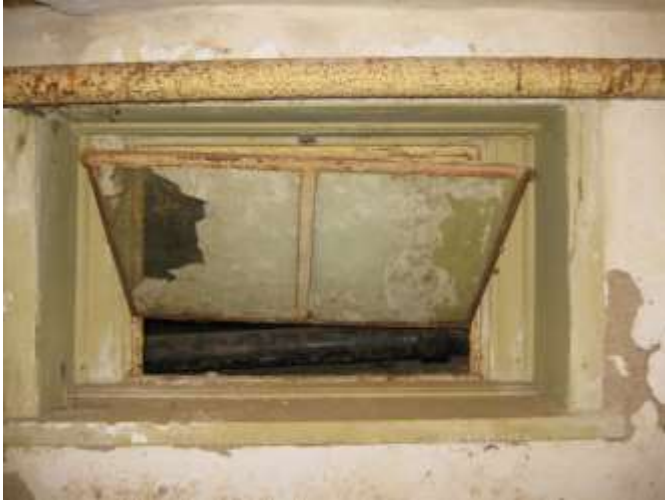
Room 002, window on east wall

The window on the east wall in the southeast corner goes into crawl space, under addition, two light, made of metal, with a wood casing. Depth is 1' 1/2", height is 1' 10". Window lifts up and out and is located 4' 1/2" up from the cement floor.

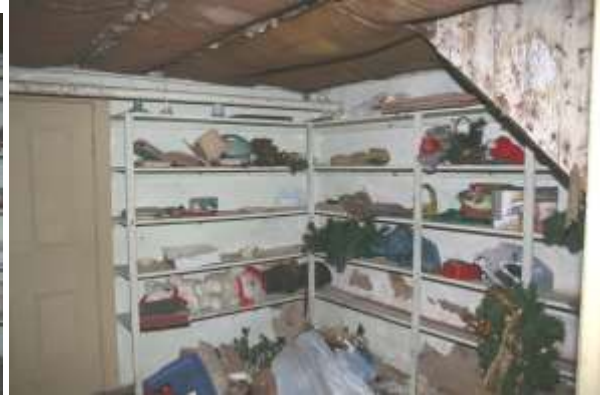
View Southeast

The east wall is constructed of first stone and then brick, like the north wall, and with the same layers of plaster in evidence. On the east wall, in the bottom northern corner, the plaster which has crumbled away to leave a cross-section of the wall reveals nails which were beneath all the plaster and therefore must have been put in prior to the plastering. Also a nail which is beneath the first two layers of plaster, possibly originally holding the metal lath to the wall, since it is surrounded by the rust ghost marks.

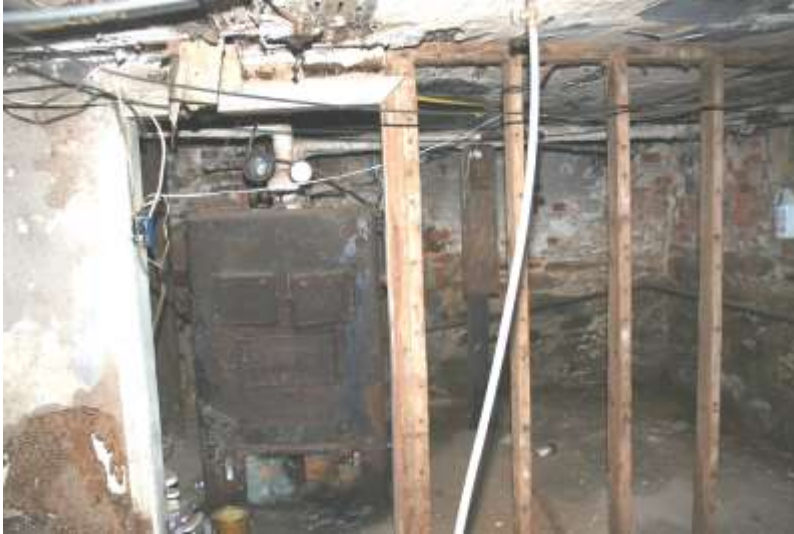
A more recent room partition segmented the room, partitioning the furnace from the balance of the room. The walls of this partition were of metal lath and the door was surrounding by 3" architrave.

Room 004, furnace and partition

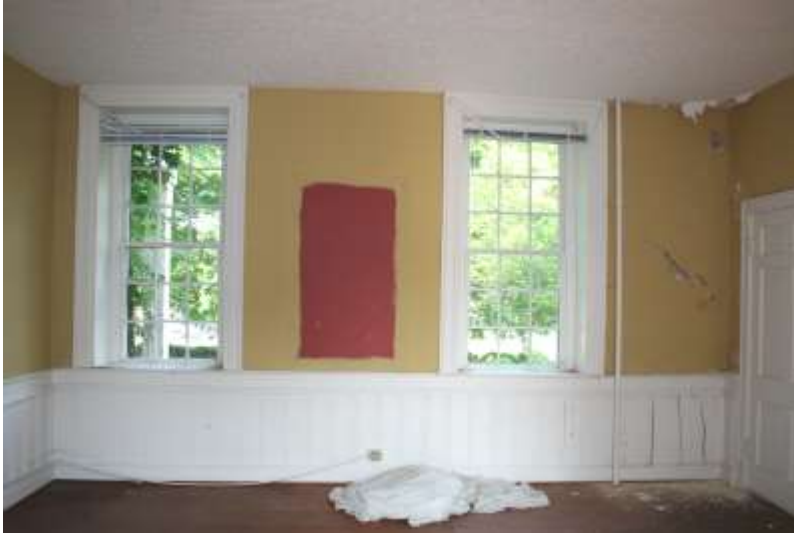
Room 101, west wall

Evidence of water damage was apparent on the East and West walls. Replastering on walls was also apparent, although not repairing the visible water damage. A cut nail was pulled from the wainscoting, which was collected for sampling. The architrave around the window is two part, 6".

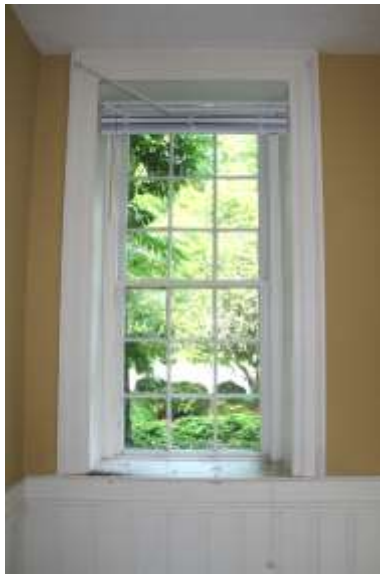
Room 101, west window

There are three windows, two on the West wall, one of the East. All are 9/9 double sash. Glass appears to be cylinder, but no specific evidence confirms this. The windows had splayed sides by about .5". The windows measure 3"-4' x 6"8'. The jams are 1' 1.25 deep. Some window panes were cracked. All windows were covered by retrofitted with modern aluminum louvered blinds.

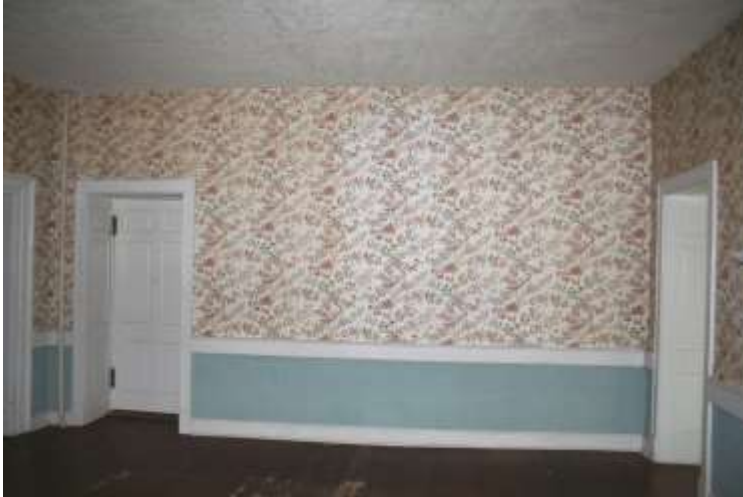
Room 102, East wall. Doorway on left was originally a window and window on right filled-in.

On the east wall, no windows remain, however, originally there would have been two windows opposite those on the west wall, in accordance with the symmetry of the federal design. The location of door 2, opening rooms 102 and 103 to each other, is the prior location of a window. This is apparent due to the hollow space found above the door when knocking; there are not bricks behind the plaster, which would indicate that a cut out in the original exterior wall existed prior to the doorway. A doorway would not have required the height of the window, therefore this space was originally a door, the wall above would be brick, as is the case above other doors in the house. The other window, which would have been located on the south side of the east wall has since been bricked up, as evident on the exterior elevation. There is no remaining evidence on the interior wall. These previously would have matched each other as well as windows 1 and 2 in room 102.

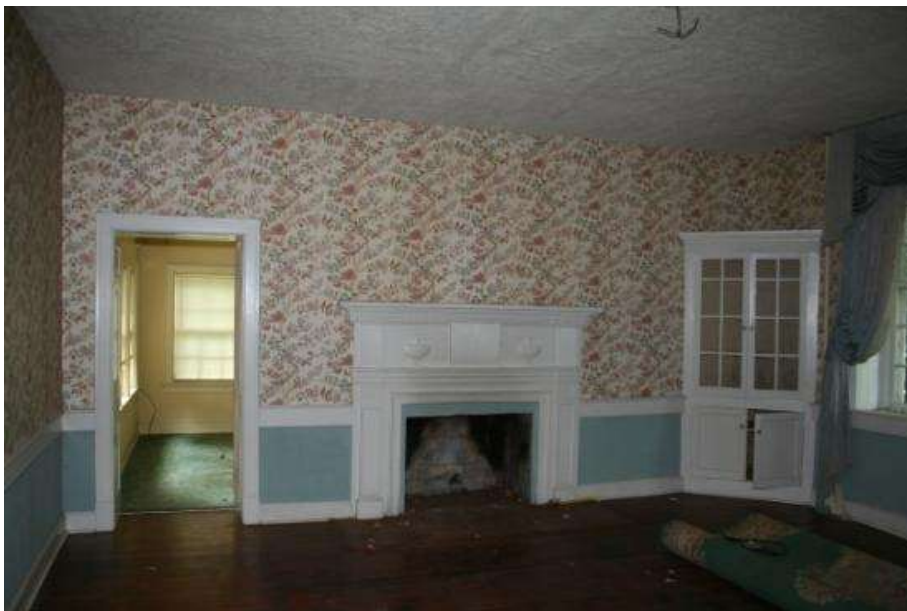
Room 102, south wall, door 3, fireplace, corner cabinet, window 1

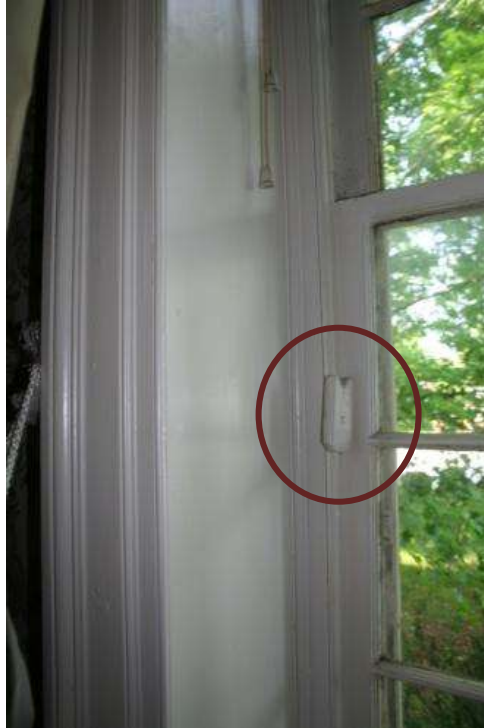
Room 102, Window 2, window sash holder (circled)

There are two windows in room 102, located symmetrically on the west wall, six feet apart. Both windows are believed to be original, although the trim is different from those upstairs. They are double sash with 9/9 lights. All of the framing is wood painted white. The windows are 6'8" from the sill to the bottom of the architrave. Each light measures 9 ½ inches wide and 11 ½ inches high. The muntins measure ¾ inches wide. The depth of each window jamb is 1'0". The width of each window is 3'4" without the architraves, which are 5 ½" wide each. On the jamb of window 2, a sash holder remains, indicating that the bottom sash, like others in the house, was not hung. The top sash were typically fixed and did not move. The wooden piece, painted white, serves to hold open the sash. (See photograph below, where it is circled.)

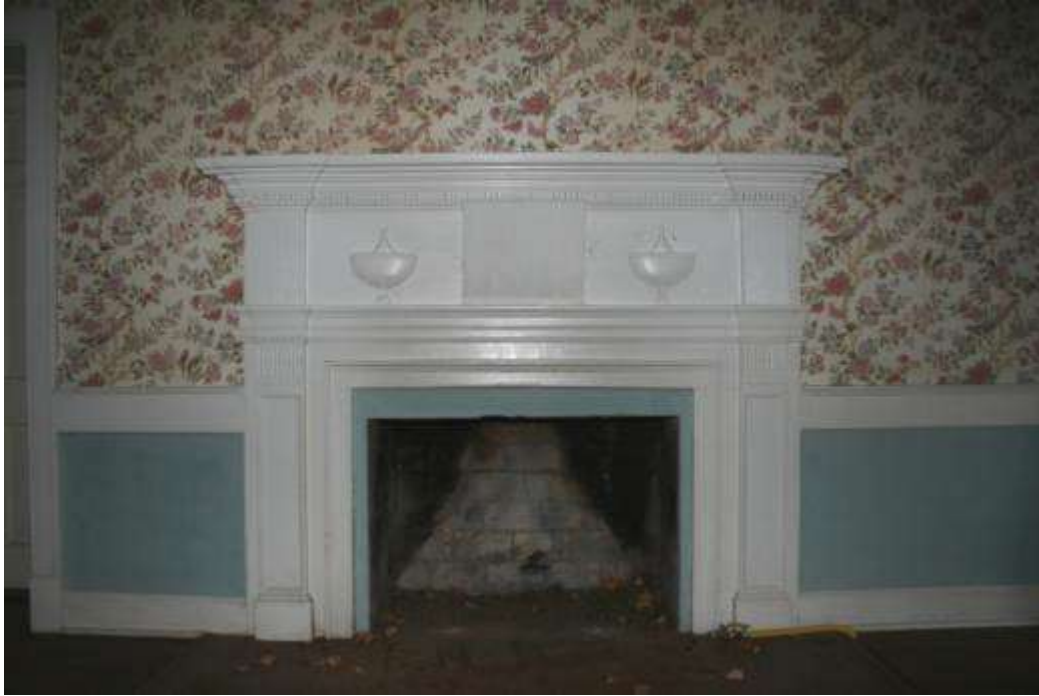
Room 102, Fireplace and mantel

The mantel is constructed of wood. It is currently painted white, but investigation reveals a black coat, which would indicate it may have been painted to look like basalt. It measures 7'2" wide with the shelf. It is $5'4\frac{1}{2}$ " in height. The shelf is $1\frac{1}{2}$ " thick. The fireplace was later converted to a gas fireplace, as indicated by the yellow pipe in the photograph. The mantel is believed to be original.

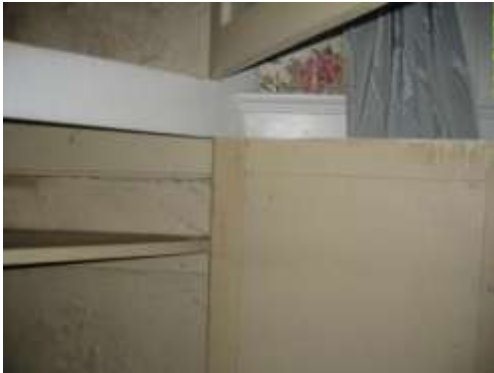
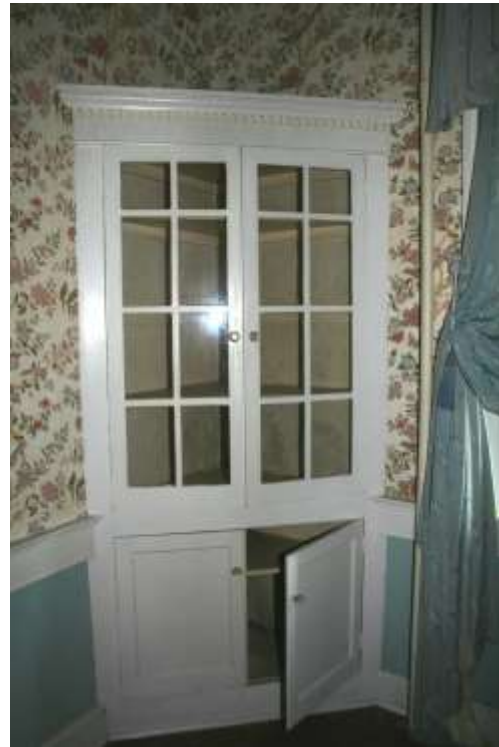
A corner cabinet has been added in the southwest corner of the room. There is not a back to the cabinet; the shelves are supported by wood pieces?? About 1 ½ " thick. The cabinet is determined to not be original, as the surbase is seen in the bottom portion of the cabinet. However, the cabinet was likely added before the wallpaper and blue paint was applied since the shelves reveal the top coat of plaster, though without a white lime wash. The cabinet measures 7'7 ½" in height and 3'6" across the front. The shelves are isosceles triangles, measuring 2'5 ½" on each side (the west and south walls of the room.)

Room 102, southwest corner, note surbase visible within the corner cabinet as well as the unpainted plaster

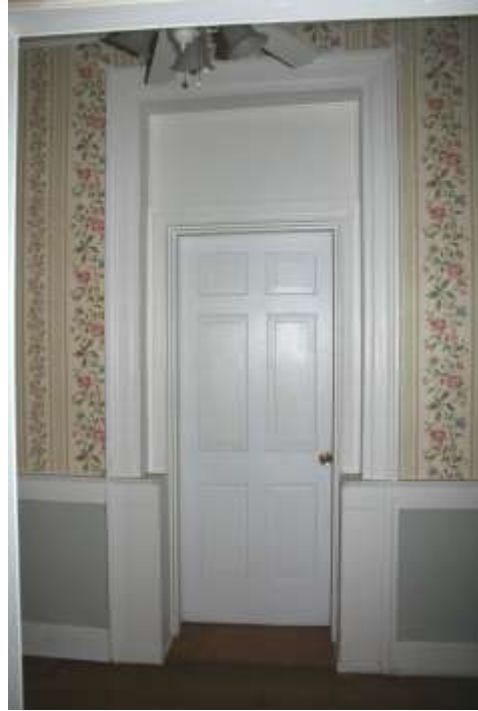
The east door (D206-1) opens into a later ell addition, and might have been converted from a window, which would have been the sole window in the hall. The door opening is cut into the surbase, and its two-part architrave reflects its later addition. The outer architrave is 6" deep, and the inner is 2 ½" deep. Above the door is what appears to be a filled-in transom light which matches the corresponding door on the first floor (window made into second period doorway with transom?). The door opening is 2' 6" by 6' 7". The entire door opening with the architrave and transom is 4' 2" by 9". The door is paneled with a modern brass-plated knob.

east wall, originally a window

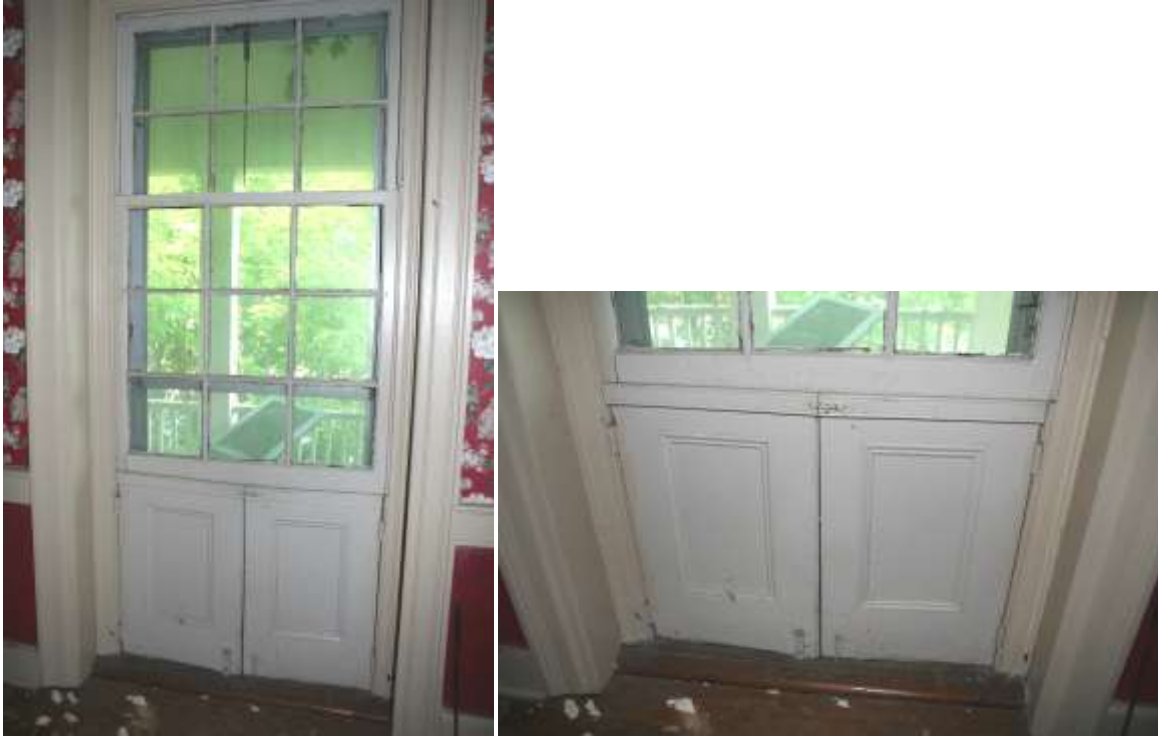
Room 201 West Wall, Jib Door

measures 1'7.75" x 2'6" x 2" deep. The top sash is fixed while the bottom is moveable and held open by a makeshift rotating stop secured with a wire nail. Two window panes are missing in the lower sash and some panes are cracked in both sashes. The door secures to the floor and interlocks with three sliding bolts. There is a mill finish metal storm door on the exterior of the jib door that leads to a portico.

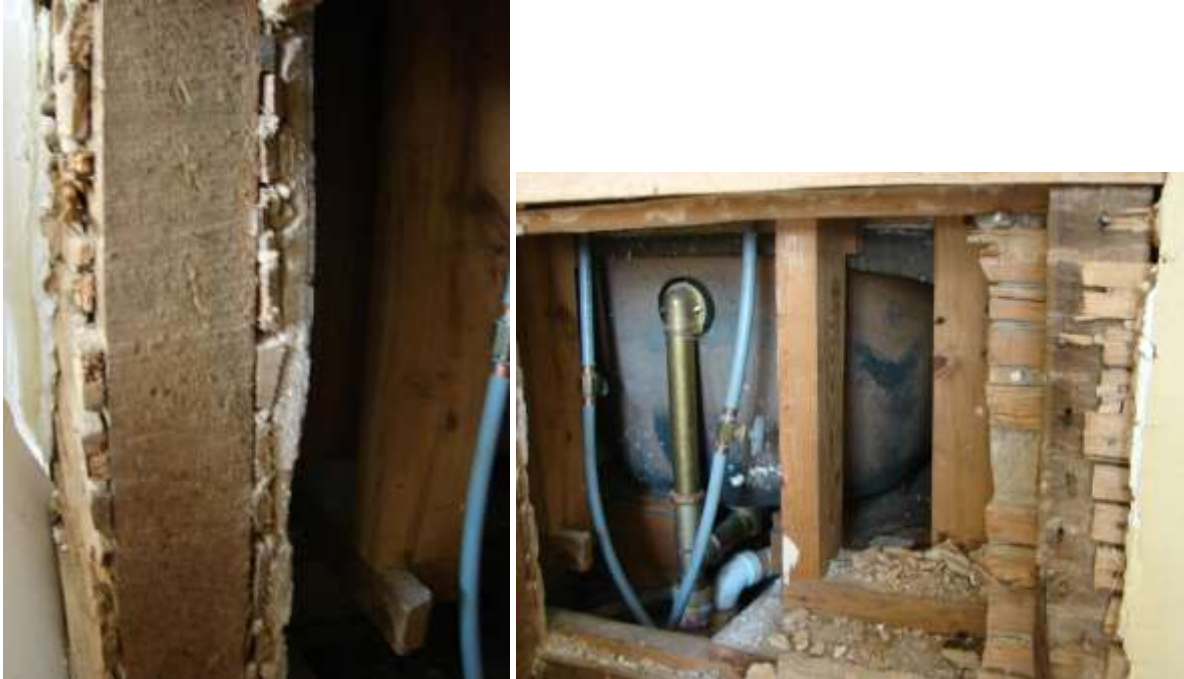
The east wall is a later partition constructed of a wooden frame of pit-sawn wood with split lath of poplar wood nailed to it and a lime-based plaster, infilled and plastered and painted over. There is one panel near to the northern corner where the original lath has been removed, to allow access to the plumbing of the bathroom next door. Foam insulation has been added here and a cardboard partition stapled to the original beams, which show the ghost-marks of the old laths, to cover the gap. Inside, the previous surbase and baseboard can still be seen,

Room 202 East wall, open panel with lath and plaster

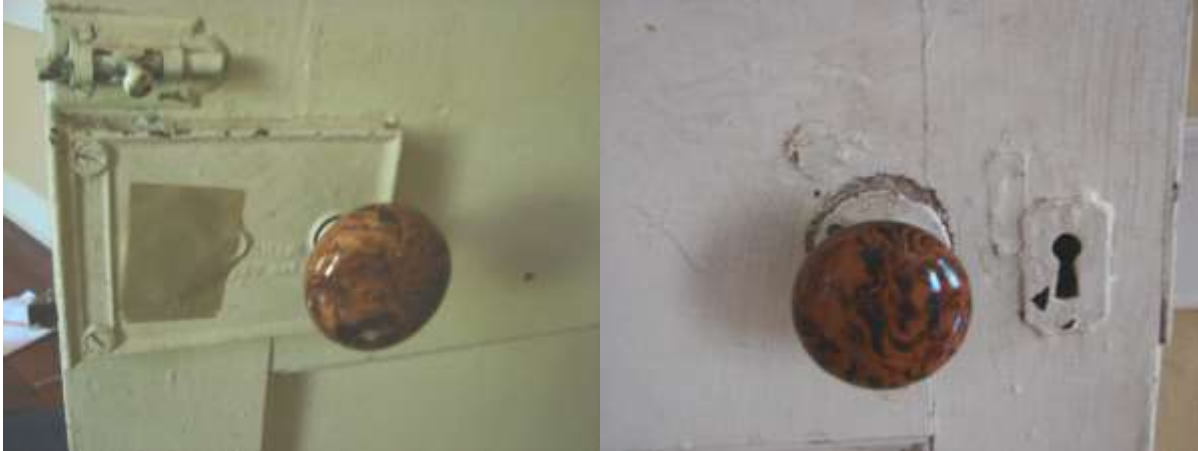
Room 202 left: rimlock and bolt on inside; right: current handle and ghost of previous lock

There are ghost-marks from an earlier keyhole and doorknob on both sides of the door. The door has two layers of white paint, and beneath that a layer of dark red paint. Faint ghost-marks can be seen through the white paint of faux-graining, on both sides of the door. The door is paneled, and appears to be first period. It may have been moved from the infilled doorway in the south wall. The architrave is of later date.

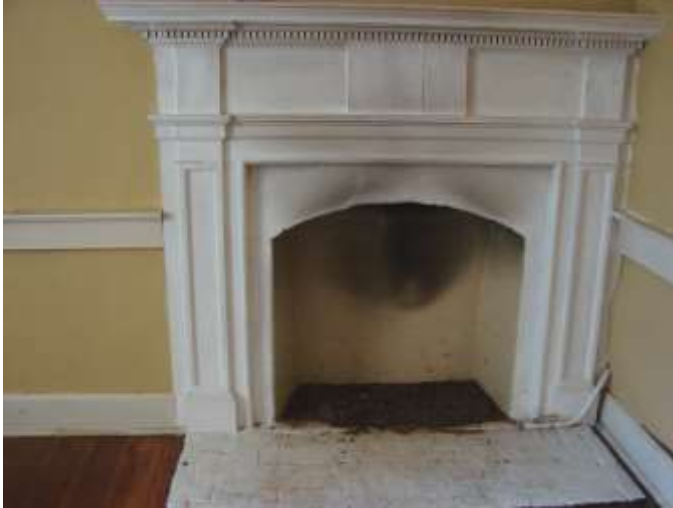
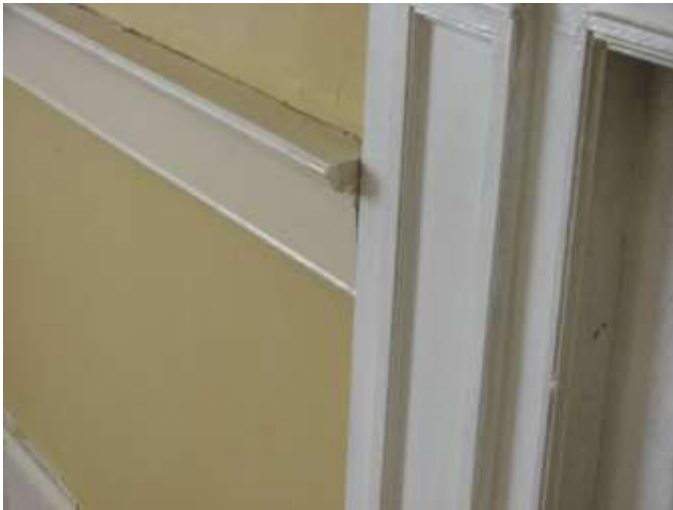
The brick of the hearth does not extend as far to the right as the end of the mantel post on that side.

The fireplace is rather shallow, so may have been filled in a little, and there is a metal pipe wedged long-ways inside the chimney shaft to block it.

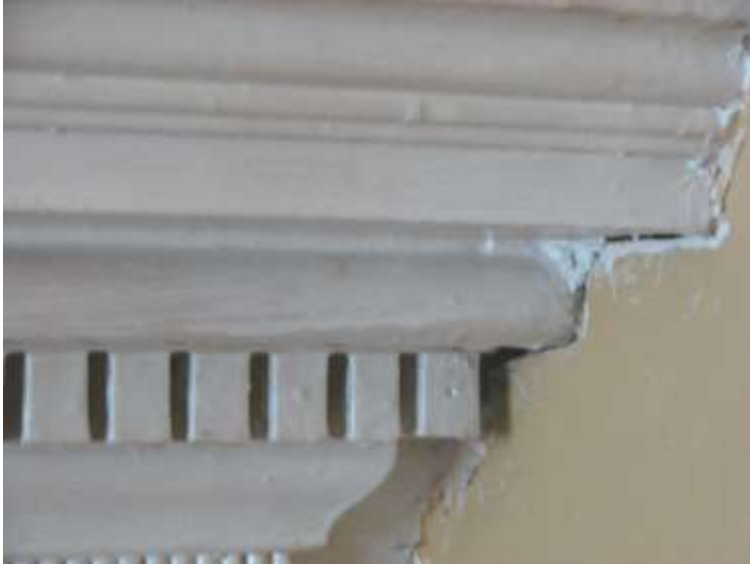
This is white painted wood and plaster in the federal style. The mantel shelf, and the dental decoration below it, does not stop when they reach the eastern wall but run on into it.

Room 202, mantel and east wall

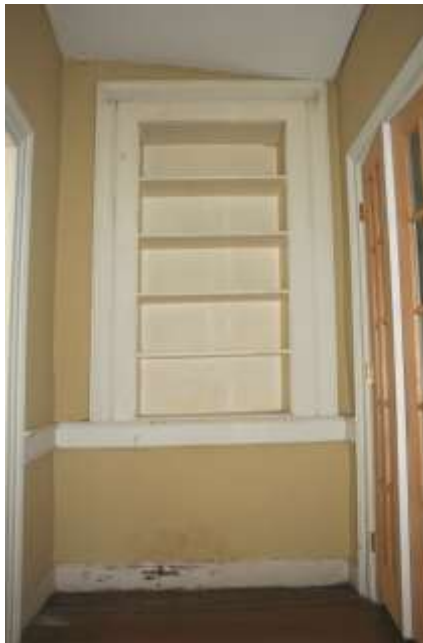
204, formerly part of 202; window blocked up.

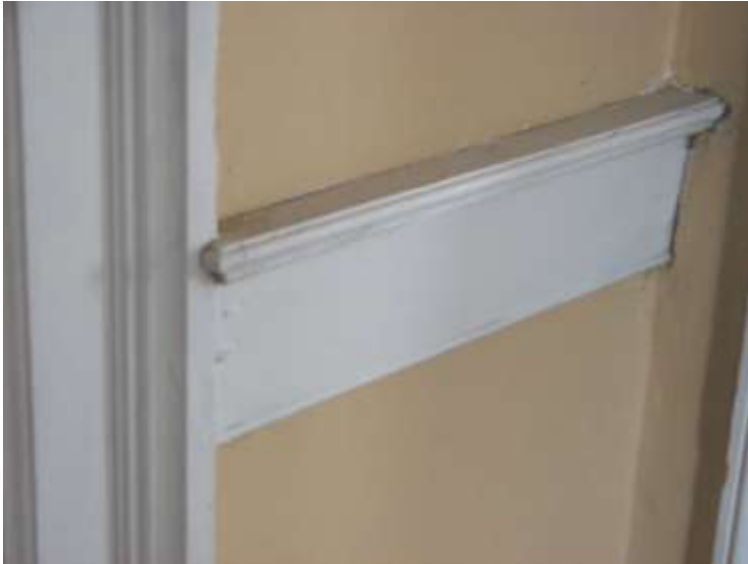
The south wall is a continuation of the south wall of room 202, and the doorway from the main foyer room 204 is set in this wall. The doorway appears to have been cut into the wall after it was made. The trim along this wall is not first period, since the edge of the surbase is notched into the architrave of the doorway.

Room 204, surbase on south wall fitted into south door trim

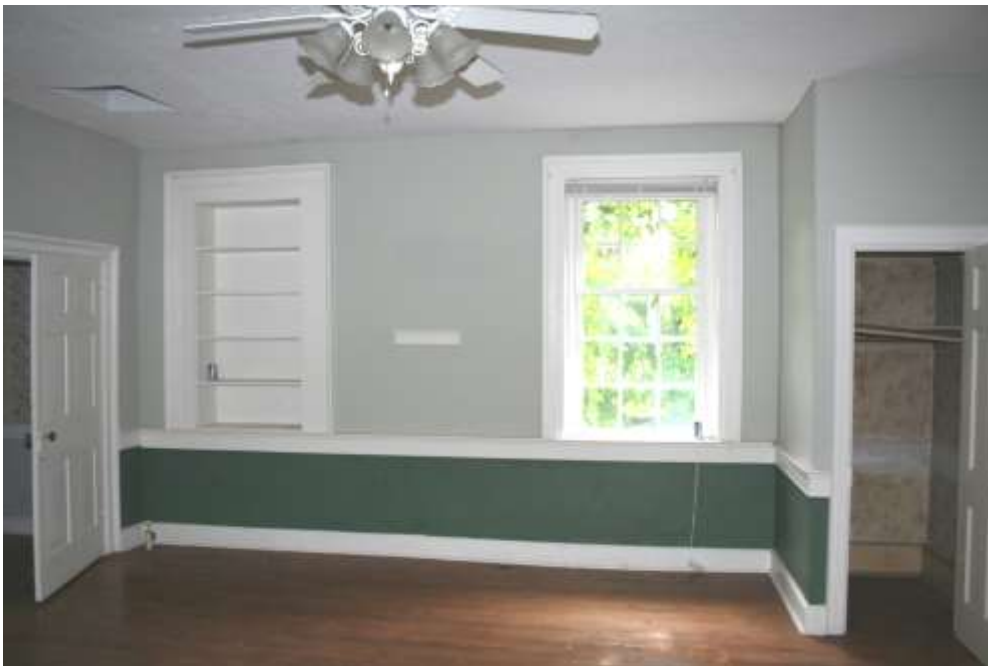
204, east wall; closet on right added. Window blocked by addition and now bookshelf.

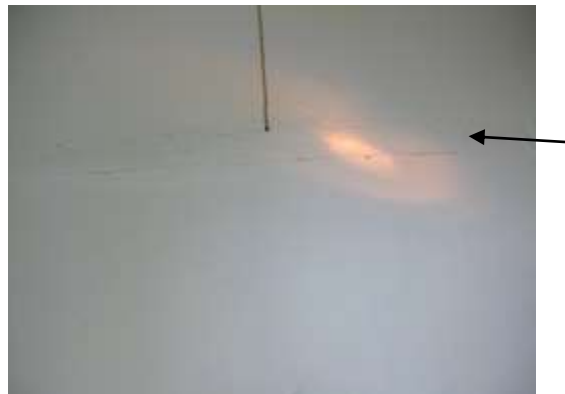
Room 205, Ghost mark of wall trim

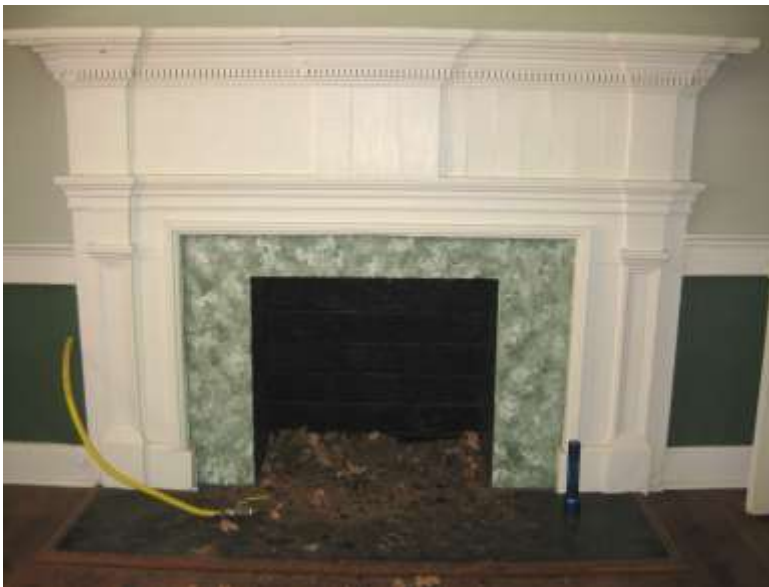
The fireplace is located on the south wall. The firebox is made up of brick painted black. The firebox height is 2' 5 ¾" from the hearth, the opening width is 2' 8 ¾", and the depth is 1' 2 ¼". There is no damper and the lintel consists of metal. The fireplace surround is a green faux marble design, which is not original. The hearth is stone, painted black, and has wood trim that is face-nailed to the floorboards. The width of the hearth is 6'1 ¼", and from the back of the firebox to the edge of the hearth is 2' 11 ¼" with an additional 1 ¼" trim. The trim is most likely not original. This fireplace was later converted to a gas fireplace, as indicated by the yellow tube next to the mantel.

Room 205 Fireplace

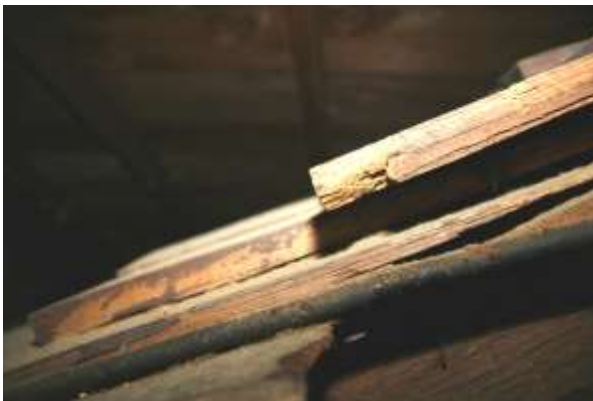
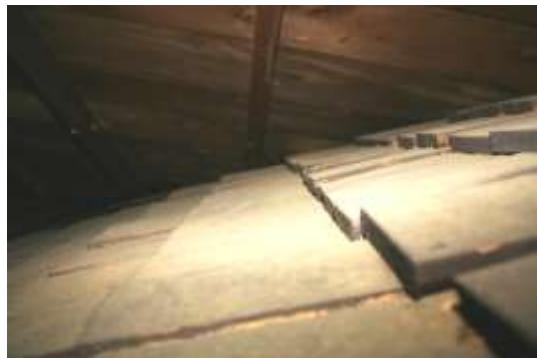
When the west portico was built it encapsulated some of the west roof. A hole in the sheathing from the main roof allows a view into the portico space. The 18" square-butt chestnut shingles have a 6" exposure and show evidence of red paint/stain (see Pictures). A nail pulled from one shingle appears to date to the mid-early 19th Century and does not match other hand wrought nails extant in the framing, indicating that the shingles were probably a second period covering, replacing a first period shingle roof (the encapsulated shingles were also in very good shape with little signs of weathering). The shingle roof was replaced prior to the addition of the portico. The lumber in the portico roof is circular-sawn material, indicating that it is no earlier than mid nineteenth-century. The Greek Revival style would suggest a late antebellum date.

Second period shingles encapsulated in west portico pediment roof. Note red paint on shingle in left photo.

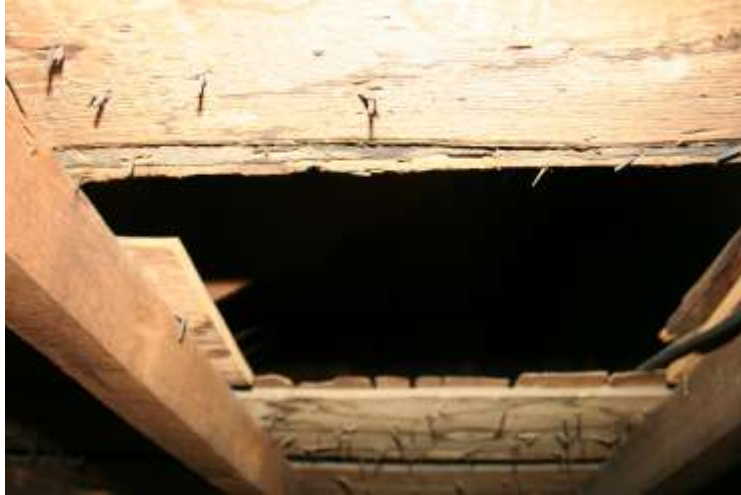
West roof slope with hole looking into portico pediment space
