## OAKLANDS

### NORTH FAÇADE

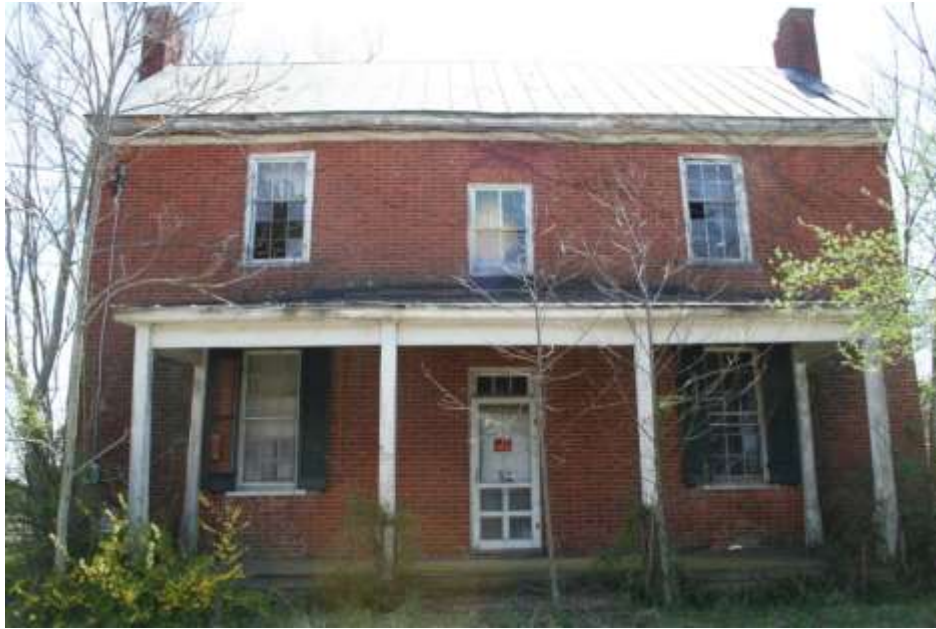
Figure 1.0- Elevation. North Façade

Facing US 460, the North façade of Oaklands is the front façade of the house. It is distinguishable by its three bay organization and front portico.

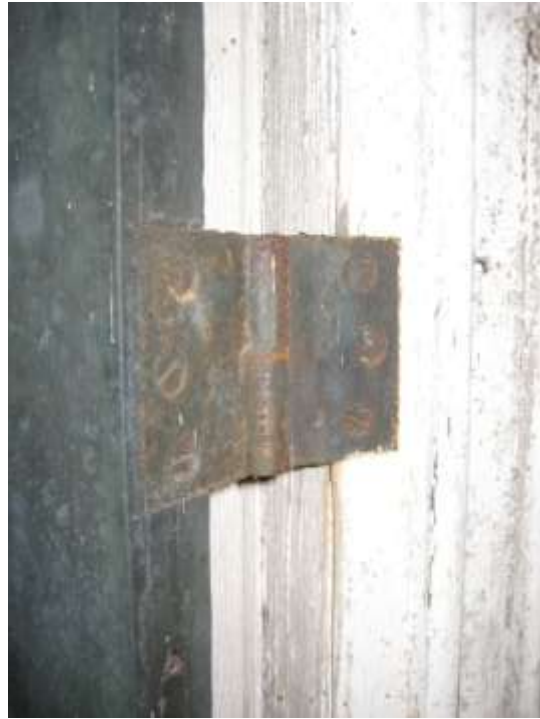
Figure 7.0-Shutter Hinge. North Facade

attached with two **(type)** hinges [Fig 7.0] and held to the façade with oblong shutter dogs attached to the brick [Fig 8.0]. The shutter dogs are painted the same green as the shutters. The fact that the shutter dogs are attached to the brick rather than the mortar suggests they were added later. On the left shutter of pair, there is a shutter clips [Fig 9.0]. The west windowsill has a rounded metal eye to which the clip could attach; there was no eye on the east window. Above these windows, the second floor outer bays have 6/9, double sash windows, also with wooden sills and frames [Fig 10.0]. Above the front door in the central second story bay, there is a 2/2 double sash wooden window [Fig 6.0]. This window has larger panes (14.75x24 inches) and wider muntins (1.25 inches) with a different profile than the other windows, supporting the other evidence of this window being added later within a previous doorway. All of the trim on the front façade is painted white.

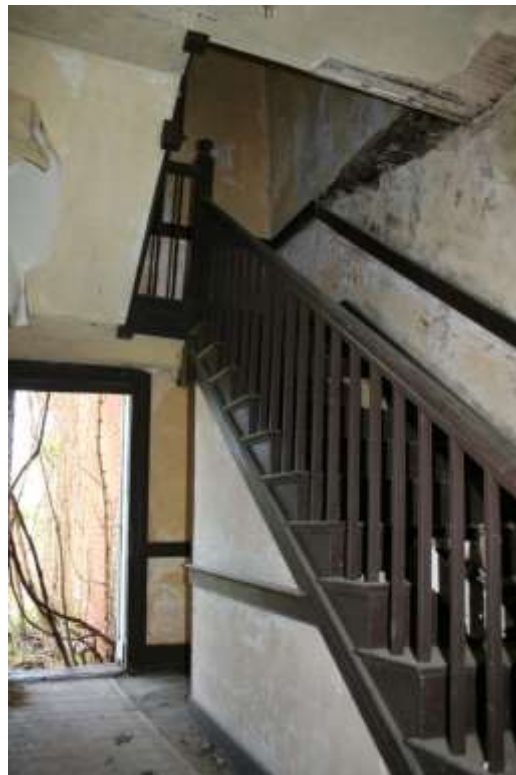
Figure 16.0- Looking Towards South Wall Door. Room 100

**Walls-** The walls are plaster with traces of a mustard yellow paint. The plaster ceiling has traces of white wallpaper, and there are traces of a floral wallpaper border on the South wall. The West wall is the only wall to have lathe underneath the plaster; the other walls all have the plaster applied directly to the masonry. The walls around the stair have a 6-inch baseboard with top beading. Continuing up the staircase and on the perimeter walls, the baseboard is 6.25 inches with top beading as well as a 2-inch additional rounded piece along the bottom edge. Starting 2 feet 0.75 inches from the top of the baseboard there is a 4.5-inch chair rail. This moulding is continuous on all the perimeter walls and continues up the staircase. Aligning with the top of the door architraves, a 4.25-inch picture moulding with top and bottom beading runs along the North, East, and South Walls. This moulding does not continue up the staircase. The picture moulding has holes, some with pieces of metal hooks still attached, at variable distances along the center of it. There is no cornice. At the corner of the stair walls, there is a round wooden piece that runs vertically from the baseboard to the bottom of the stair trim broken only by the chair rail, in order to protect the corner because the plaster would be too brittle and prone to breaking. All of the moulding is currently painted a dark brown. [Figs 16.0 & 17.0]

**Doors-** There are four doorways in Room 100. The front door on the North wall and a back door on the South wall are aligned [Fig 16.0]. There are also doorways adjoining the stair hall to the two first floor rooms on the East and West walls. The back entrance door on the South wall has evidence of the lock and hinges being switched at some point from one side to another [Figs 18.0 & 19.0]. It is a four-panel wooden painted door. The doors to the adjoining rooms are six-panel painted wooden doors. Around all four of the doorways in Room 100 there is a 5.5-inch

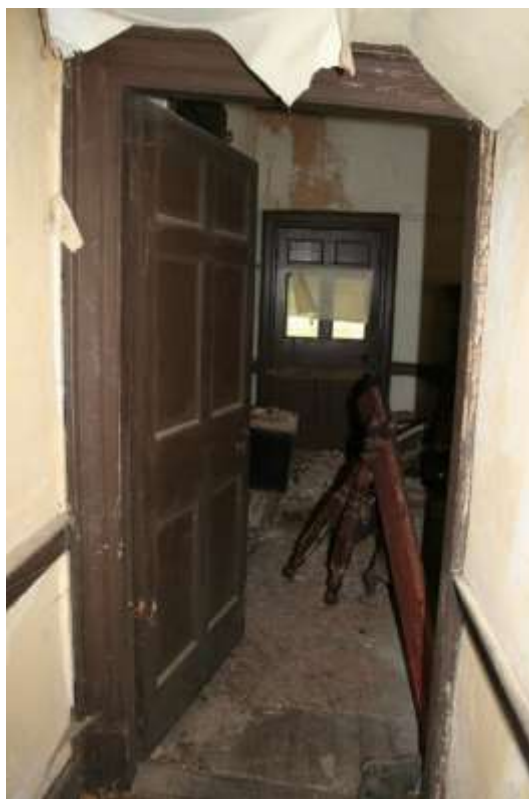
Figure 20.0- Doorway to Room 102. Room 100

architrave, although due to the location of the stair walls it is cut off on the right side of the door into Room 102 [Fig 20.0] . This architrave moulding is also located along the bottom of the side of the stair on the East stair wall. All of the doors except the front door have round doorknobs with a brown ceramic glaze. The front door has a smaller round metal knob.

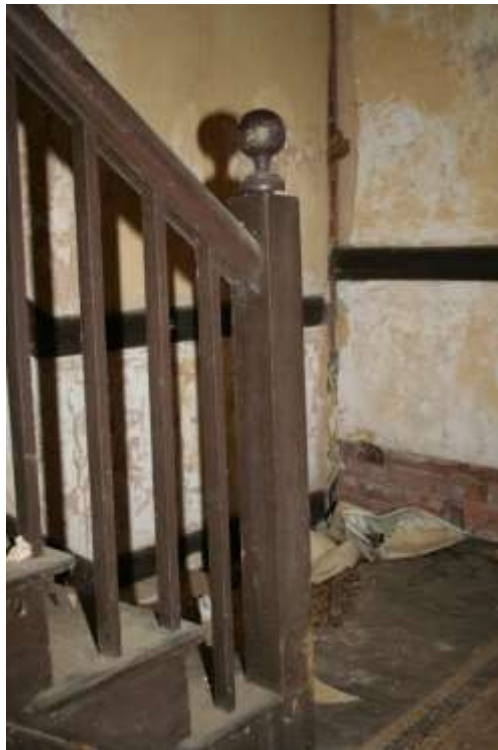
Figure 22.0- Balustrade and Newel Post. Room 100

newel posts are 3.5-inch square posts rising 41.75 inches with a 5.75-inch finial on top. They are located at every turn in the stair as well as at its beginning [Fig 22.0]. The balustrade turns continues past the last newel post on the second floor and terminates in the West wall. The finial is a spherical piece set on top of a curved pedestal base. The rail is at a height of 34 inches and is on the outer side of the stair only. The chair rail runs parallel along the wall. The round handrail with orthogonal base and bottom nosing has a diameter of 2 5/8 inches and runs continuously between each newel post.

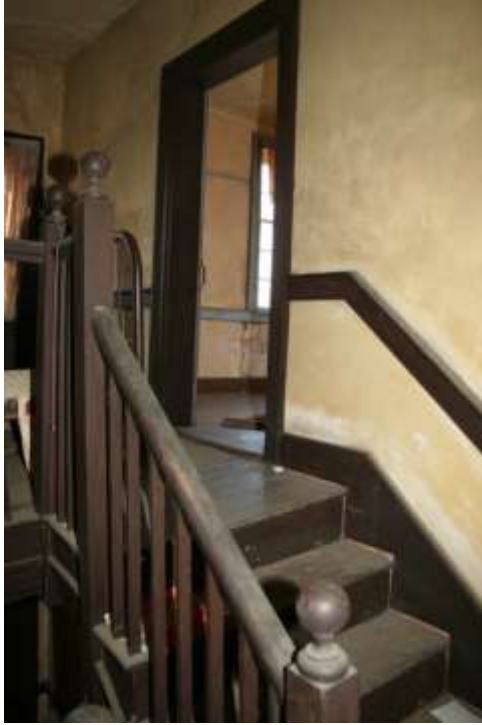
Figure 23.0- Looking Towards East Wall From Staircase Landing. Room 200

moulding with top beading that followed the stairs is continued around the walls of the second floor stair hall, as is the chair rail. There is no picture moulding or cornice. [Fig 23.0]

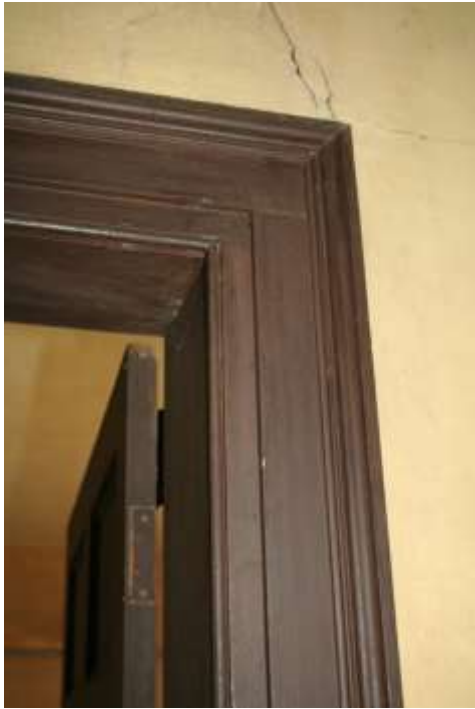
Figure 24.0- Architrave Detail. Room 200

**Doors-** There are two doors at the top of the stairs in Room 200 leading into Rooms 201 and 202, as well as a small door under the attic stair for a small storage closet. Both of the large doorways have a 5.5-inch architrave around them [Fig 24.0], which is also used along the bottom edge of the attic stair outer wall. Because of the angle of the attic stair, the top right corner of the doorway connecting to Room 202 has been cut off. The small door underneath the attic stair measures 25.5x25 inches (WxH). It has the same architrave trim as the other doorways on the landing. It is a double panel wooden door with interior beading. [Fig 25.0] There are hinges on the left side of the door, but the doorknob is missing. Behind the doorway is a small storage space underneath the attic stair. The window located at the top of the stair on the North wall appears to at one time to have been a doorway as the architrave trim continues to the floor and the wooden jamb construction is similar to the construction of the front door.

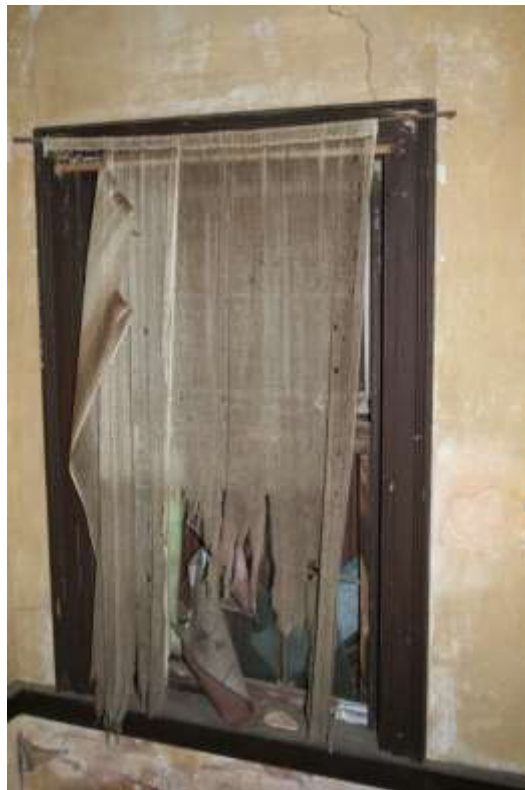
Figure 28.0- South Wall Window at Stair Landing. Room 200

**Windows-** There are two windows in Room 200. At the top of the stair there is the 2/2 window located in the center bay of the North façade, and on the landing between the two floors there is a 6/9 window on the South wall aligned with the 2/2 window, therefore not centered on the wall. The 2/2 window is double sashed with 14.75x24 inch glass panes with 1.25 inch muntins. There is a wooden piece adhered to the side of the frame in order to lock the top sash in place. The window appears to be set into an earlier doorframe because the architrave extends down to the floor and the space underneath the 25-inch high windowsill between the architrave mouldings is infilled with 3.25-inch vertical wooden boards. The window also has larger panes and muntins than the other windows in the house suggesting that it was added later. [Figs 26.0 & 27.0] The larger 6/9 window on the stair landing has 9.5x15.5 inch panes with 1.5 inch muntins similar to the windows in the rest of the house. The 5.5-inch architrave matches the doorways in Room 200. [Fig 28.0]

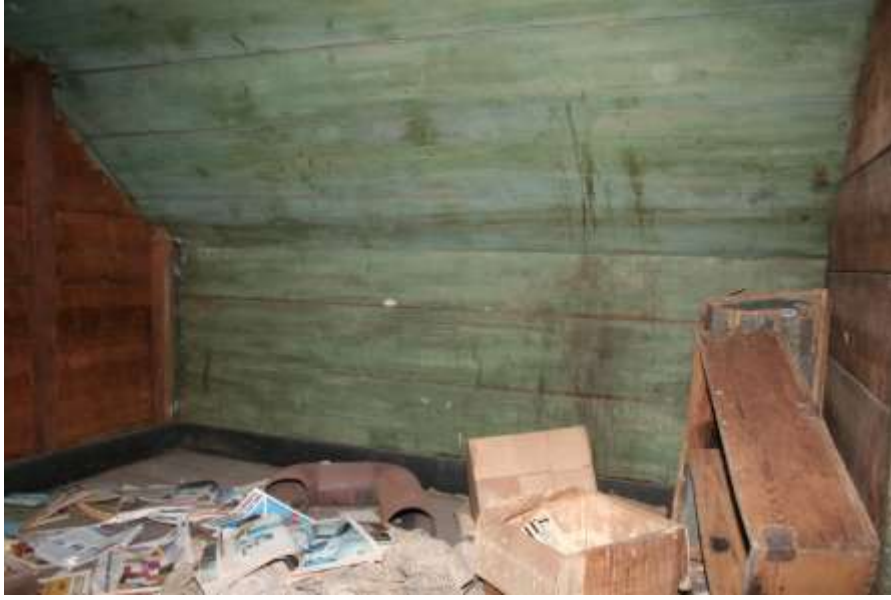
Figure 29.0- South Wall. Room 300

**Walls-** There are two types of walls in Room 300. The North and South walls are made of hand planed 12-inch wooden boards with bottom beading. These boards are painted with a green wash. [Fig 29.0] The East and West walls have unfinished and unpainted wooden boards approximately 9.5-9.75 inches wide. [Fig 30.0] The right side of the East wall does not have boards, but rather the studs are exposed. [Fig 31.0] The baseboard is a 5.5-inch moulding with top beading. This moulding runs around the perimeter of the floor including the section of the East wall with no wall surface. The ceiling of Room 300 has the same 12-inch boards as the North and South wall except that they seem to be machine planed. They are set underneath the wallboards, so the wall and ceiling are contemporary to each other.

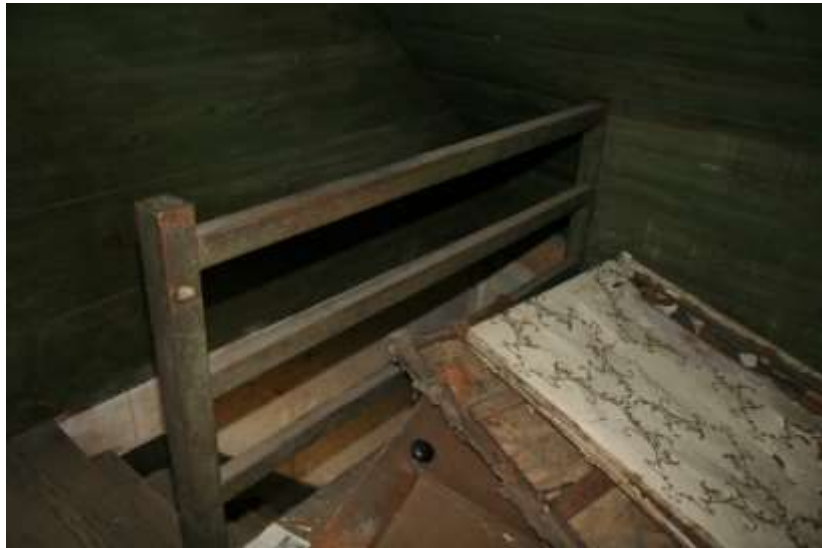
Figure 34.0- Balustrade and Newel Post. Room 300

At the top of the stair, there is a 3 1/8 x 2 5/8 inch rectangular newel post with a 3-rail ladder running from it to the North wall. The horizontal beams of the ladder measure 2.25x2.5 inches and are spaced 9.5 inches apart starting 3 inches down from the top of the newel post. This newel post and balustrade are painted the same brown as the trim in Rooms 100 and 200. [Fig
