## **Restoration Field School**

Thomas Jefferson's Poplar Forest

## Architectural Investigation of Hog Town House

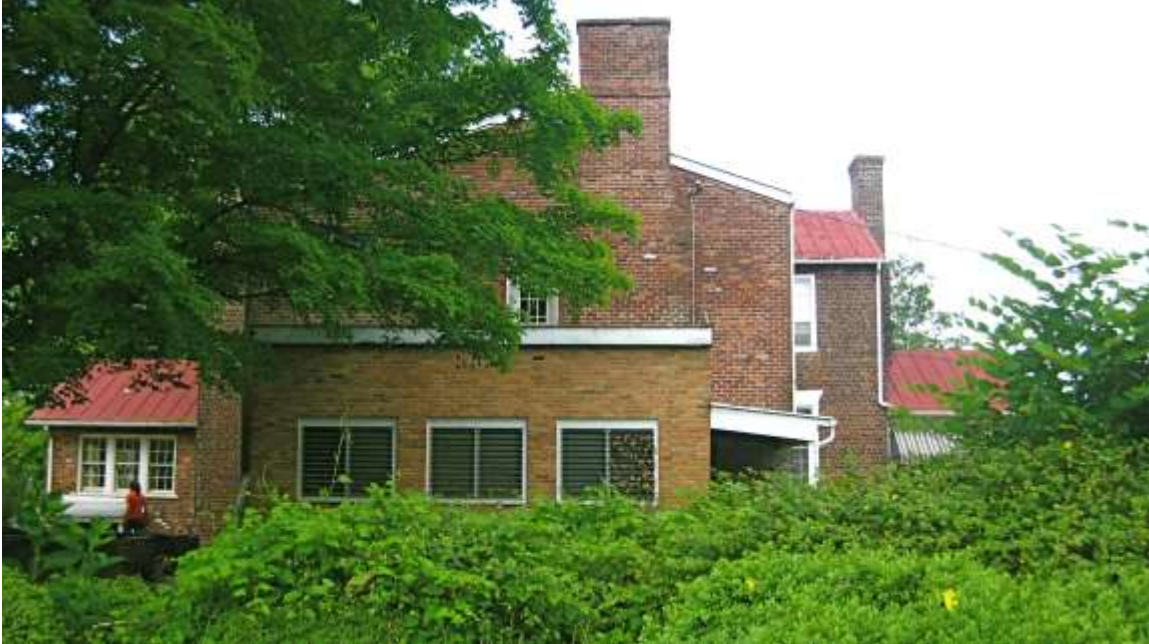
Hog Town House, May 2008, East Elevation

The following image is of the east elevation. The below descriptions start to the leftmost side of the picture, the South, and continue to the right, North.

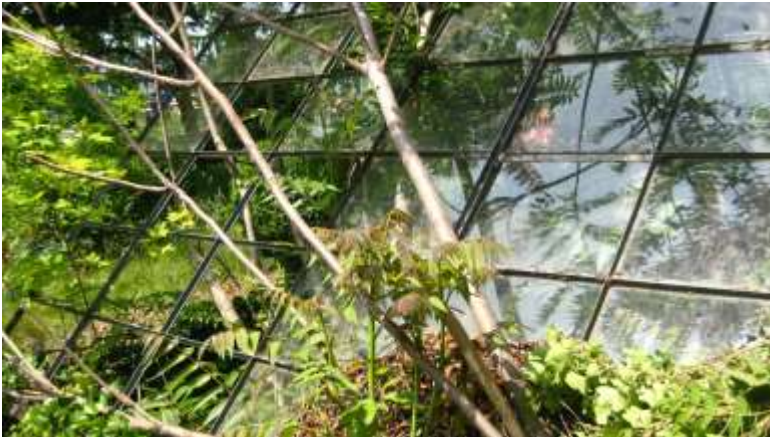
Hog Town House, May 2008, South East Elevation, Green House

Section 1: The greenhouse of steel in A frame design with seven foot by seven foot sides. Although many panes of glass were missing, they remaining were 1'8" x 1'4". The floor of the greenhouse was sunken by 3'4" below grade. See South elevation for more detail.

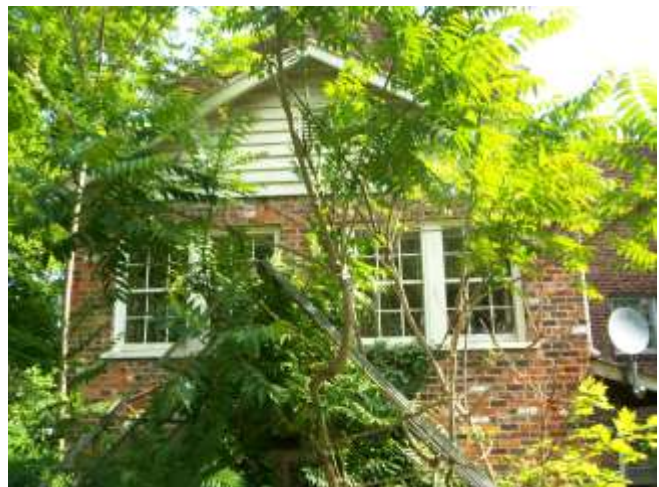
2. Sunroom addition, south elevation.  
Alden Watts, May 2006.

Attached to the old section of the house is a one-story sunroom addition, which measures 13' 6 ½" and has a poured cement foundation (figure 2). The addition is brick laid in a stretcher bond with cement mortar. The brick appears to be a mix of older and modern bricks, and measure

approximately 8 ½" x 3 ¾". The older bricks are darker, and some have paint and stucco remnants, indicating reuse.

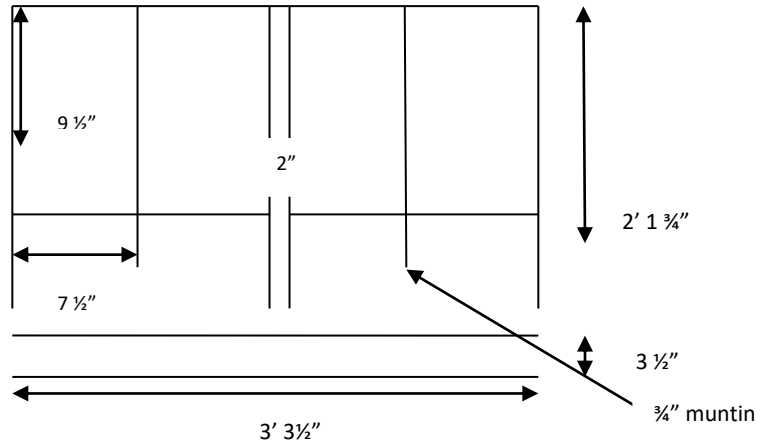
Windows: Two windows on west wall, each a sliding sash.

South window is mortis and tendon with pegs. North window was fastened with wire nails.  
Evidence of tan paint on window. Both windows are located 4' 2 1/2" from cement floor.

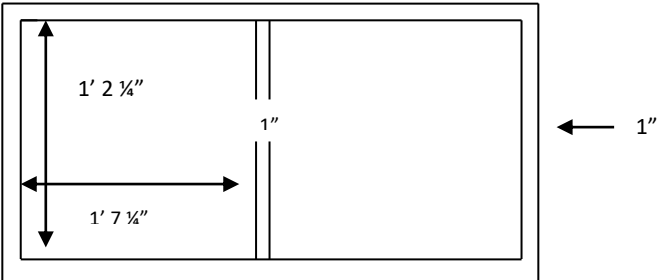
Window on east wall in southeast corner goes into crawl space, under addition, two pane, made of metal, with a wood casing. Depth is 1' ½", height is 1' 10".

Window lifts up and out and is located 4' ½" up from the cement floor.

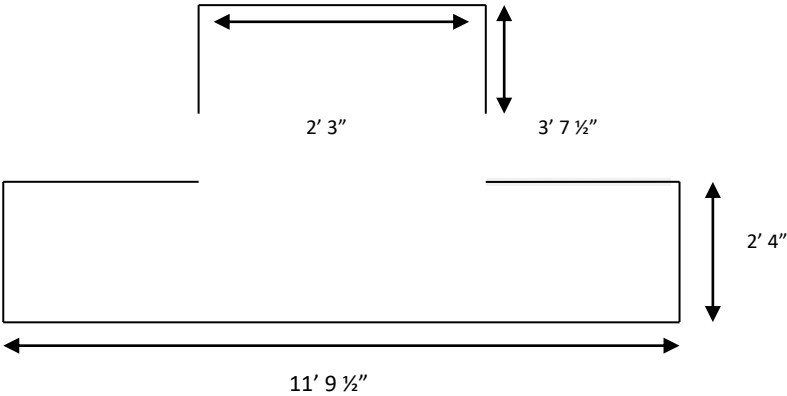
Fireplace: Not original to house but built over an existing fireplace. Made of stone with Portland cement. Massive stone lintel. Original metal lintel fell off or was removed. Rear of fireplace is lined with 4" wide brick or stone.

Mantel: Only a shelf made of stone.

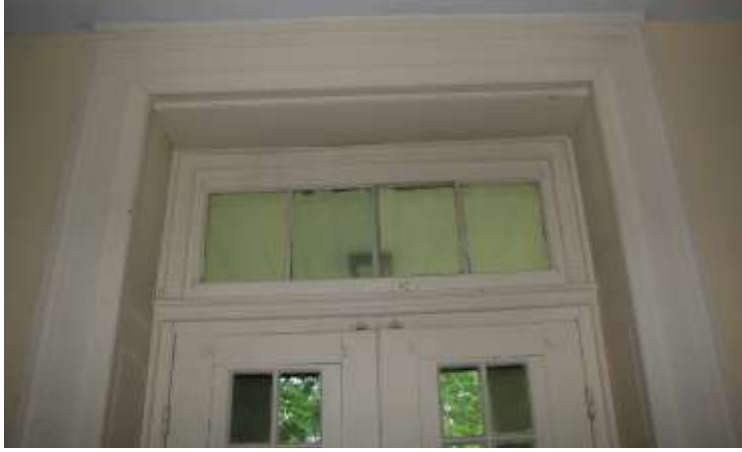
Figure 3. D100-1. Photograph by Travis McDonald, June 2008.

There are five doorways in the room. The front door (D100-1) is probably second period (figure 3). The door has an elaborate architrave with rope carving around the entire door frame, and reeding around the transom. There is a

transom containing 4 lights above the door, the thin muntins of which suggest it might be first period. The doors themselves are double, and of mortar and tenon construction. Each door measures 1' 10" by 7' 5", and has 12 lights arranged 2 by 6 in its upper 2/3. Each light measures 4 1/2" by 7 1/2", and the single panel set into the door below them measures 13 3/4" by 16". The hinges are set into the doors, and measure 3" high. The lock on the door is of two pieces; the keeper measures 3/4" by 4 3/4" and the lockbox measures 3 1/2" by 4 3/4". Both the lockbox and keeper are attached to the doors by screws, the keeper having 2 and the lockbox 4. Stamped onto the lock are the words "D.M. & Co New Haven." The doorknob is porcelain with a burlled finish.

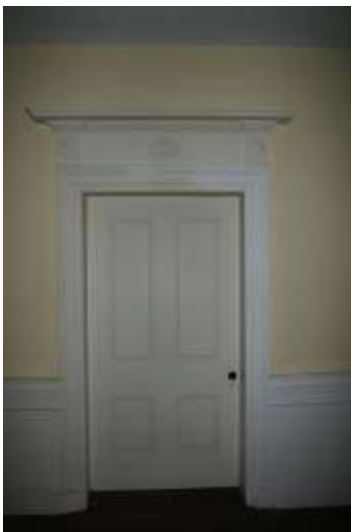
Figure 4. D100-2. Photograph by Travis McDonald, June 2008.

The north door architrave and doorcap (D100-2) matches those of the south door (D100-5) (figures 4 and 5). Both have an architrave and doorcap. The doorcap is highly ornamental in a derivative Federal folk manner. The cornice of the molding contains beaded, rope, and dentil courses. In the center and at the ends of the frieze section are what might be

er web medallions (patins?), rendered as lar  
p of the south door is chopped off on the w  
th door is of mortise and tenon constructio  
er panels. The knob of the door is porcelain

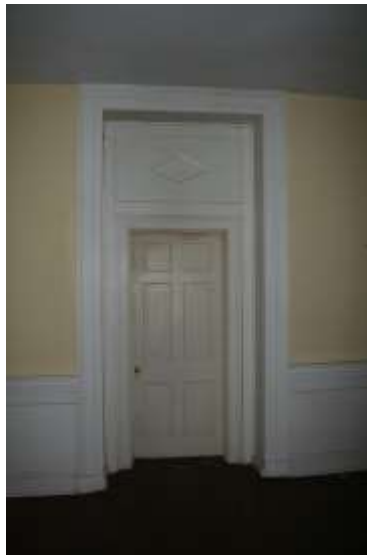
Figure 6. D100-3. Photograph by Travis McDonald, June 2008.

The east door (D100-3) is in original rear exterior door, but the architrave and doorcap are likely 6). Above the door is a panel that transom at one time. At present, large diamond in the middle. The and tenon construction with 6 panels. smaller than the 4 lower. The door construction of the south door.

the location of the door itself and its second period (figure might have been a there is a panel with a door itself is of mortise The 2 upper panels are matches the

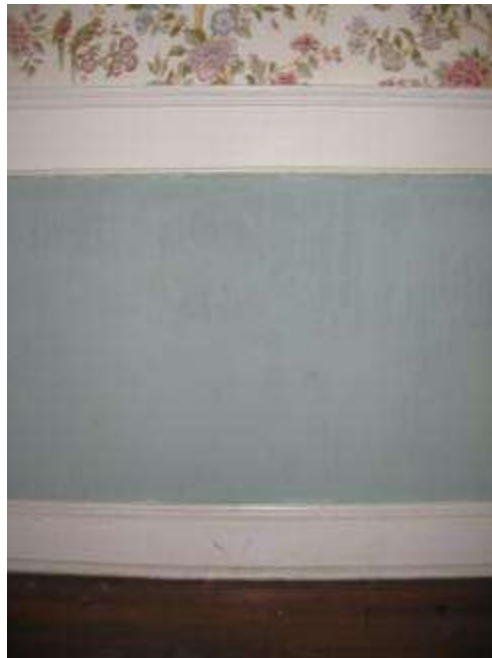
*Room 102, north wall, base and surbase. K. O'Shea*

A base runs around the perimeter of the room, extending from the floor up six inches. The surbase sits 2'5¾" from the floorboards and extends six inches to 2'11¾". Although the base and surbase are both six inches, they differ in profile. Both the base and surbase are constructed of wood and painted white, with evidence of a cream color paint underneath. This is evident on the surbase in the southwest corner and also in a paint analysis (see appendix ). The surbase is not uniform in profile around the perimeter of the room. The surbase extends behind the later addition of a corner cabinet in the southwest wall (see "other" for description of the corner cabinet).

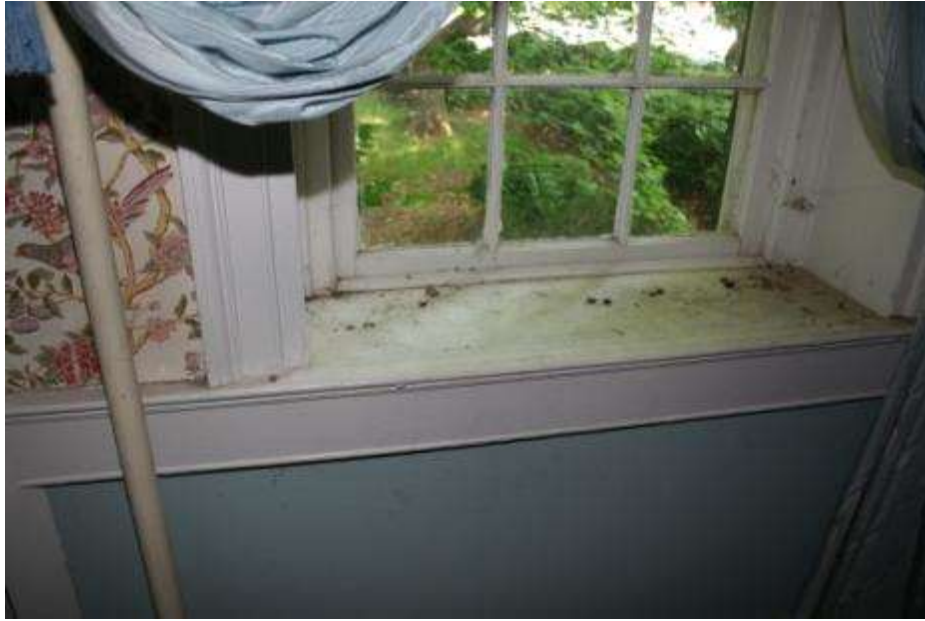
*Room 102, west wall, window 1, including the surbase, the depth to the window sash is 1'2".*

There are two windows in room 102, located symmetrically on the west wall, six feet apart. Both windows are believed to be original, although the architrave and casing differ from the rooms upstairs. The windows are double hung with 9/9 sashes. All of the framing is wood painted white. The windows are 6'8" from the sill to the bottom of the architrave. Each light measures 9 ½ inches wide and 11 ½ inches high. The muntins measure ¾ inches wide. The depth of each window jamb is 1'0". The width of each window is 3'4" without the architraves, which are 5 ½" wide each. On the jamb of window 2, a sash holder remains. The wooden piece, painted white, serves to hold open the sash. (See photograph below, where it is circled.)

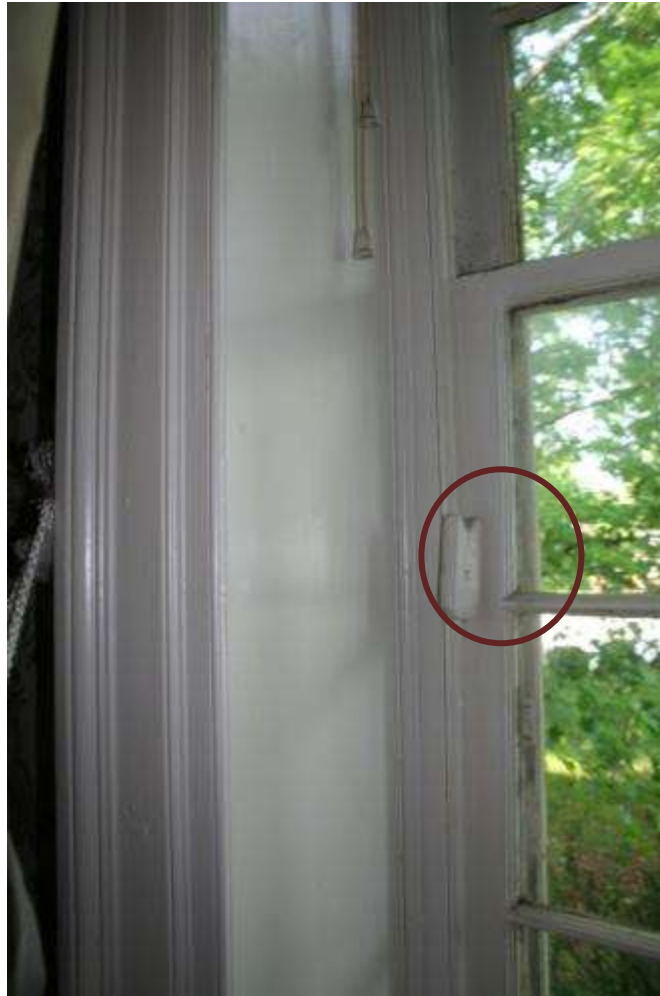
*Room 102, Window 2, window sash holder (circled), T. McDonald*

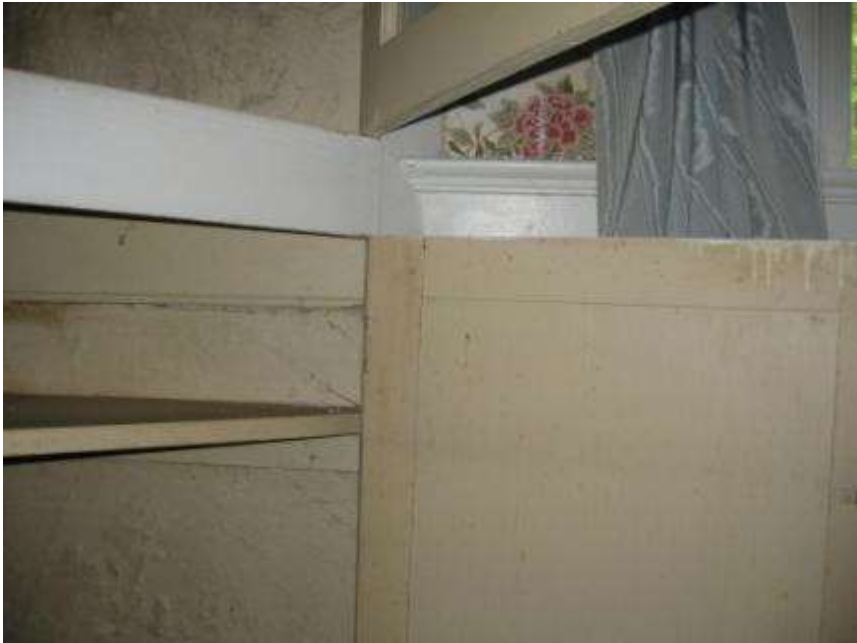
*Room 102, southwest corner, note surbase visible within the corner cabinet as well as the unpainted plaster, K. O'Shea*

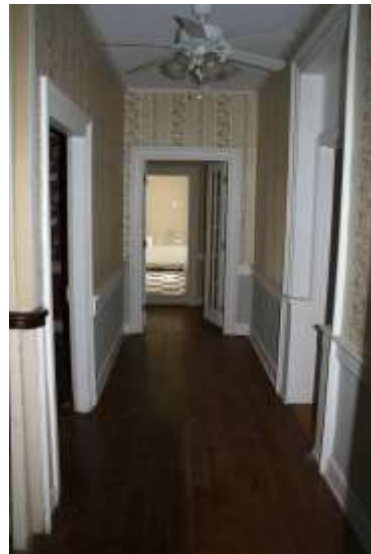
Figure 1. Room 200. Photograph by Travis McDonald, June 2008.

The walls are plaster, and feature a baseboard and sur-base (figure 1). The baseboard is 6 1/2" high, with a simple profile. There is a two-socket electrical outlet located 3' 3 1/2" north of the west door. The sur-base is placed 2' 5 1/2" above the floor, and is 6" high (figure ). The wall below the sur-base is painted grey, and above the sur-base is flowered wallpaper.

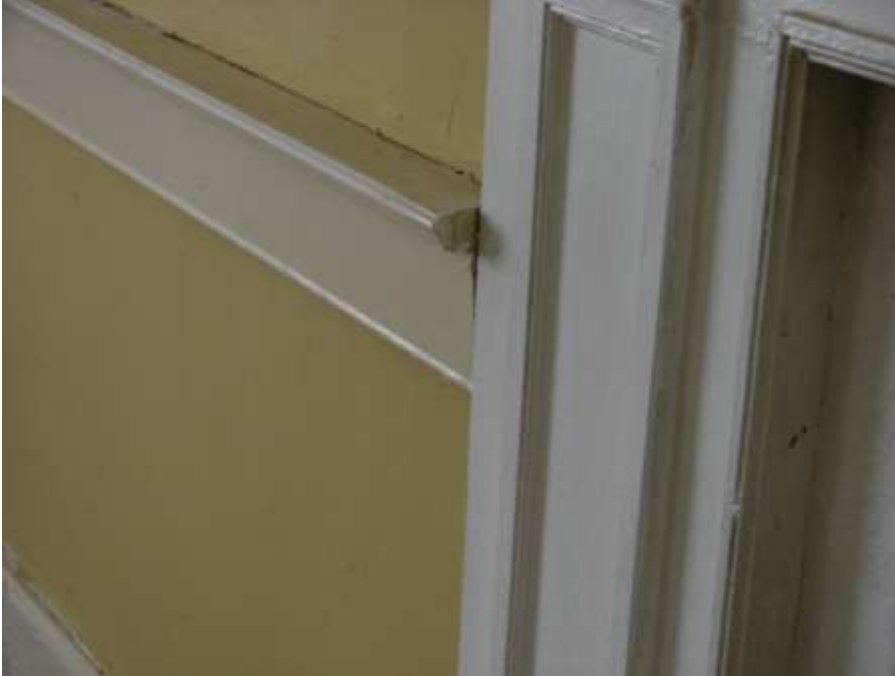
The surbase of the wall is not molded round or notched into the trim of the mantel, but cut off abruptly when it reaches it.

The brick of the hearth does not extend as far to the right as the end of the mantel post on that side.

The fireplace is rather shallow, so may have been filled in a little, and there is a metal pipe wedged long-ways inside the chimney shaft to block it.
